Halifax Public Gardens

Excavation of French Drain Near Horticultural Hall

Archaeological Resource Impact Assessment

Davis MacIntyre & Associates Limited
109 John Stewart Drive, Dartmouth, NS B2W 4J7

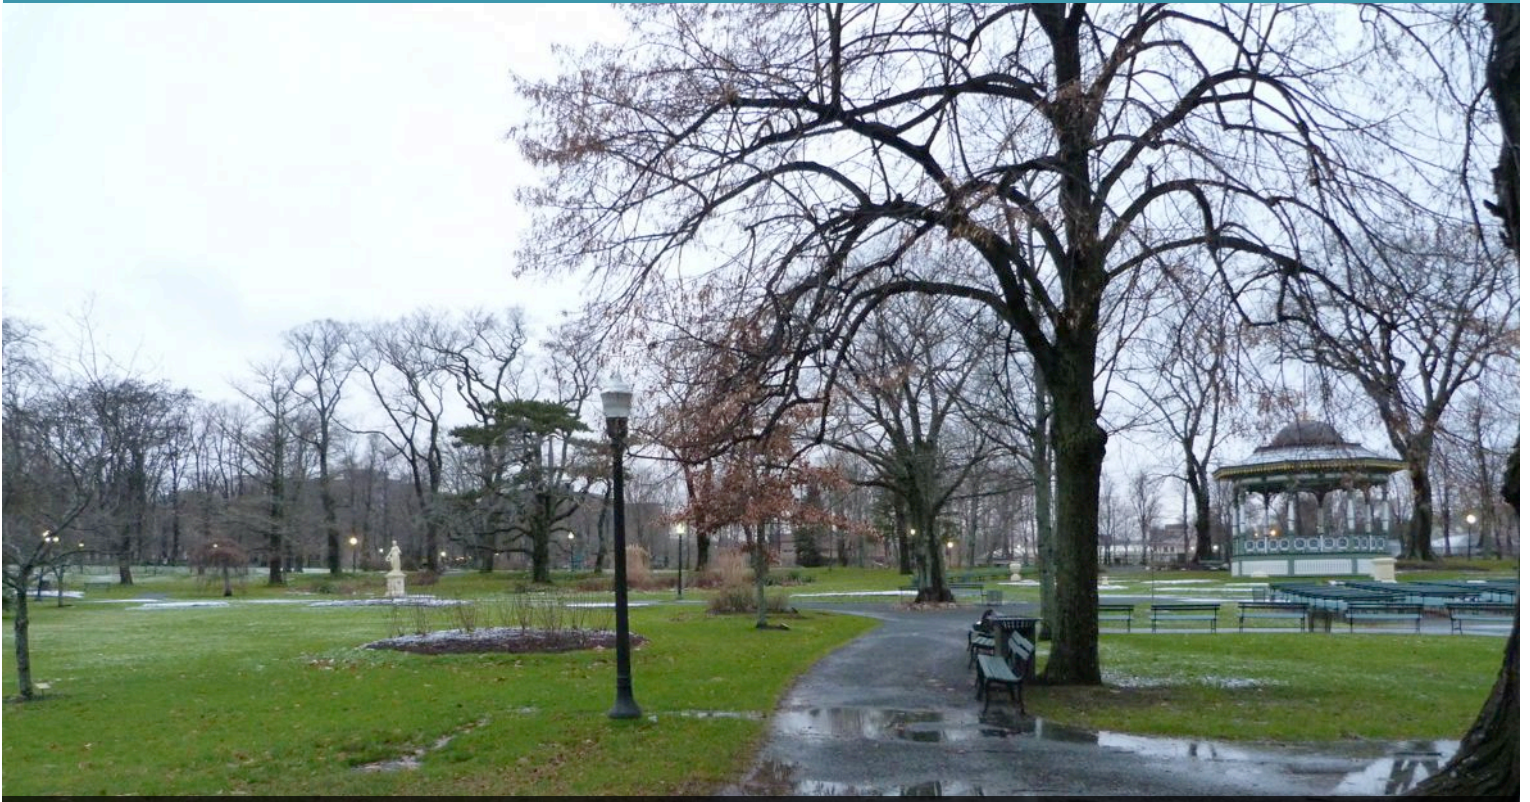
Cover image: Study area prior to excavation, looking north. The trench was located on the west (left) side of the light standard. The drainage problem is evident in the photo.

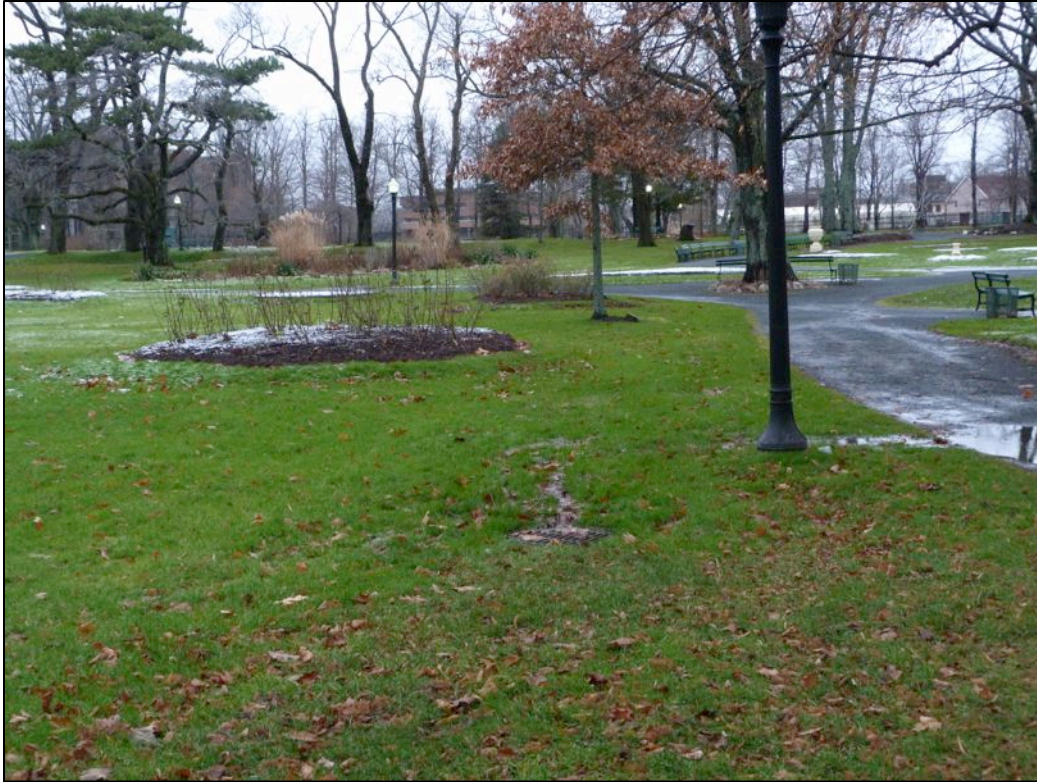
Plate 1: Location of the trench prior to excavation, looking north.

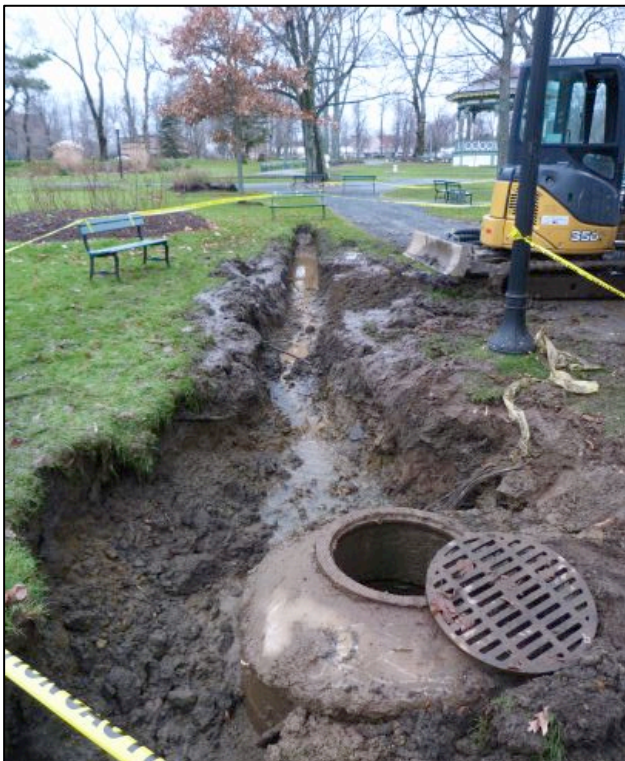
Plate 2: The trench after excavation, looking north.

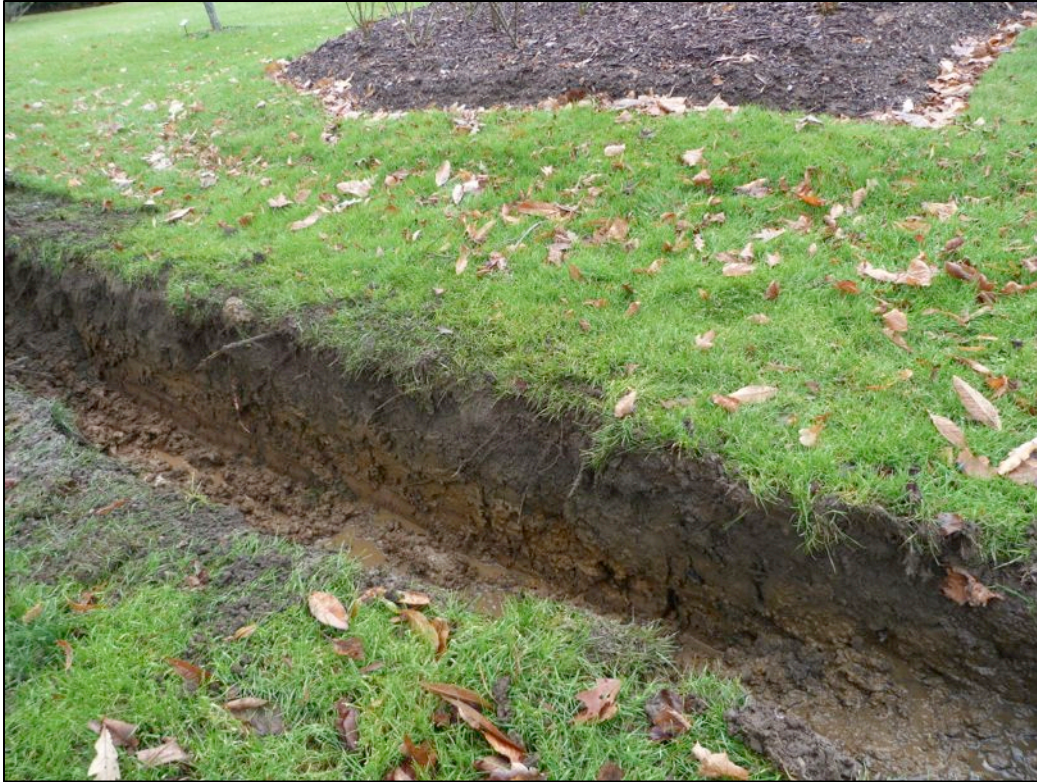
Plate 3: West wall profile of the trench north of the light standard, looking southwest.

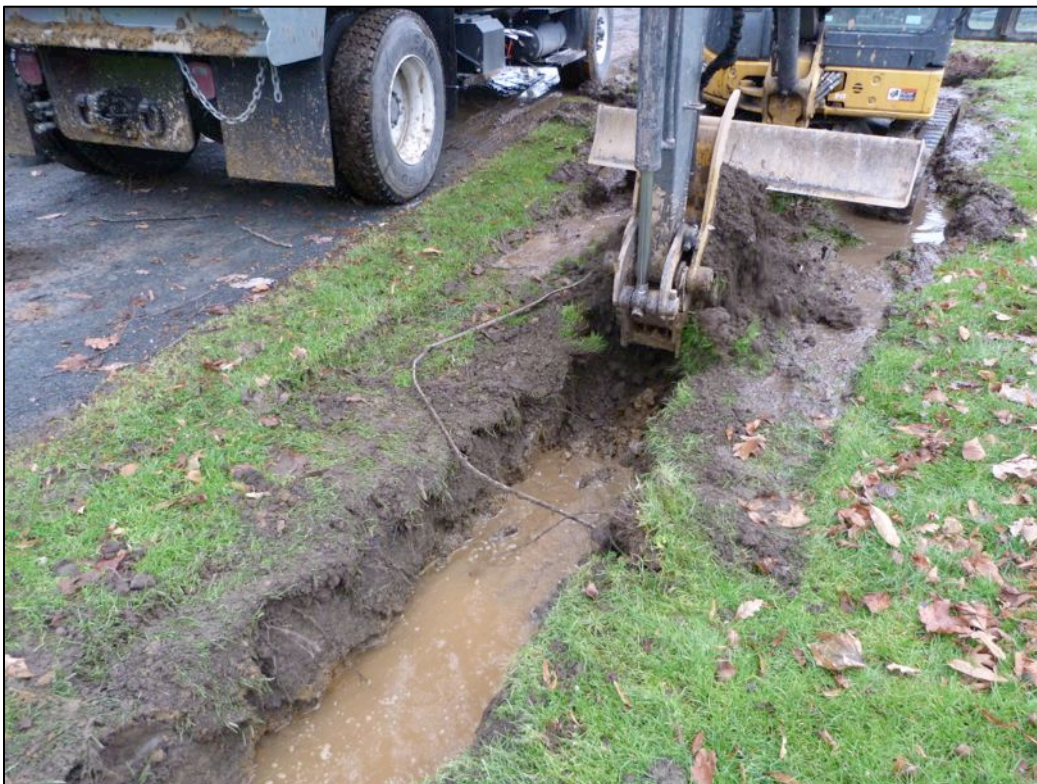
Monitoring of excavation of the trench was conducted by April MacIntyre on December 20, 2012. The trench was approximately 13 meters long and 0.6 meters wide and ran parallel to the walkway that runs north-south along the west side of Horticultural Hall (Plate 1). The trench ran northward from the catch basin adjacent to the light standard (Plate 2). The soil to the north of the light standard was clean medium brown sandy clay loam and natural till was reached at approximately 12 inches (30 cms) below the surface (Plate 3). A lead electrical conduit was encountered running along the long axis of the trench approximately 6 meters north of the light standard (Plate 4).

Plate 4: A lead electrical conduit can be seen in front of and beside the excavator bucket (looking south southeast).

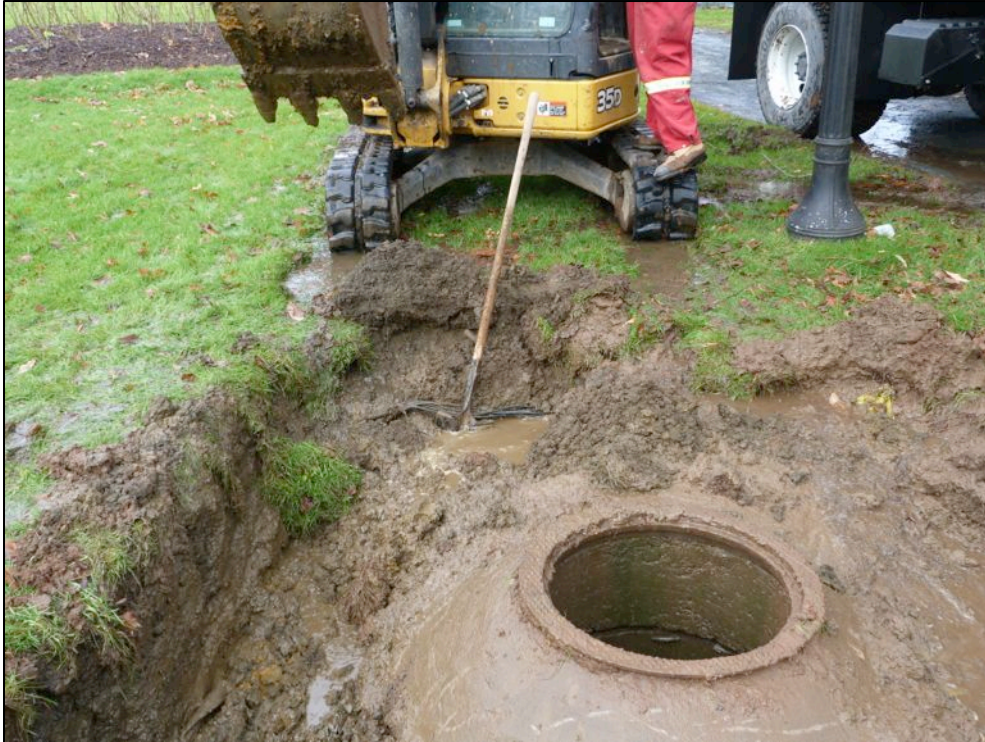
In the south end of the trench, there was significantly more disturbance related to previous activities. The installation of the catch basin at the southern boundary of the trench resulted in obvious disturbance in this area and it appears that there may have been an earlier French drain on the west side of the catch basin as this area was in-filled with clear stone which was underlain by geotextile fabric (Plate 5). The drain was encountered at approximately 18 inches (45 cms) below the surface. The drain was capped with a layer of clay. On the north side of the catch basin adjacent the light standard, exposed electrical wires (no conduit) were encountered running across the trench (Plate 5). A single sherd of blue transfer printed whiteware was seen amongst the disturbance but was not collected as it was in a disturbed/secondary context.

Plate 5: Beginning of excavation at the south end of the trench at the catch basin. An older French drain was installed on the west (left) side of the catch basin (looking north). Exposed electrical wires can be seen just in front of the excavator and are being secured in place by the upright shovel.

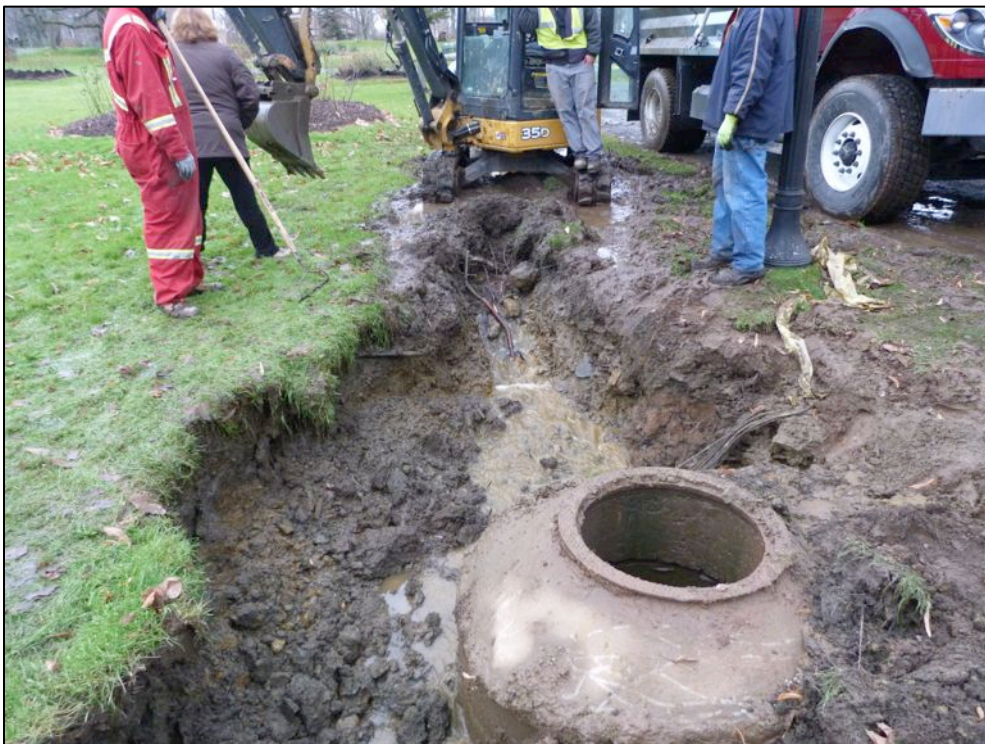
Just north of the light standard in the area where water could be seen seeping to the surface, running water was encountered (Plate 6). It appeared to be a natural rivulet running across (east-west) the trench. Along the path of the flow, broken rock and brick fragments were encountered which appear to be related to a fill episode, perhaps as an attempt to in-fill the stream (Plate 7). The debris does not appear to be structural in nature, meaning that it was not likely associated with a formal drain feature. A single unmarked clay tobacco pipe stem was noted among the stone and brick fill.

Plate 6: The south end of the trench showing the rivulet (at the far north end of the excavated area) draining out (looking north).

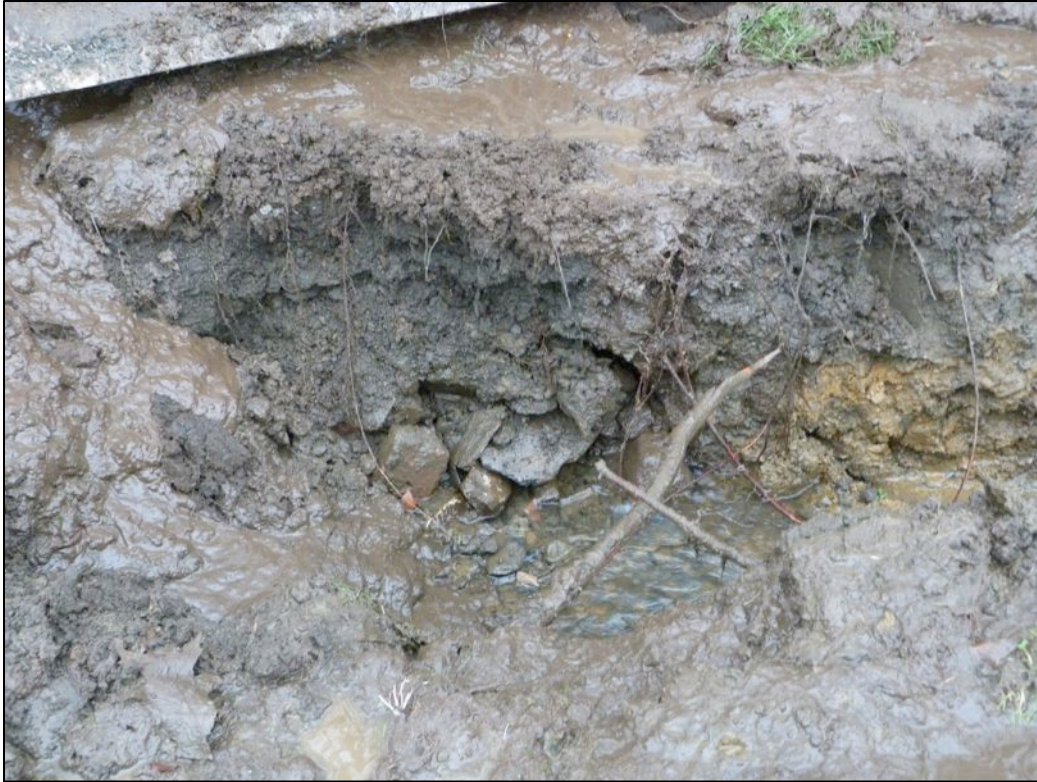
Previous archaeological investigations in the Public Gardens, particularly in the vicinity of the current study area, have indicated that there is significant disturbance to the soils. This is further corroborated by the record of past activities in the area including installation of catch basins and light standards. No significant archaeological resources were encountered during excavation of the trench. It was shown that a small watercourse once ran through this area, which was likely the source of the recent drainage problem, and that an earlier attempt had been made to in-fill this watercourse.

Plate 7: East wall profile of the trench where the rivulet cuts across it. The watercourse appears to have been in-filled with brick and stone.
