**GOVERNMENT HOUSE, HALIFAX:
ARCHAEOLOGICAL RESOURCE IMPACT ASSESSMENT**

Heritage Research Permit A2006NS76, A2007NS05

March 2007

Submitted by:
Davis Archaeological Consultants Limited
6519 Oak Street
Halifax, Nova Scotia
B3L 1H6

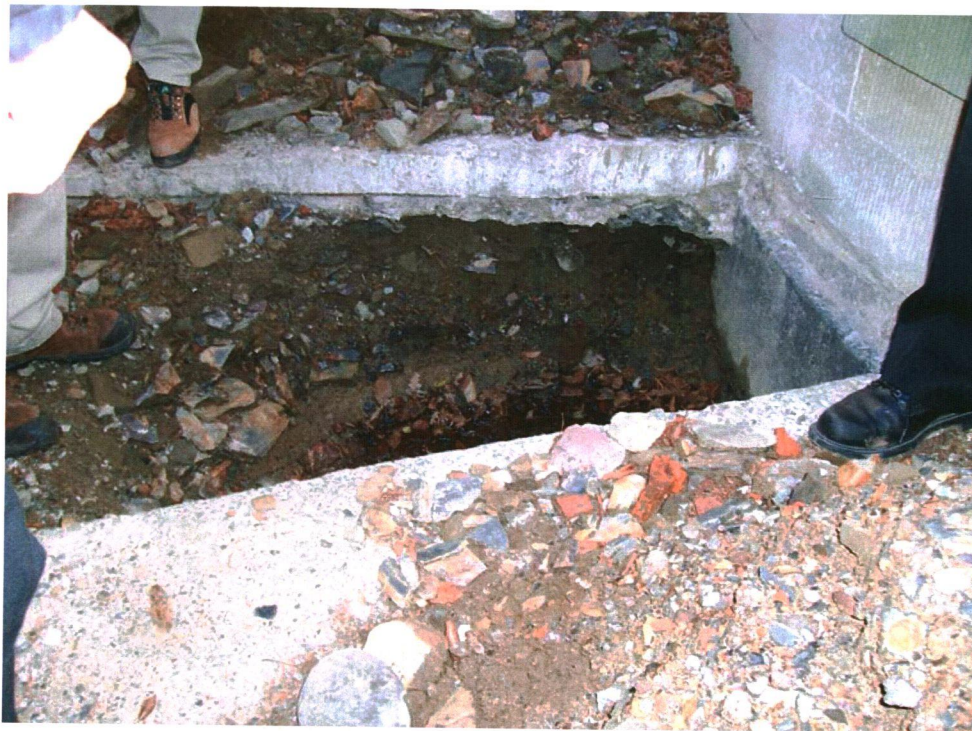
Plate 2: Removal of concrete and fill from north end of moat for initial inspection on 21 November 2006.

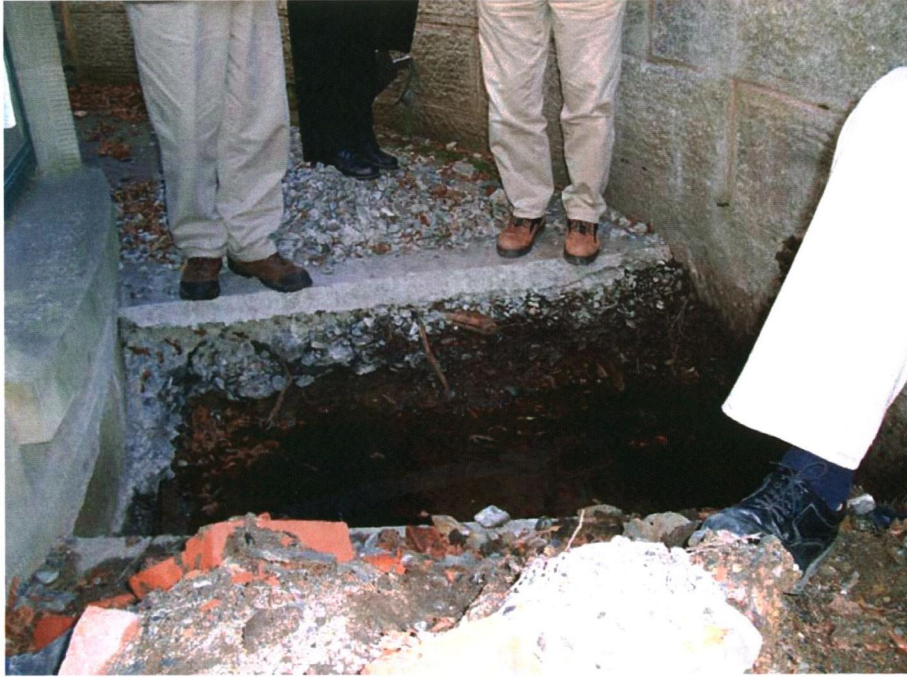
Plate 3: Removal of concrete and fill from south end of moat for initial inspection on 21 November 2006.

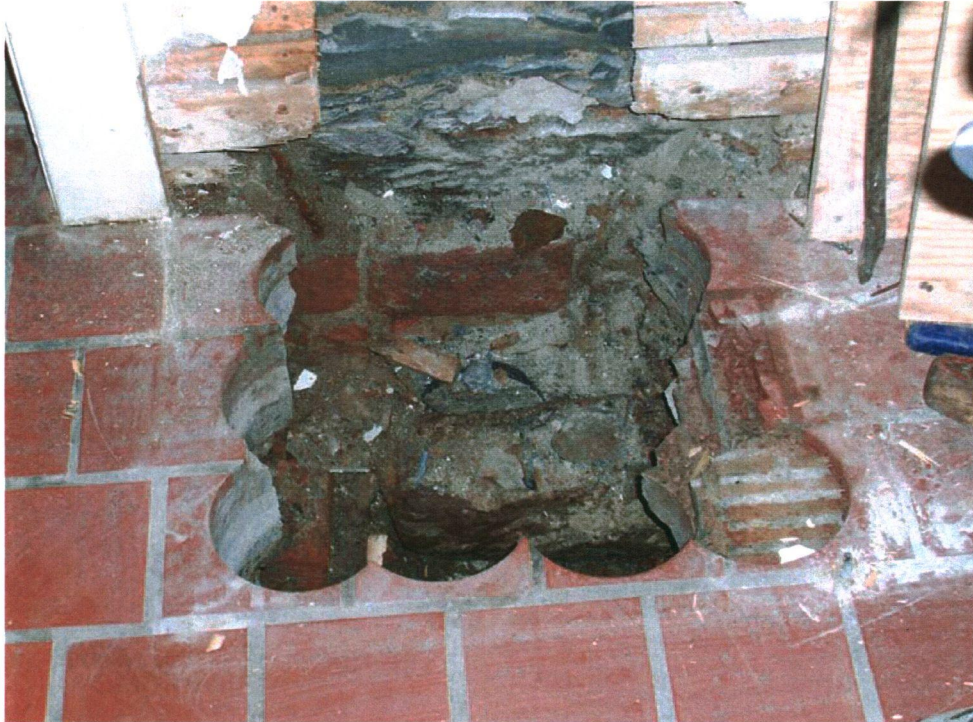
The first drilled area in the basement was in the locker room on the north side of the kitchen immediately west of the kitchen entrance. Here, a potential footing or threshold approximately 0.3 metres wide and constructed of a single course of brick on top of Halifax slate was observed. The original dry-stone slate wall of the kitchen was exposed from behind the current wood planked wall (Plate 5).

Plate 5: Stone and brick footing or threshold beneath the existing floor on the north side of the kitchen.

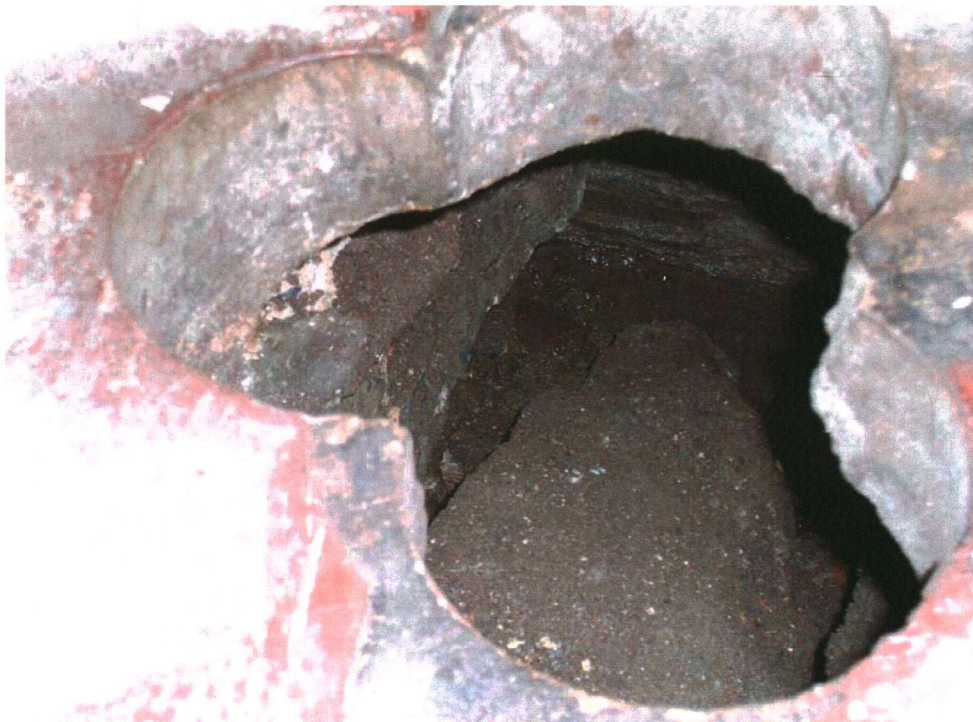
The second drilled area was in the room immediately east of the locker room along the room's north wall. A stone drainage feature was observed running north-south (Plate 6). The final drilled area was on the north wall of the locker room in an area slated for an elevator shaft. Directly beneath the current floor were slate floor tiles from the original floor (Plate 7).

Plate 6: Stone drainage feature beneath the existing floor, east of the locker room.

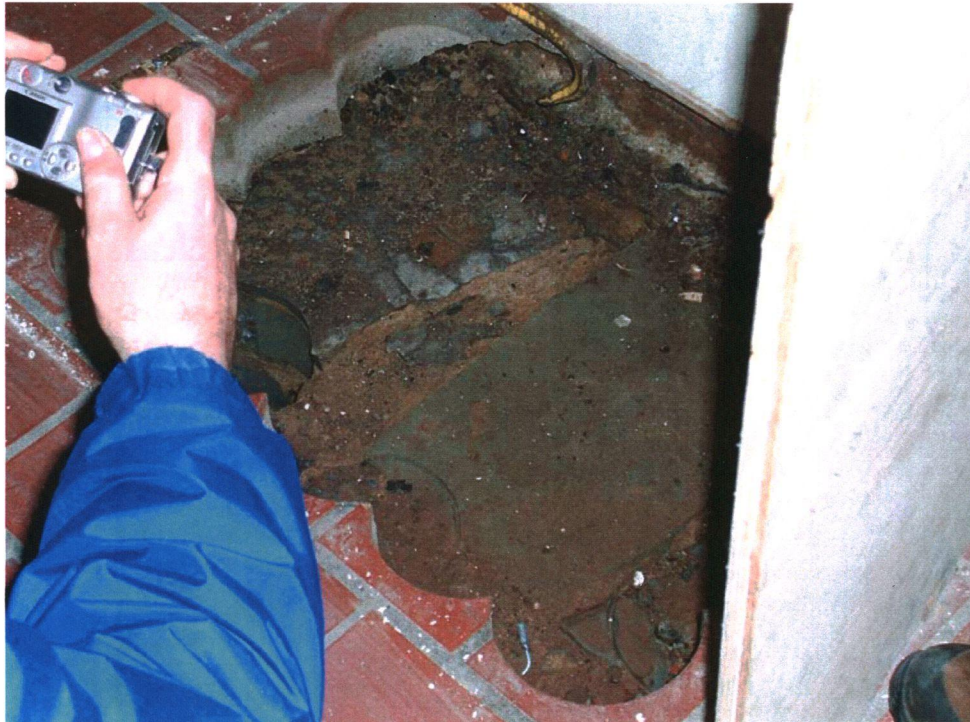
Plate 7: Slate floor tiles beneath the existing floor on the north wall of the locker room.

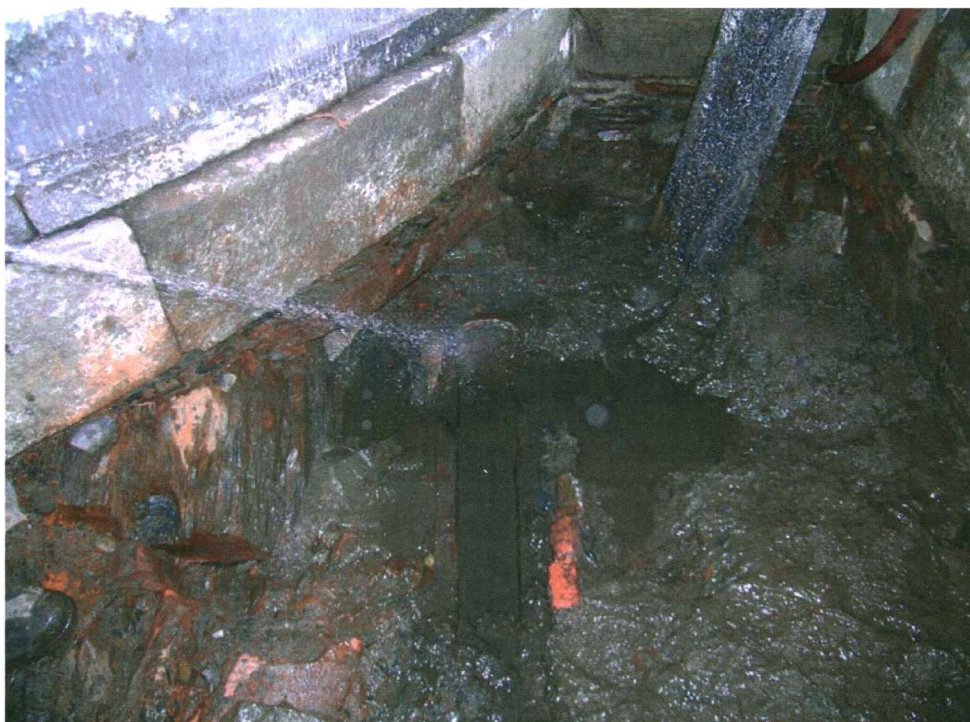
Archaeological monitoring of a wood-lined drain in the south moat was conducted on 07 February 2007. The drain was oriented roughly southeast by northwest and extended across the width of the moat. Adjacent to the house, the wood-lined portion of the feature connected to a clay drainage pipe which leads under the exterior wall of the house into the kitchen area. The interior of the drain was heavily silted (Plate 8). No artifacts were encountered in the drain.

Plate 8: Wood-lined drain the south moat, looking southeast.

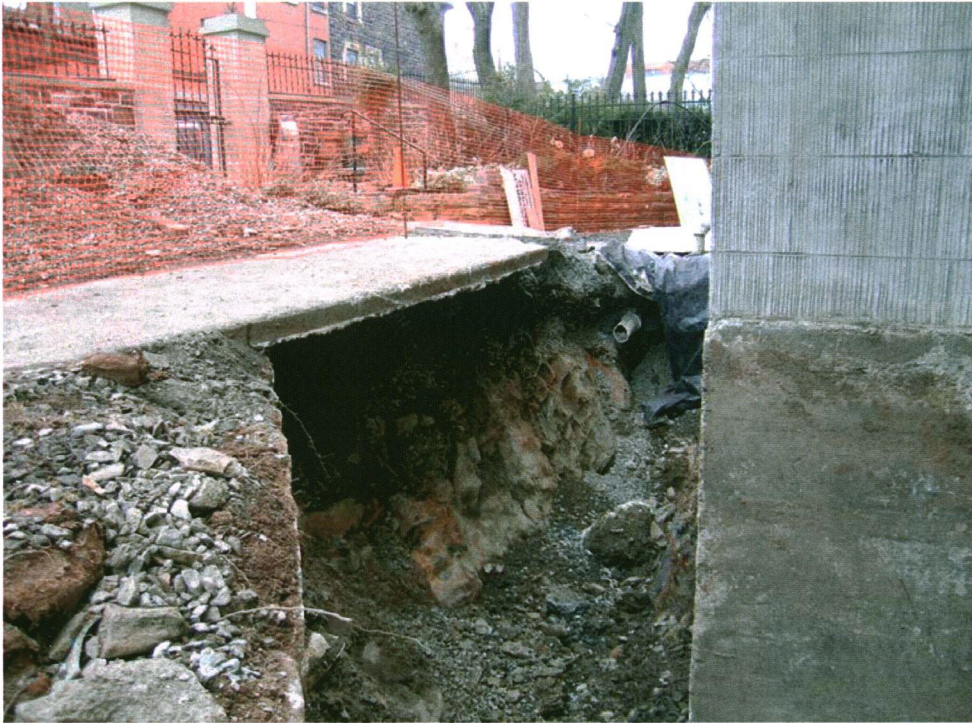
The gardens near the southeast corner of the house have revealed artifacts associated with the early (c. 1805-1840) occupation of the house. This area was recently disturbed by excavation of a trench for sanitary sewer. Investigation of an excavated trench at the exterior southeast corner of the house and along the south wall revealed gravel fill beneath the concrete walkway. Directly beneath the gravel was bedrock. PVC conduit could be seen running through the gravel fill (Plate 9). On the east side near the corner was an area approximately 0.60 metres in length in the trench profile which showed undisturbed soil. No *in situ* artifacts were encountered in this area.

Plate 9: South side of Government House near southeast corner showing previous disturbance and modern fill associated with sanitary sewer service.

Excavation in the southeast garden revealed previous disturbance associated with installation of sanitary sewer services. However, excavation in this area prior to archaeological monitoring did reveal numerous disturbed artifacts which were observed on the surface, many of which are associated with the earliest occupation of the house. Historic depictions of the grounds show that there were guard houses near the Hollis Street entrance to the house and gardens on the north and south sides. Due to the potential for additional in-situ resources on the east side of the house, it is recommended that any future ground disturbance in this area be monitored by a qualified archaeologist.

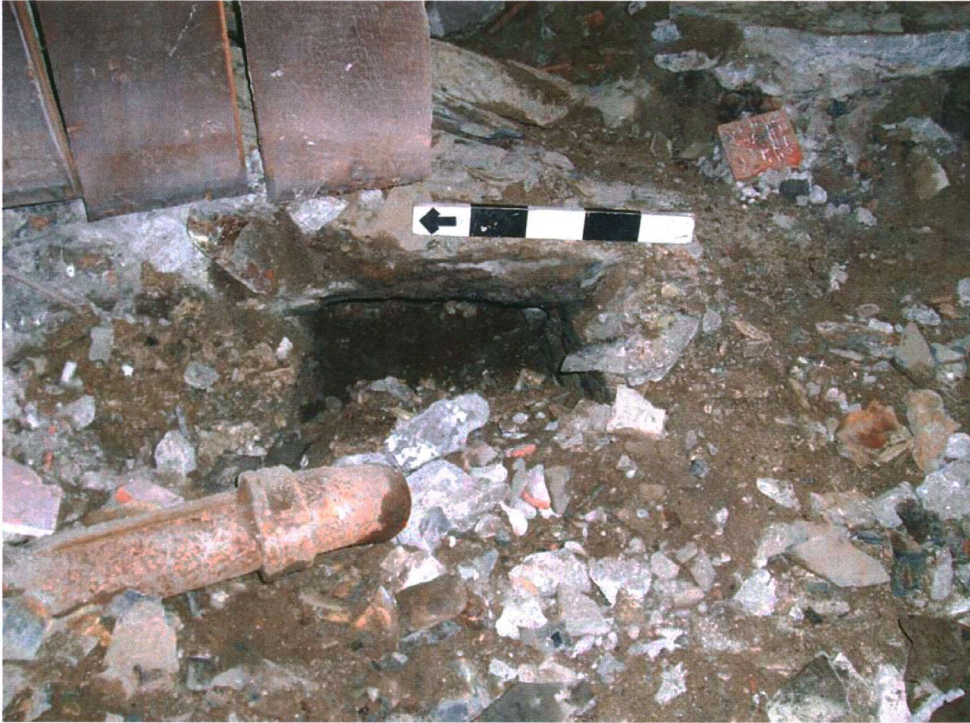
Plate 11: Stone-lined drain running east-west through the front-facing storage room, looking east.

The cap stones from the drainage features were removed and the drains in-filled for stabilization beneath the new flooring. The walls of the drains themselves were minimally disturbed, if at all.

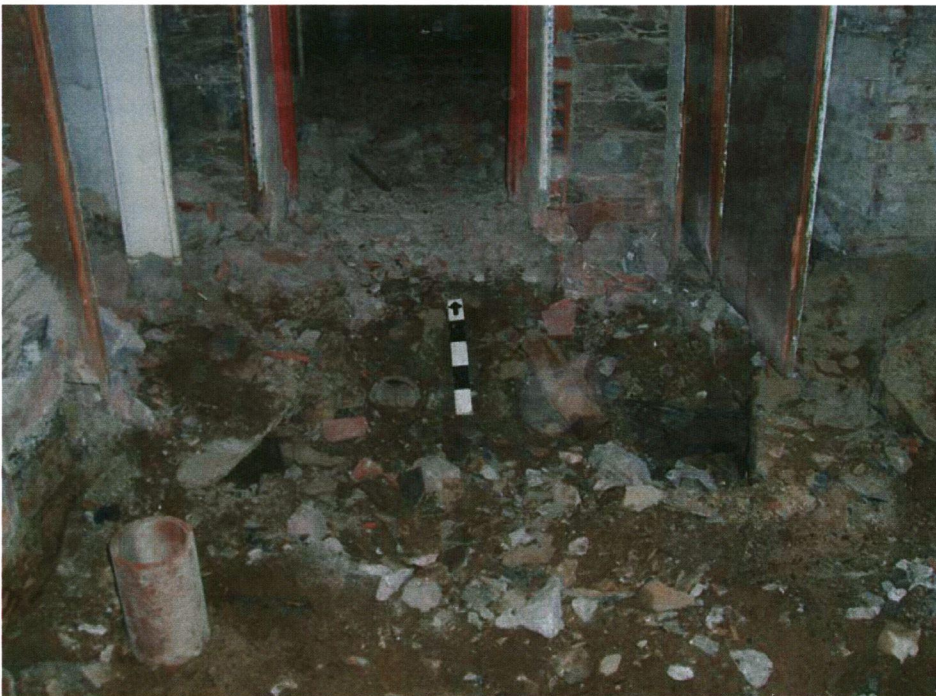
Plate 12: Stone-lined drain running east-west through the storage room (horizontal in photo), and intersecting north-south drain at course earthenware pipe junction, looking north.

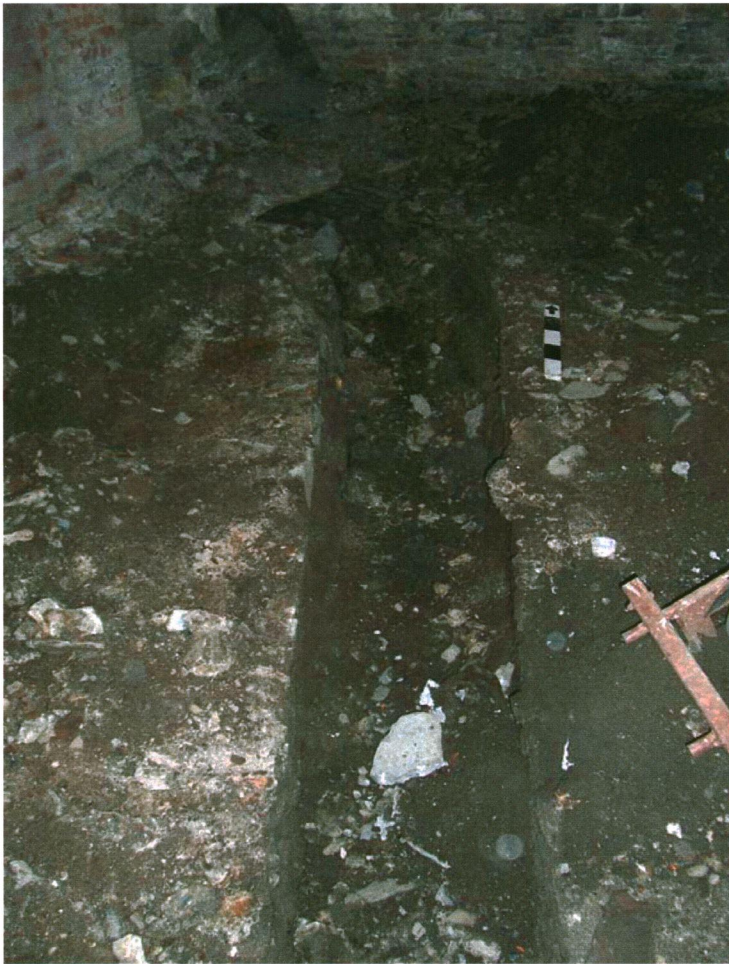
The east-west aligned drain continued under the east wall of this room to the storage room in behind (to the east). Here, the drain curved southward and continued beneath the south wall of the storage room (Plate 13). It was not seen in the room to the south.

Plate 13: Curved stone-lined drain in storage room, looking northwest.
