**FISHERIES MUSEUM OF THE ATLANTIC
STABILIZATION AND RENOVATION
ARCHAEOLOGICAL MONITORING 2013-2014
LUNENBURG, NOVA SCOTIA**

FINAL REPORT

Cultural Resource Management Group Limited

CRM Group Project Number: 2013-0014-01

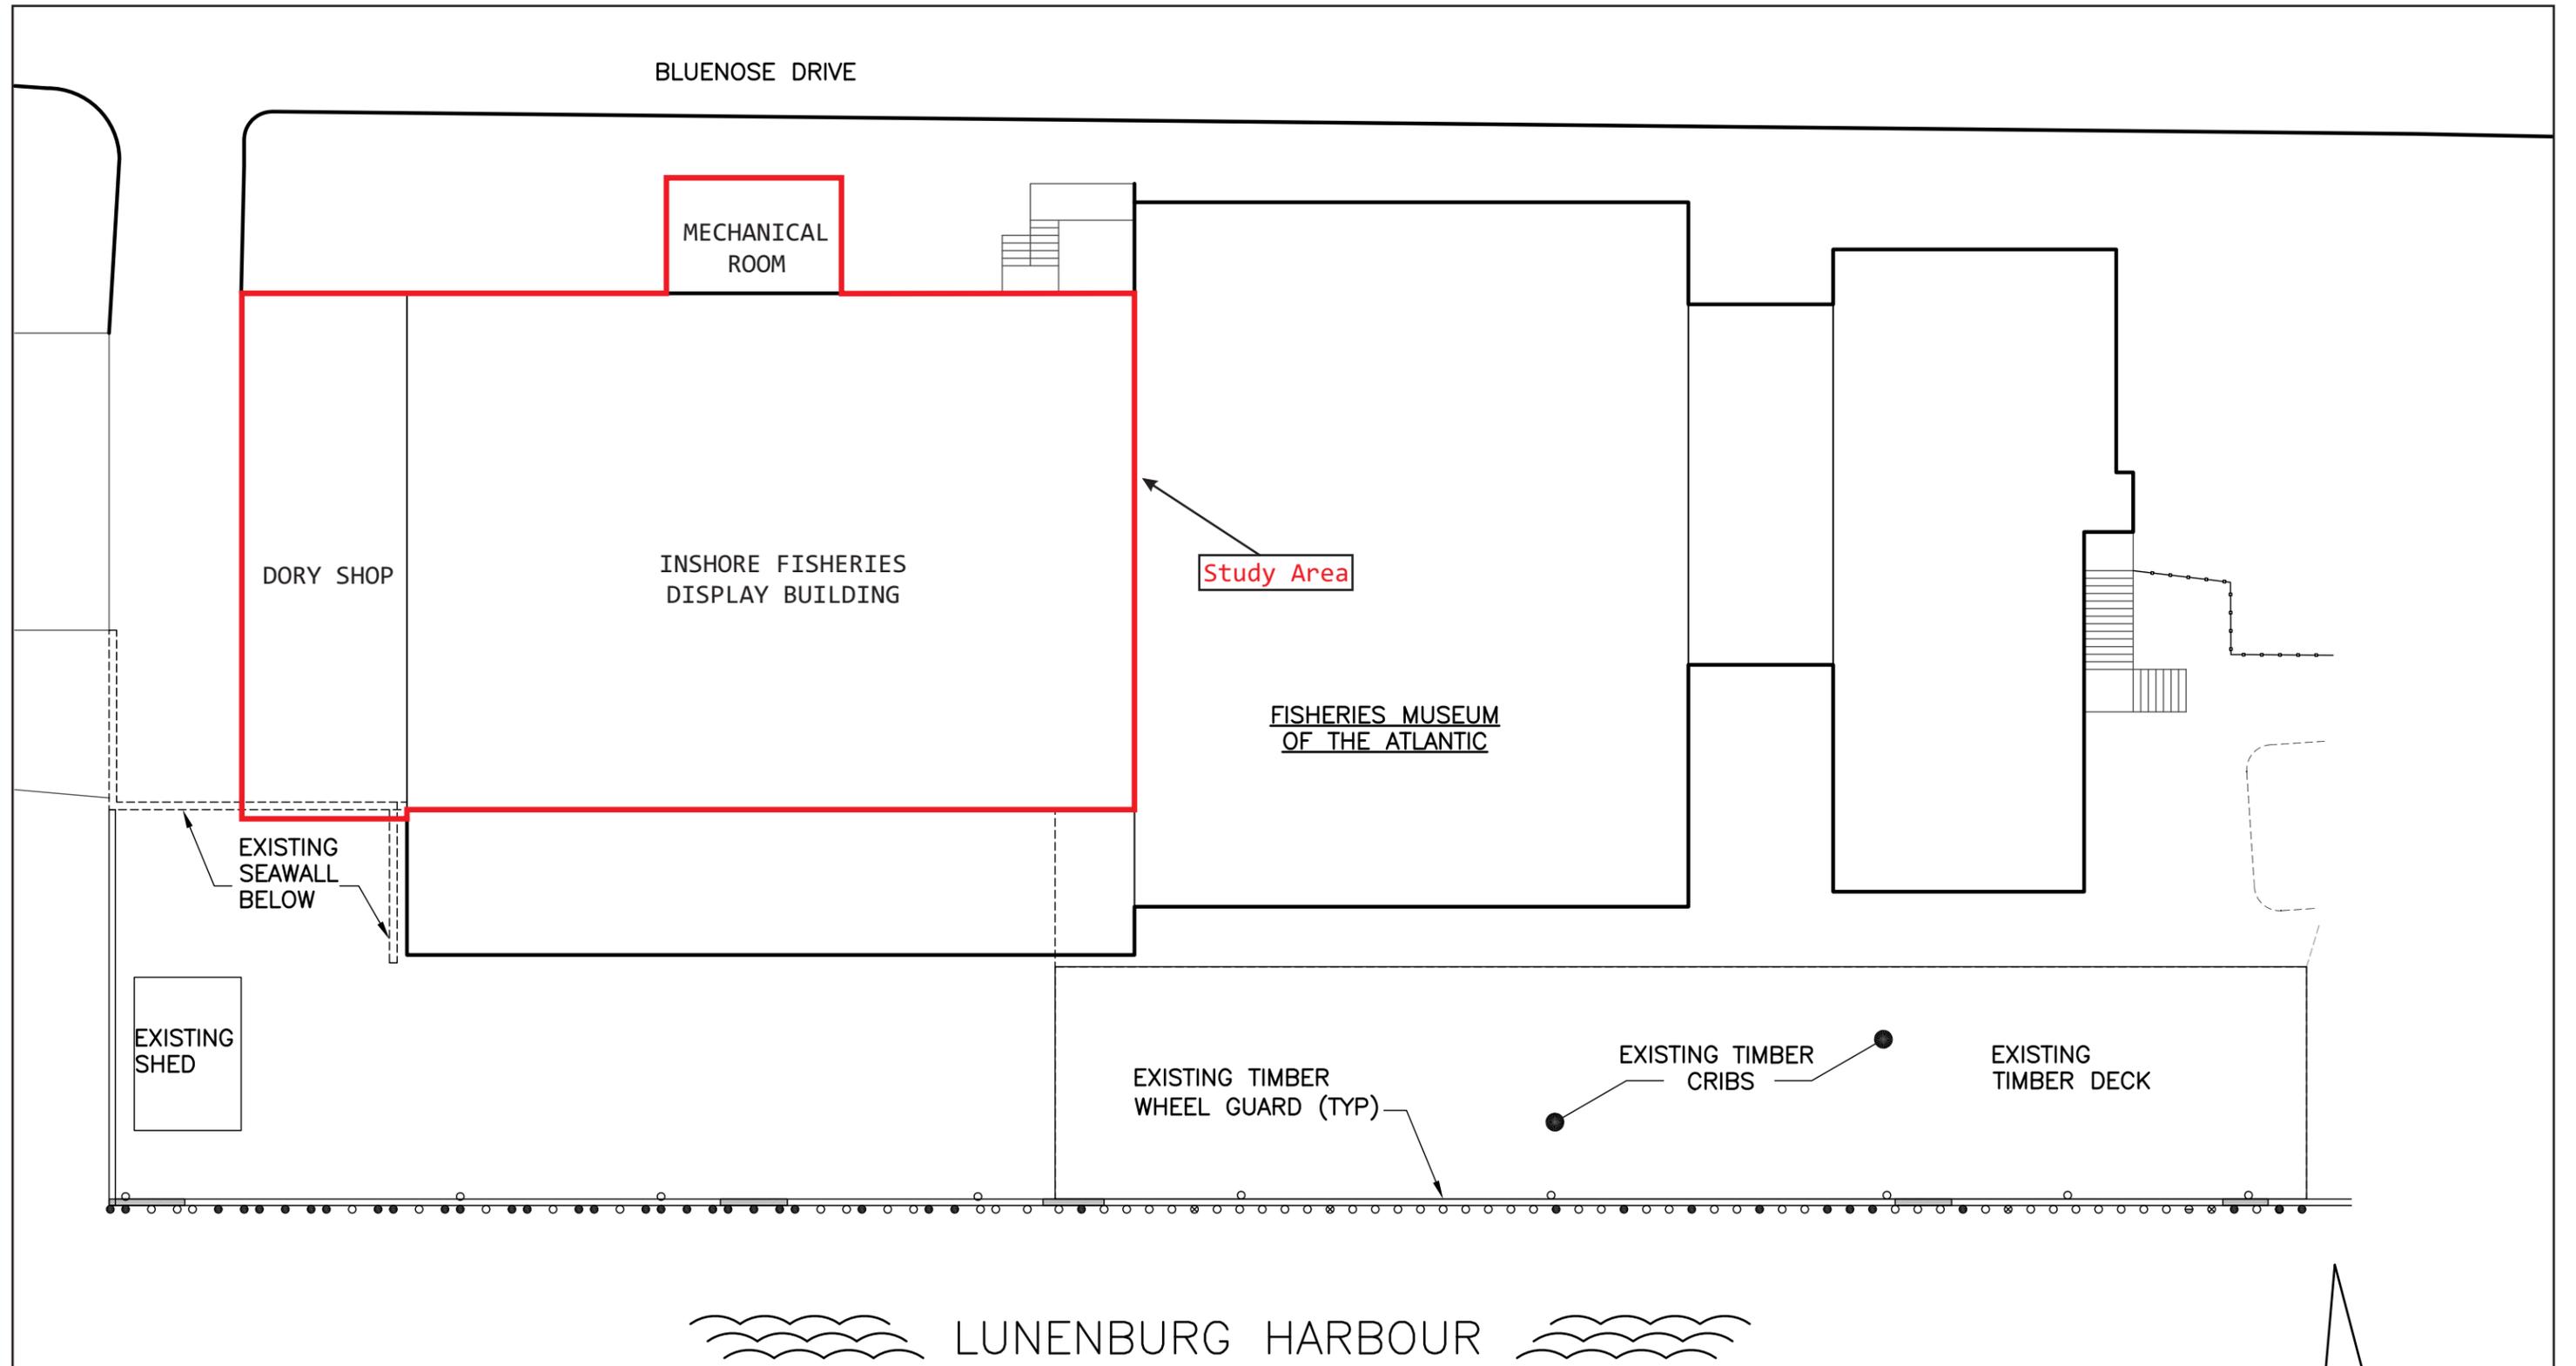
<i>Detailed Site Plan</i>	<i>Figure 3</i>
	FISHERIES MUSEUM OF THE ATLANTIC RENOVATIONS ARCHAEOLOGICAL MONITORING 2013	June 2014
	LUNENBURG, NOVA SCOTIA	Scale 1:250

The FMA Inshore Fisheries Display Building and Dory Shop (hereafter referred to together as the Fisheries Buildings) are located at 68 Bluenose Drive in Lunenburg and are the westernmost buildings in the FMA complex. The FMA property is bounded on the north by Bluenose Drive, on the east by the Lunenburg Fisheries Memorial Monument and the Adams and Knickle Limited warehouses, on the south by Lunenburg Harbour, and on the west by a vacant lot - the former site of an Irving Oil Limited oil tank yard (**Figure 2**). Excavations were carried out within the full footprint of the Fisheries Buildings structure, as well as on the FMA mechanical room, a northern extension off the Fisheries Buildings (**Figure 3**).

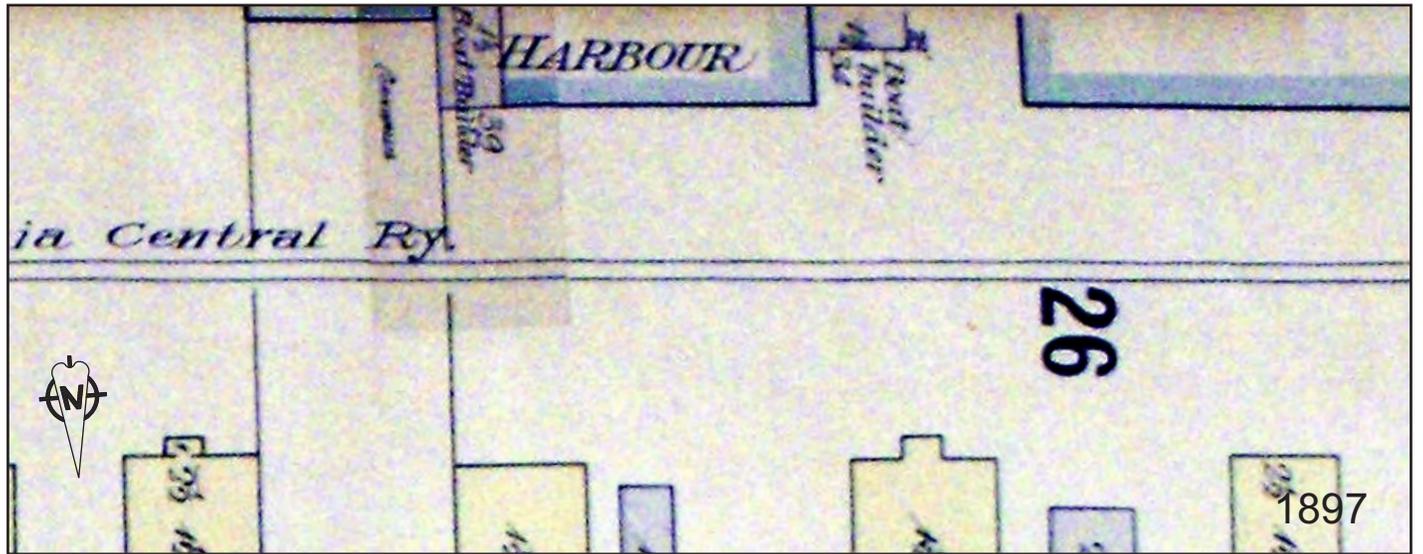
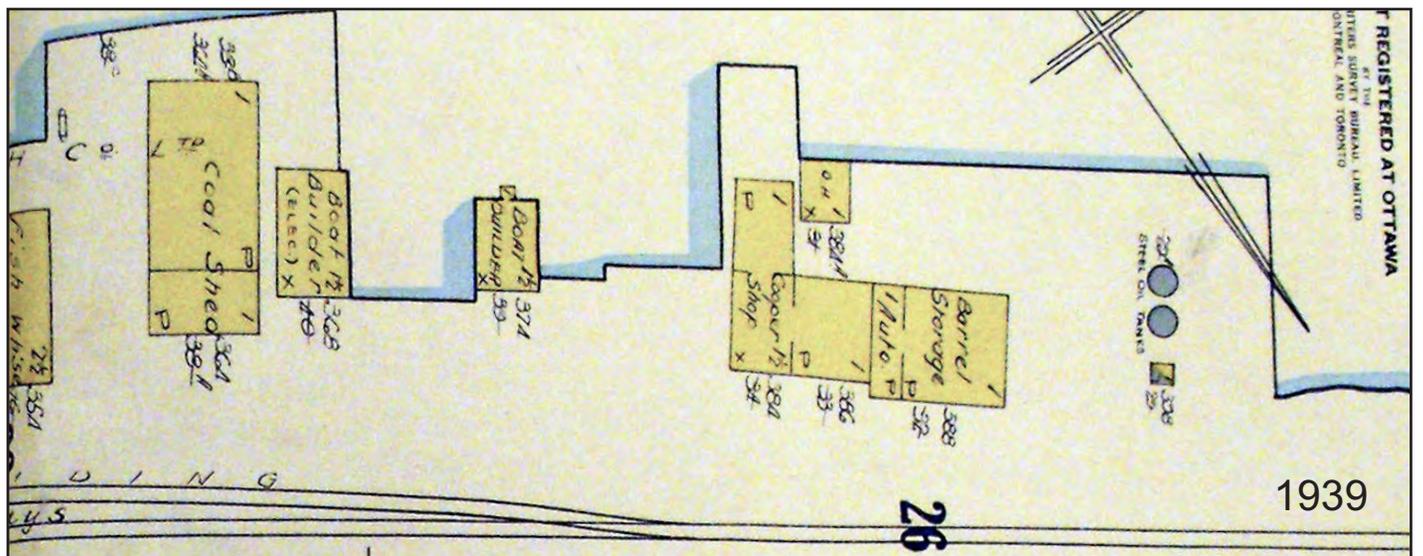
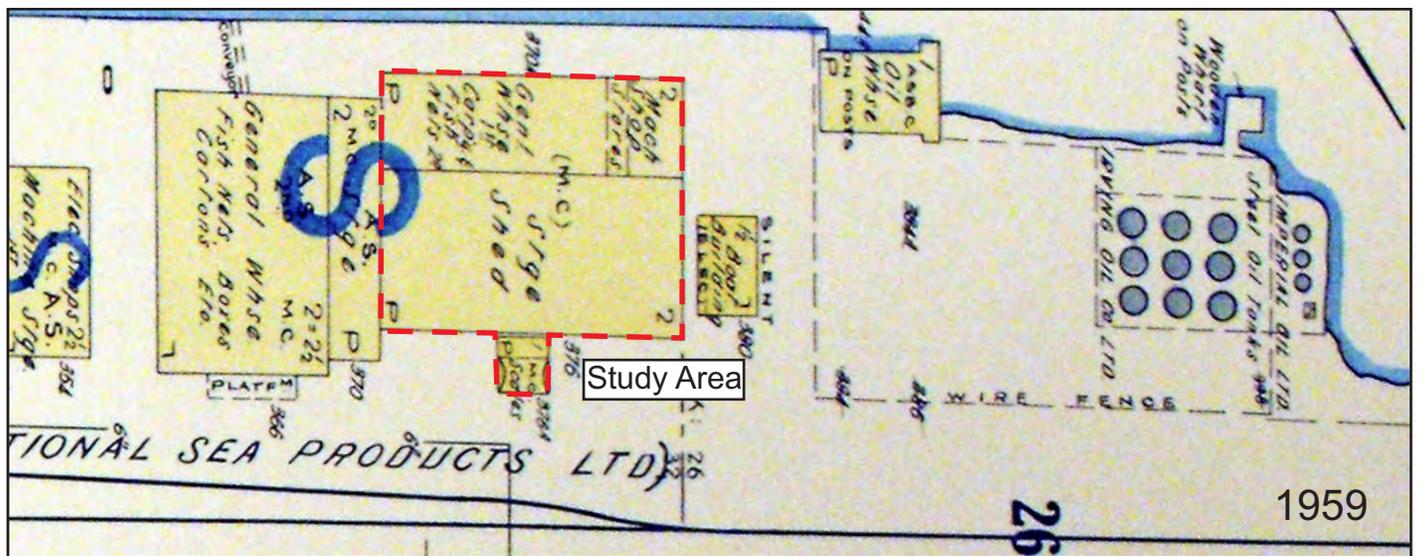
Figure 9
 June 2014

A useful tool in examining the development of the Lunenburg waterfront are the various editions of the town fire insurance plans. Published and periodically updated between 1888 and 1959, they display with considerable accuracy a snapshot of the location of structures in Lunenburg at that time. The 1897 update of the plan includes a "Boat Builder" shed at the base of Cornwallis Street, likely the same building indicated in the bird's eye view map (**Figure 9**). By 1939, a second shed had been added within the footprint of the study area. The 1959 plan shows the boat sheds replaced by an expanded wharf structure and the buildings that would comprise the current FMA complex. These buildings include the "storage shed" that would become the Fisheries Buildings and the attached mechanical room.

Lunenburg Fire Insurance Plans
 FISHERIES MUSEUM OF THE ATLANTIC RENOVATIONS
 ARCHAEOLOGICAL MONITORING 2013
 LUNENBURG, NOVA SCOTIA

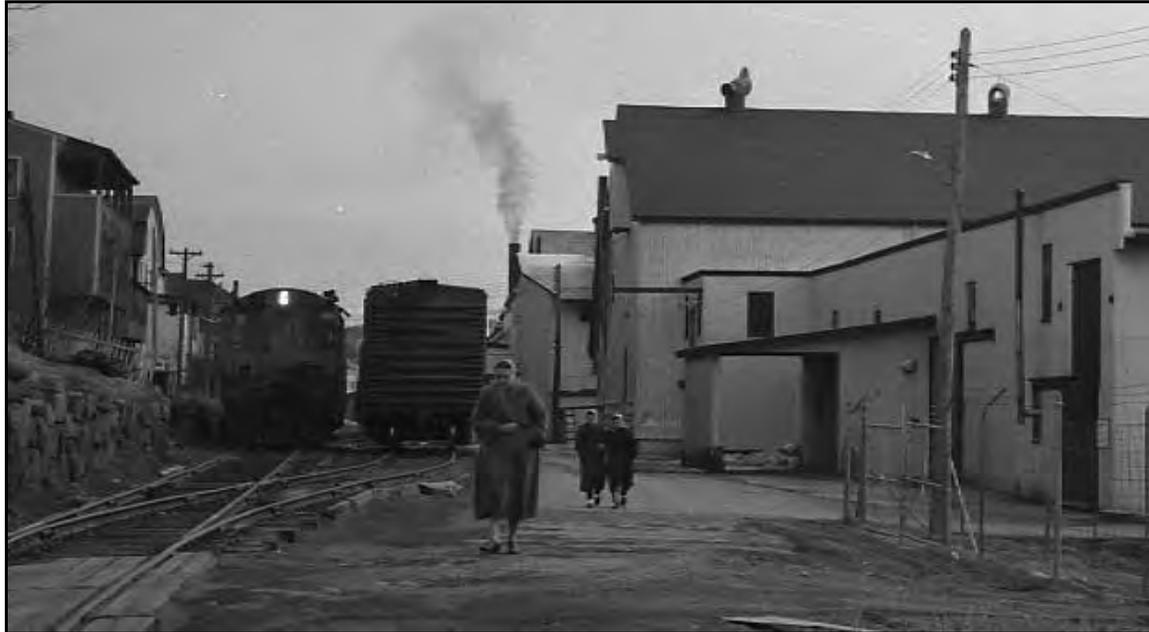
PLATE 1: Undated photo (post 1953) of railway and fish plant buildings along Lunenburg waterfront; facing west.

An undated photo from the archival collection of the FMA shows the Fisheries Buildings prior to the removal of the railway (*Plate 1*). The photo shows the stone retaining wall erected during railway construction and the twinning of the railway track depicted in the fire insurance plans (*Figure 9*). On the right is the weigh scale/mechanical room and the storage room that would become the Fisheries Buildings. *Plate 2* is a modern image from a similar perspective, during demolition of the mechanical room.

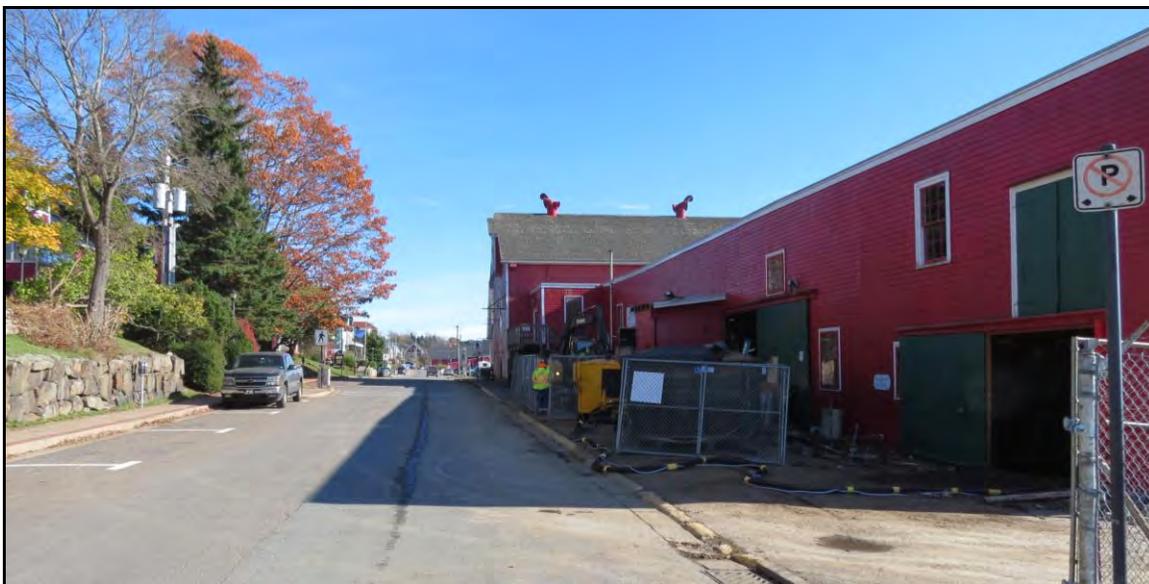
PLATE 2: Modern image of Bluenose Drive; facing west; November 5, 2013.

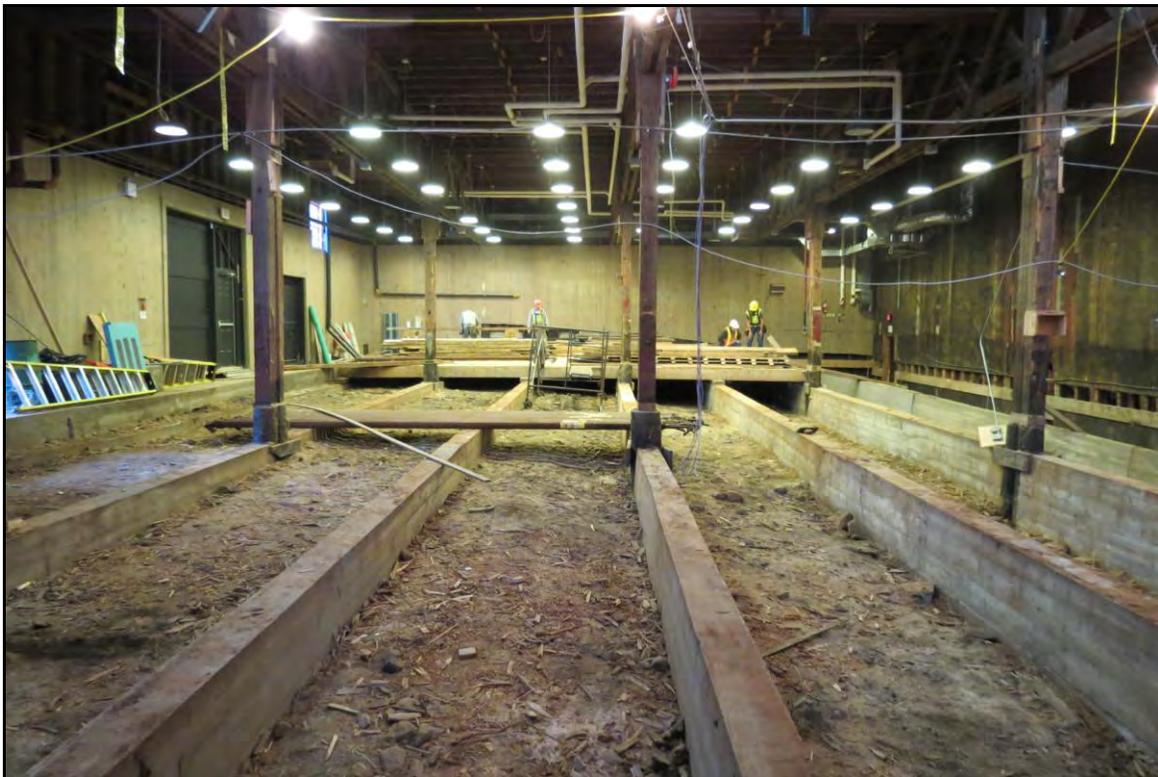
PLATE 3: Interior of the Inshore Fisheries Display Building, prior to removal of concrete joists; facing east; October 22, 2013.

Archaeological monitoring of the FMA property commenced on October 22, 2013, with the break-up and removal of the reinforced concrete floor joists and entrance ramp of the Inshore Fisheries Display Building (*Plates 3-5*). While the floor was supported by concrete joists, the building itself was not supported by a concrete foundation, but rather by a series of exterior pilings and interior columns set into the ground (*Plate 6*). The floor joists were shallowly set (approximately 20-30 centimetres deep) into a medium brown clay and gravel fill surface. The total height of the concrete joists ranged from approximately 60 centimetres in the northern end of the building to 110 centimetres in the south. The difference in height of the joists addressed the elevation of the fill, which sloped downward to the south, toward the shore.

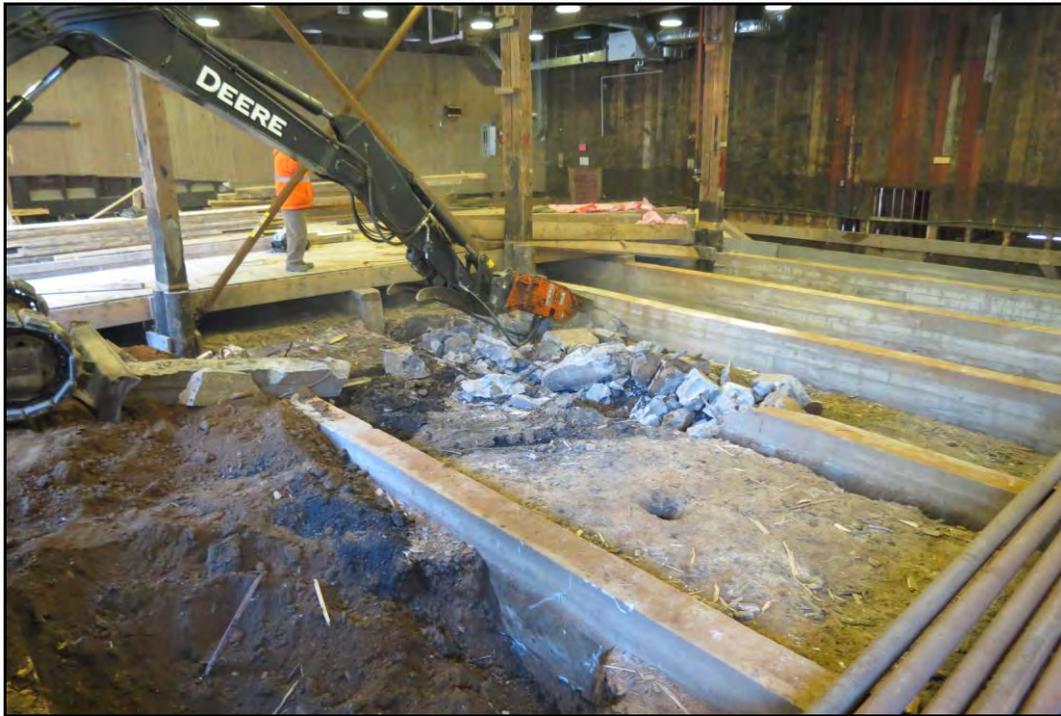
PLATE 4: Commencement of the break-up of concrete floor joists; facing southeast; October 22, 2013.

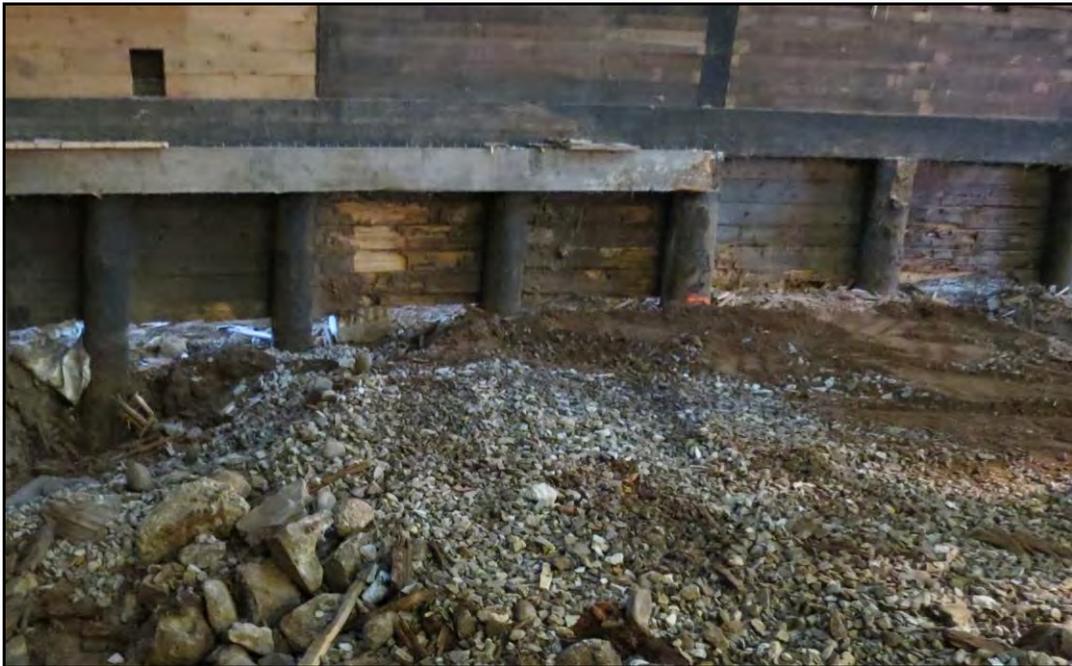
PLATE 6: Support pilings along the west side of the Inshore Fisheries Display Building; facing west; November 6, 2013.

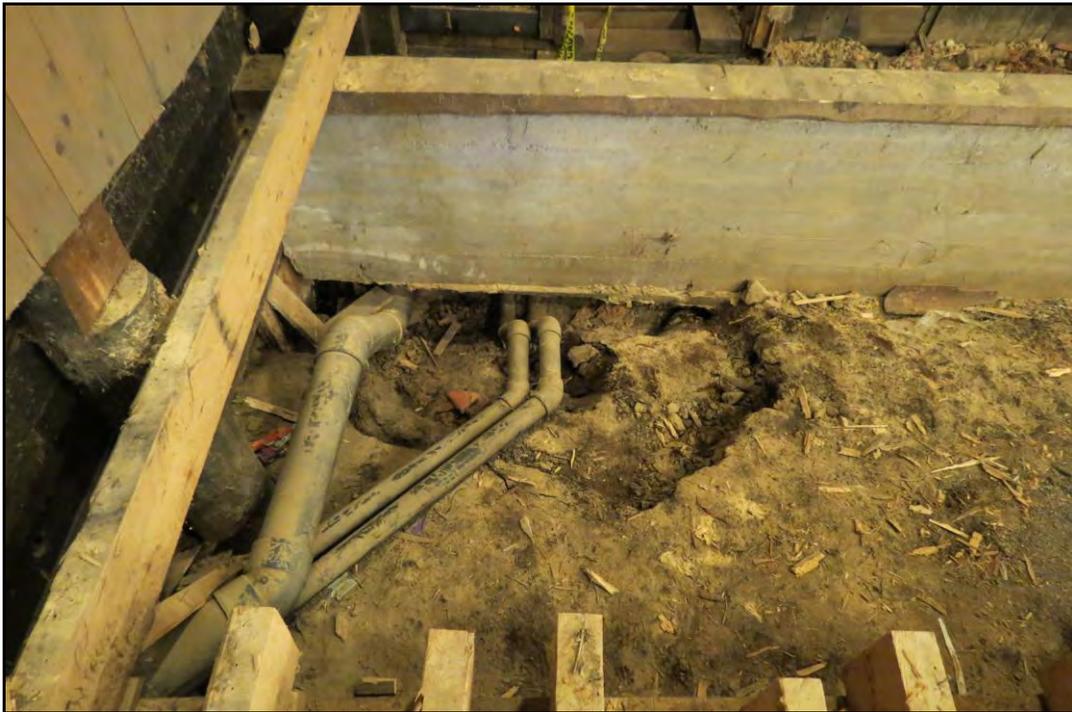
Existing PVC plumbing in the southeast corner of the building ran beneath the concrete joists (*Plate 7*). Fill between the southernmost joist and the south wall of the building consisted of granular material overlying geo-textile (*Plate 8*). Noticeable collapse of the fill and tilt of the concrete joist had occurred in this part of the building, as it settled over time, furthermore, the material has been affected by wave action and erosion of the nearby shoreline (*Plate 9*).

PLATE 7: Plumbing running beneath a concrete joist; October 22, 2013.

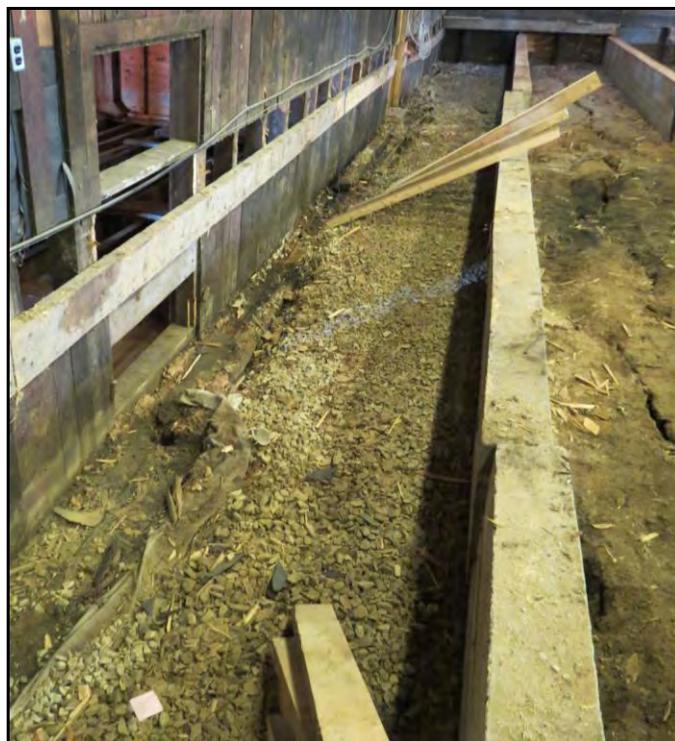
PLATE 8: Granular material between southernmost concrete joist and south wall of the Inshore Fisheries Display Building; facing west; October 22, 2013.

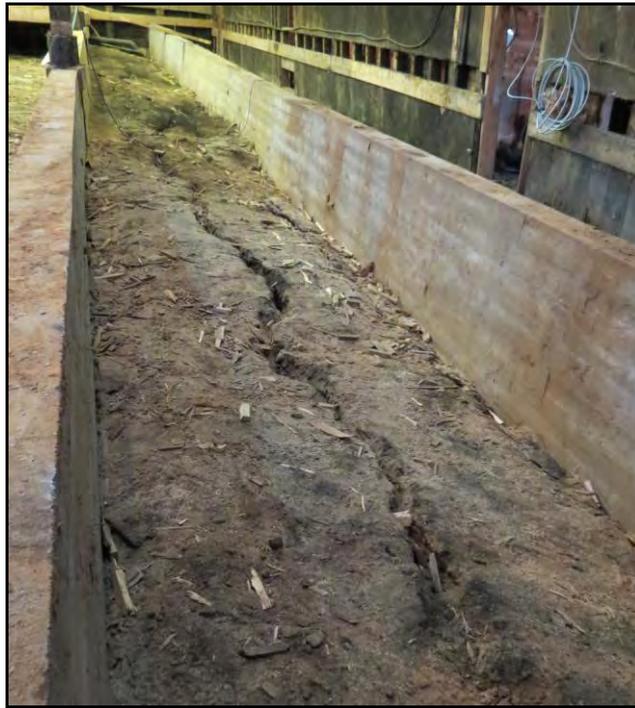
PLATE 9: Cracked and slumping clay fill and concrete joist along southern end of the Inshore Fisheries display Building; facing east; October 22, 2013.

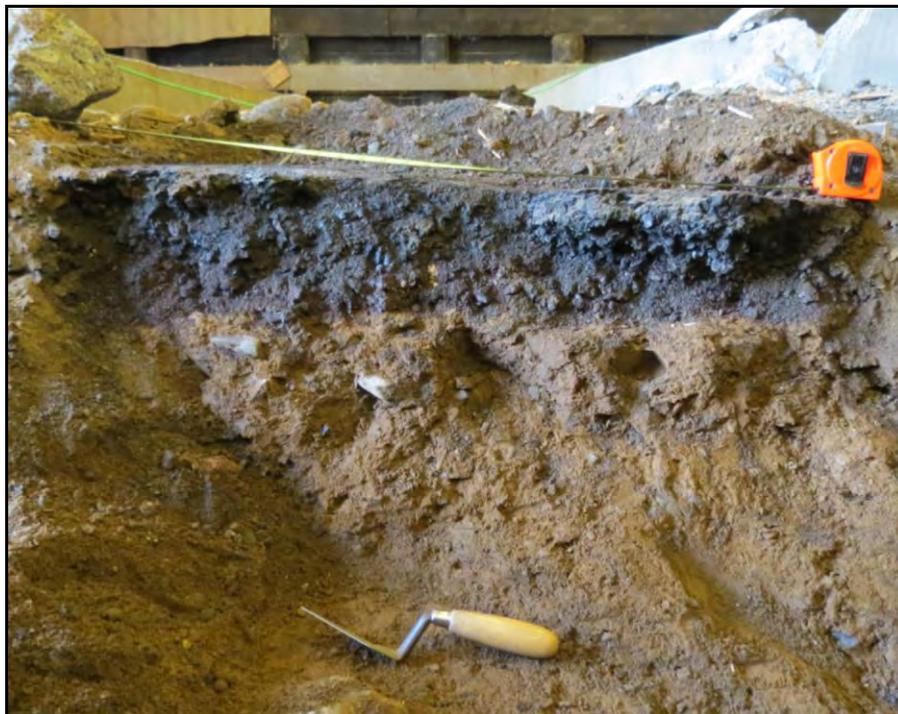
Following the removal of several concrete joists, a test excavation of fill material near the centre bay doors of the Inshore Fisheries Display Building revealed a layer of coal fragments and coal clinker, approximately 15 centimetres thick, overlying fill (*Plate 10*). This material, which was identified across the northern portion of the building footprint, accumulated during its use as a storage shed during the twentieth century. The test pit was excavated to a depth of approximately 80 centimetres and consisted of fill to that depth. Other artifacts recovered during joist removal and test excavation included several modern glass bottles.

PLATE 10: East profile of test excavation showing layer of coal and coal clinker overlying fill below floor of the Inshore Fisheries Display Building; facing east; October 28, 2013.

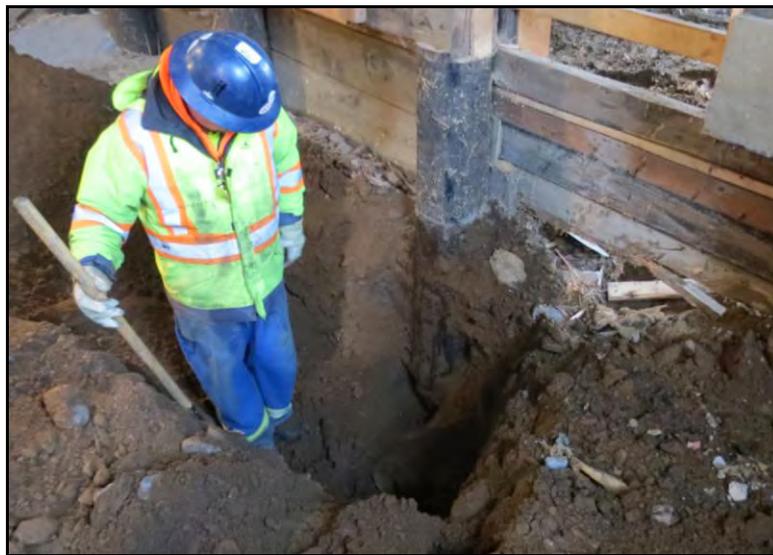
To examine the depth of building support pilings, construction supervisor Ray Leclair, of Avondale Construction, requested test pits be dug adjacent to several posts around the building. Test pits along the west and east wall of the building revealed that the presumed pilings were in fact posts resting on wooden sills. They were set into the soil, between 60 centimetres and 1.1 metres deep - much more shallowly than anticipated (*Plates 11 & 12*). These posts were all set into medium brown fill.

PLATE 11: Test excavation of support post along west wall of the Inshore Fisheries Display Building; November 5, 2013.

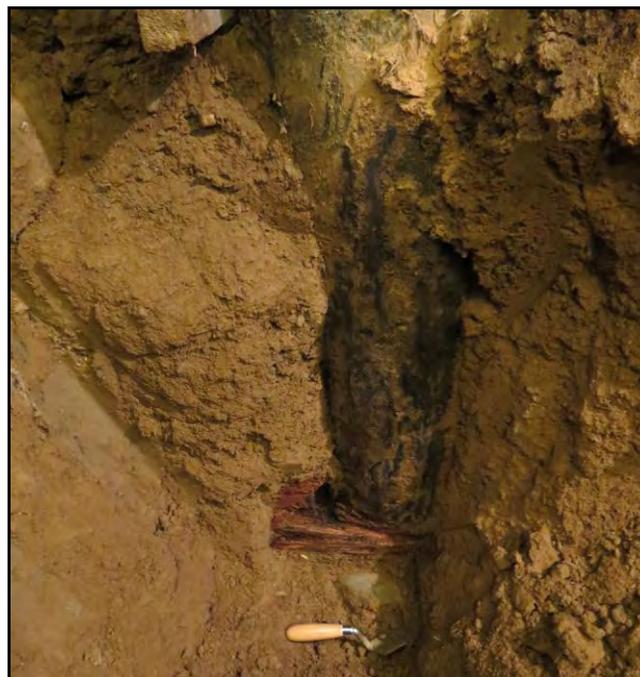
PLATE 12: Wooden sill at base of support post; November 5, 2013.

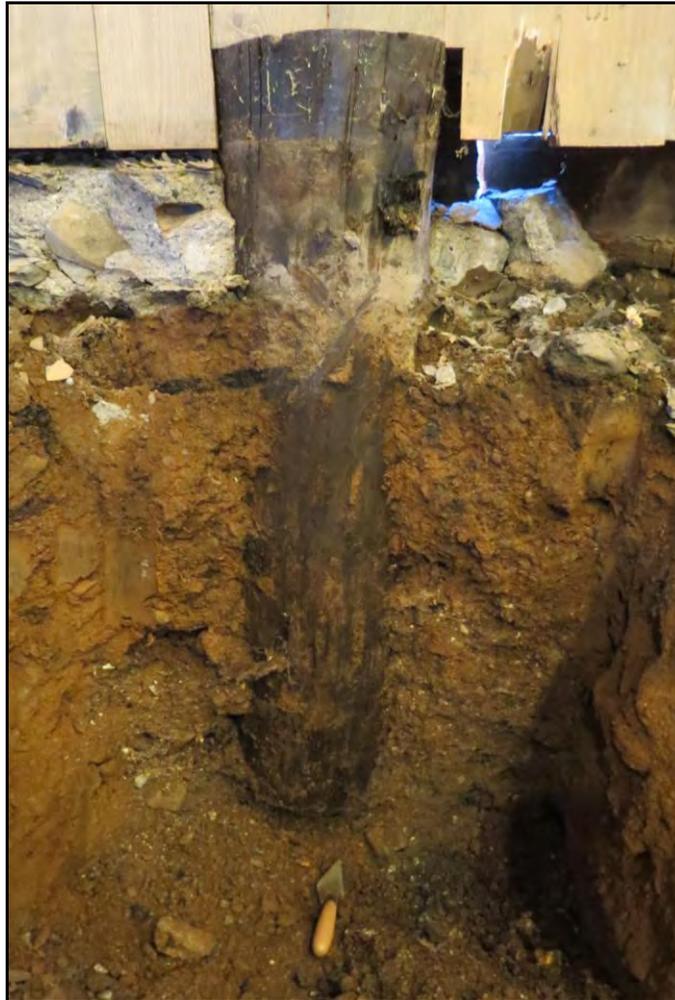
A test pit along the north wall revealed a post set into the fill at a depth of 80 centimetres (**Plate 13**). The fill consisted of 40 centimetres of typical medium brown fill overlying 40 centimetres of medium brown fill infused with sand and shell fragments. This material may be original or redeposited beach sand. No artifacts were identified in the test excavation.

PLATE 13: Test excavation of post along the north wall of the Inshore Fisheries Display Building; facing north; November 5, 2013.

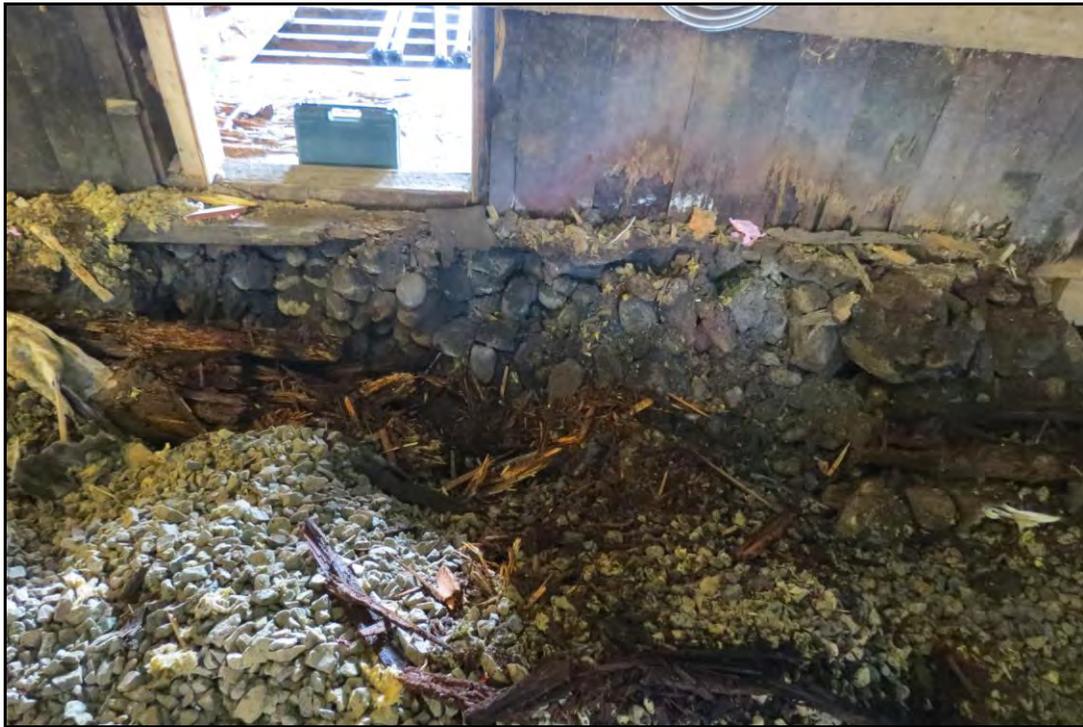
Testing along the south wall of the building revealed that the bottom plate of the wall was resting primarily on partially or completely decayed wooden joists and cobble fill (**Plate 14**). A large wooden beam was discovered running parallel and interior to the south wall, set in the cobble fill (**Plate 15**). The beam was not immediately removed due to concern for disturbing the cobbles, which may have compromised building stability. Given the shallowness of the support posts and the fragile nature of the fill supporting the south wall, excavation in 2013 was halted until concerns regarding building stability could be addressed. All test pits were backfilled by the excavator.

PLATE 14: South wall of the Inshore Fisheries Display Building resting on cobble fill; facing south; November 6, 2013.

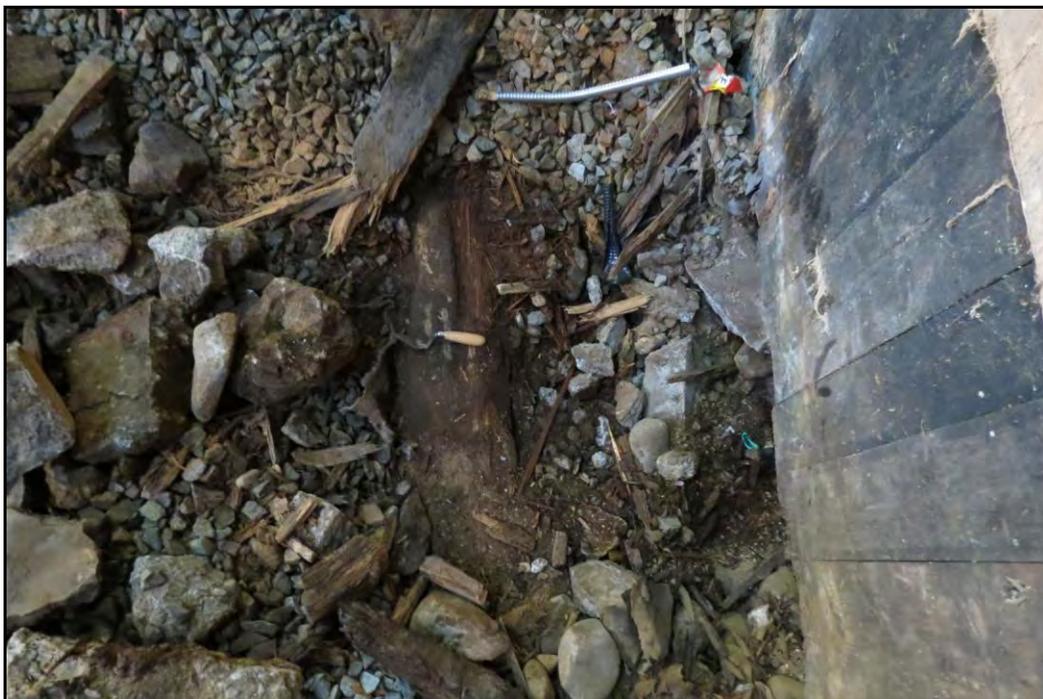
PLATE 15: Wooden beam set in fill, interior to the south wall of the Inshore Fisheries Display Building; trowel is indicating north; November 6, 2013.

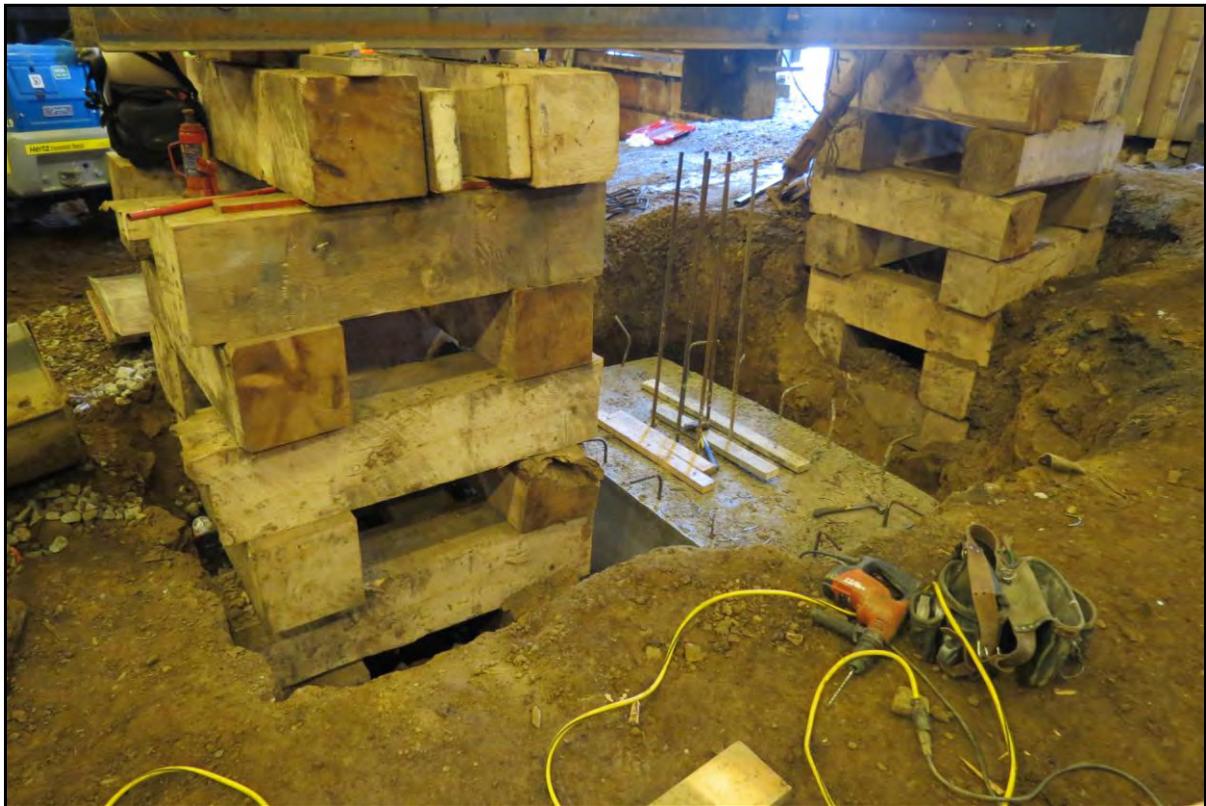
PLATE 16: Concrete piling cap poured in excavation pit between timber supports in north central portion of the Inshore Fisheries Display Building; facing northwest; January 8, 2014.

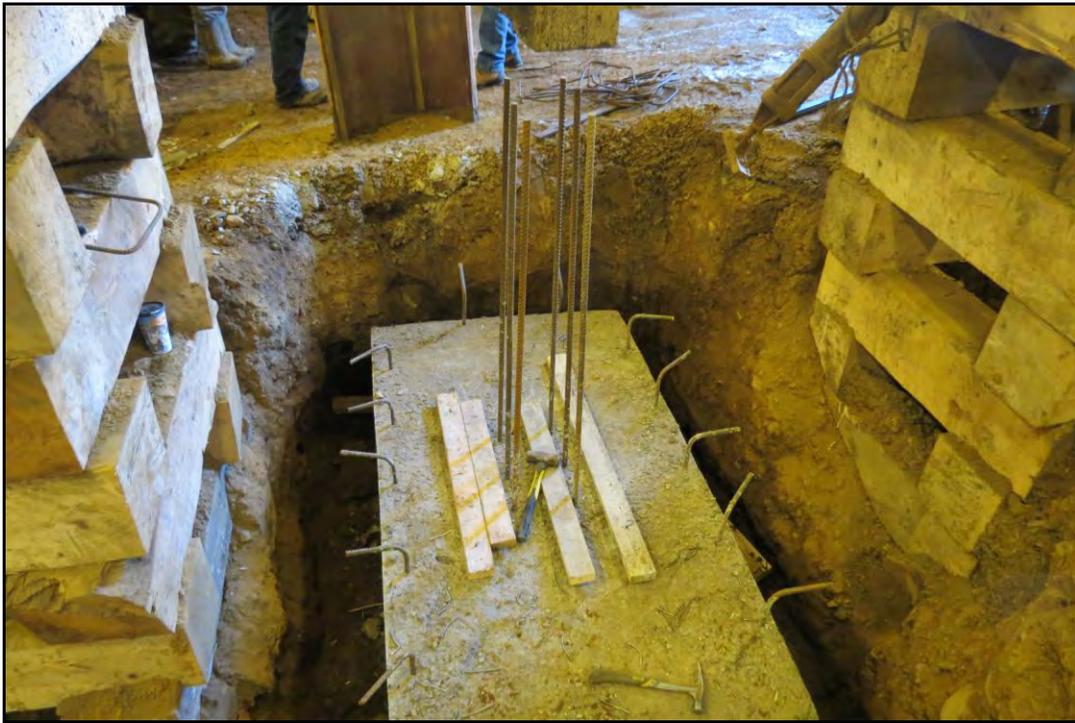
PLATE 17: Concrete piling cap set in pit dug in fill within the Inshore Fisheries Display Building; facing west; January 8, 2014.

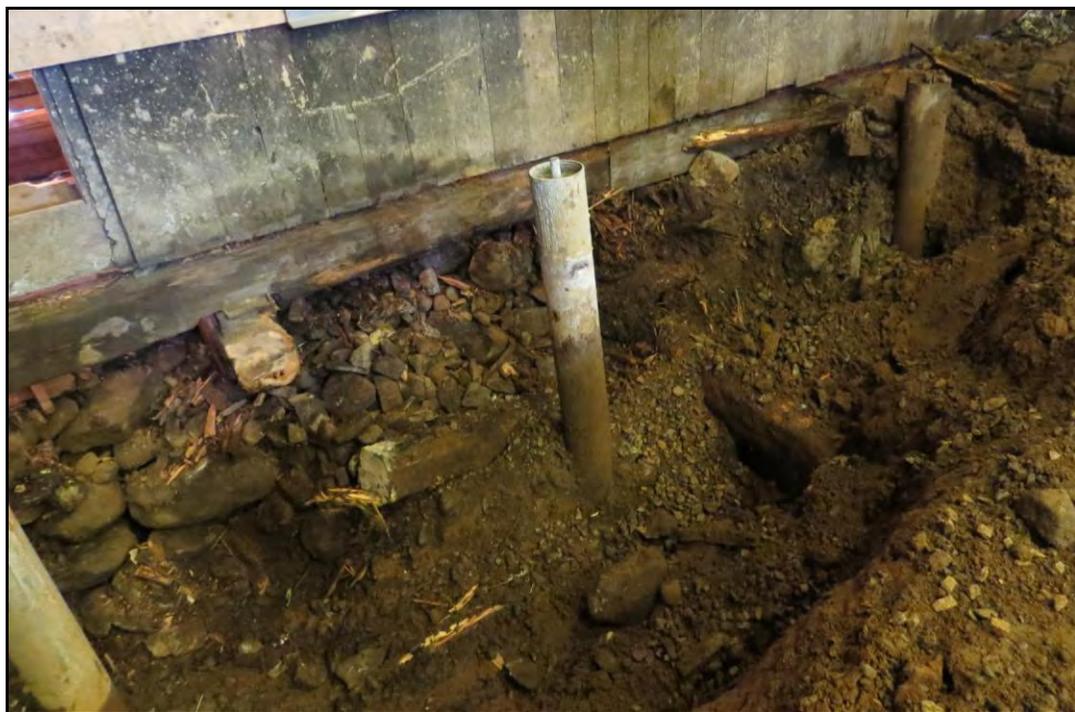
Excavation along the south wall of the Inshore Fisheries Display Building continued in 2014. It revealed additional cobble fill infilling timber framing running along the interior of the south wall (*Plate 18*). The fill continued to the depth of grade for the excavation.

PLATE 18: Cobble fill and timber framing along south wall of the Inshore Fisheries Display Building; facing south; February 6, 2014.

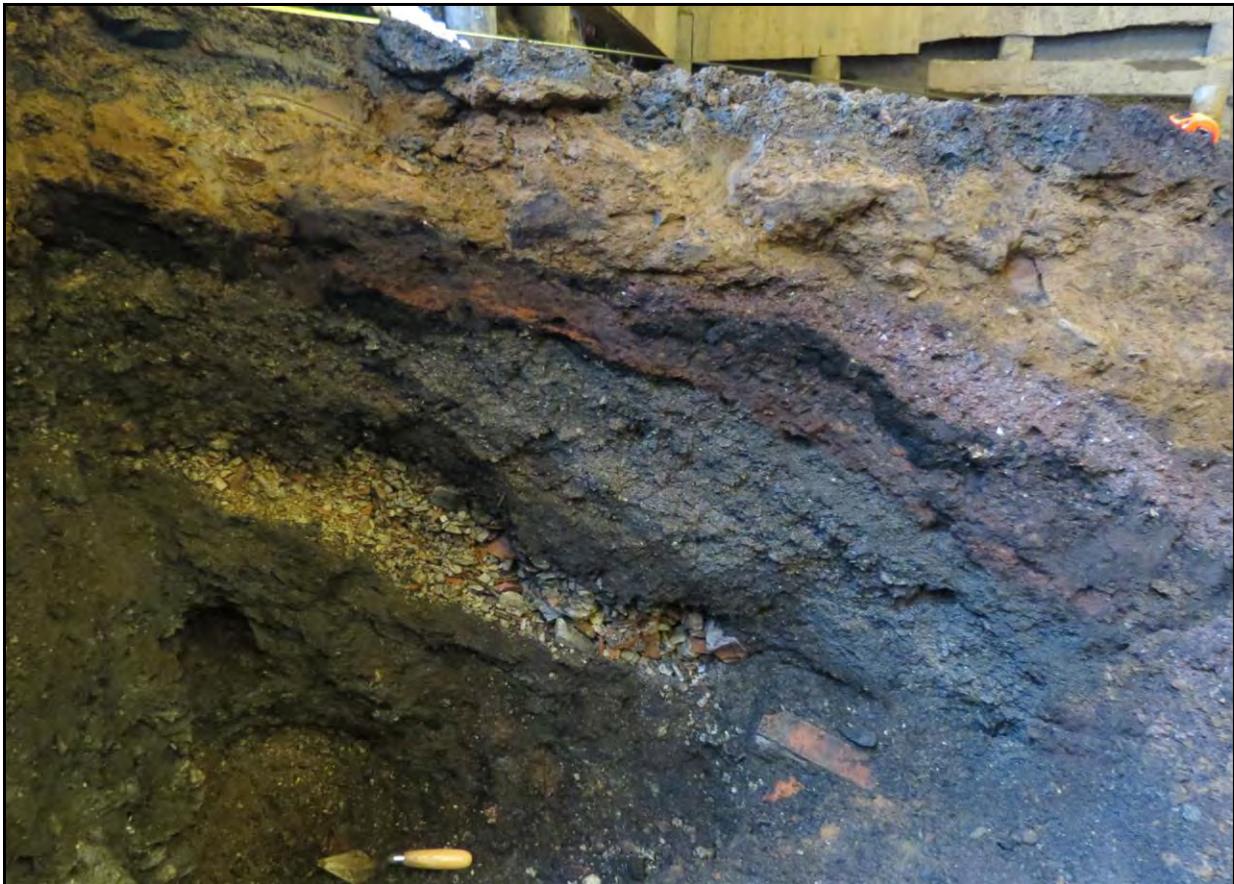
Excavation along the north wall of the Inshore Fisheries Display Building in 2014 revealed stratified layers of twentieth century fill (**Plates 19 & 20**). This wall is closest to Bluenose Drive, the former route of the railway. The fill represents twentieth century infilling events, possibly from railroad construction and use, and from past renovations of the FMA. Fill layers included medium brown fill overlying a layer of coal and coal clinker, which overlay medium grey fill, which in turn overlay a layer of bricks and brick debris, which was finally followed by dark brown gravelly fill to the depth of grade. All artifacts identified in the soil column were modern in origin, including molded green glazed refined white earthenware and molded bottle glass recovered from the depth of excavation (not collected).

PLATE 19: East profile of excavation pit along north wall of the Inshore Fisheries Display Building; facing east; April 2, 2014.

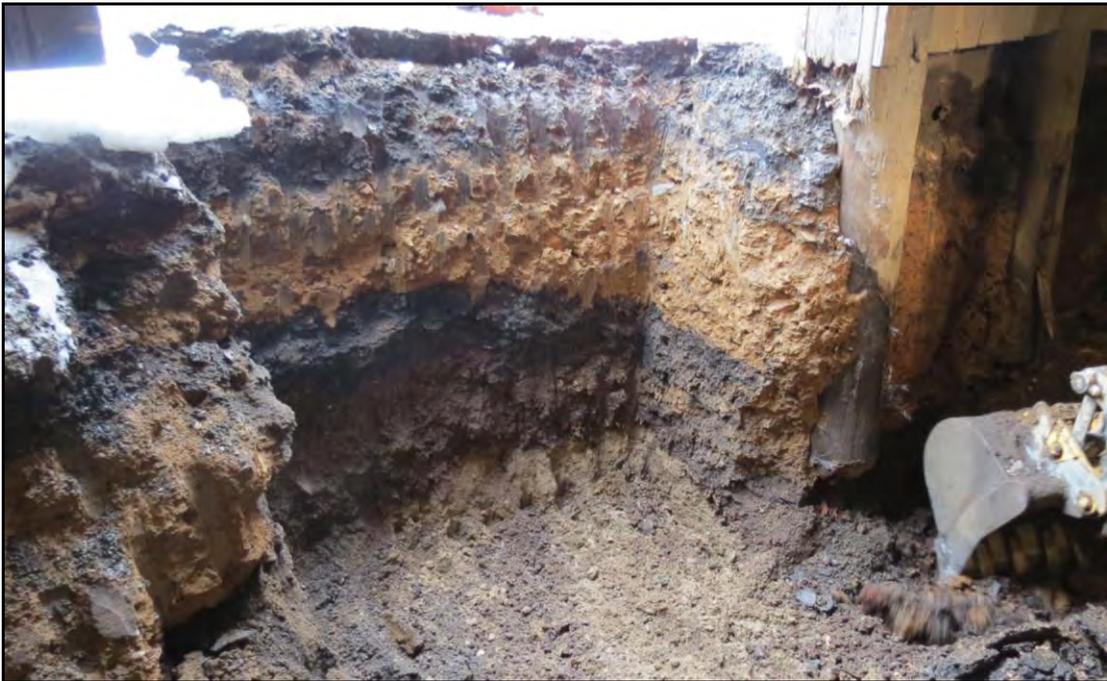
PLATE 20: Oblique view of north profile of excavation pit along north wall of the Inshore Fisheries Display Building; facing northeast; April 2, 2014.

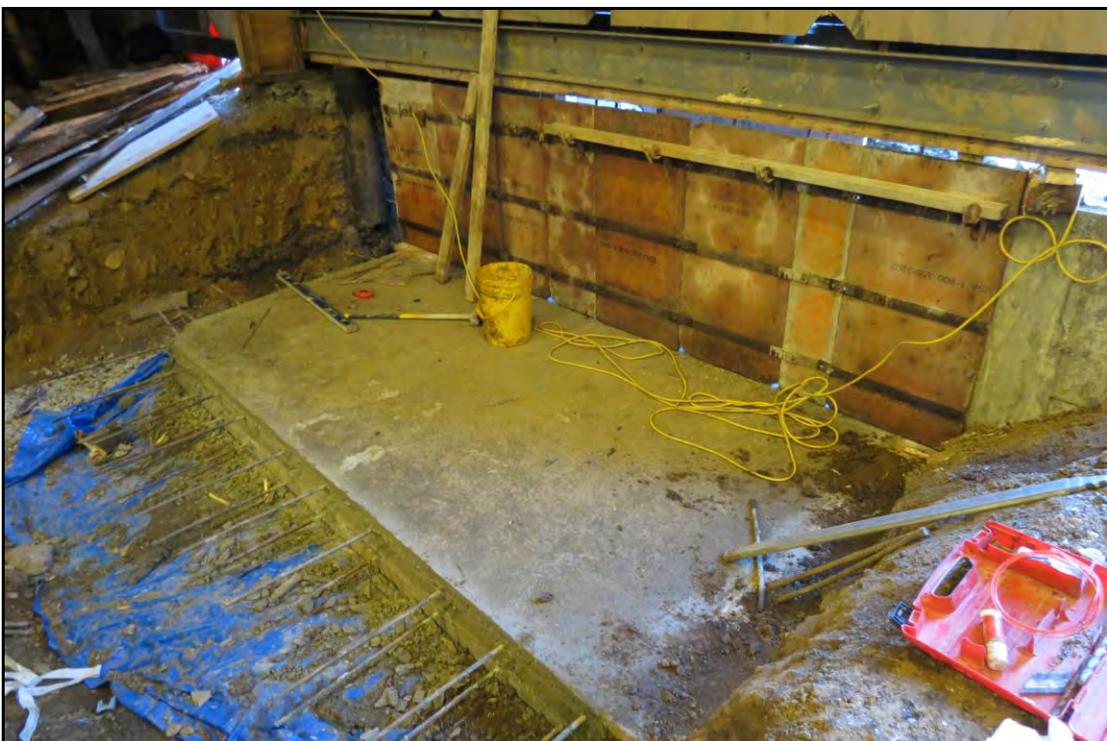
Additional work in 2014 included the pouring of a concrete slab along the north wall of the Inshore Fisheries Display Building as part of the concrete foundation for the new FMA mechanical room (**Plate 21**).

PLATE 21: Concrete slab forming part of the foundation of the FMA mechanical room; facing northwest; January 8, 2014.
