**FISHERIES MUSEUM OF THE ATLANTIC
STABILIZATION AND RENOVATION
ARCHAEOLOGICAL MONITORING 2013-2014
LUNENBURG, NOVA SCOTIA**

FINAL REPORT

Cultural Resource Management Group Limited

CRM Group Project Number: 2013-0014-01

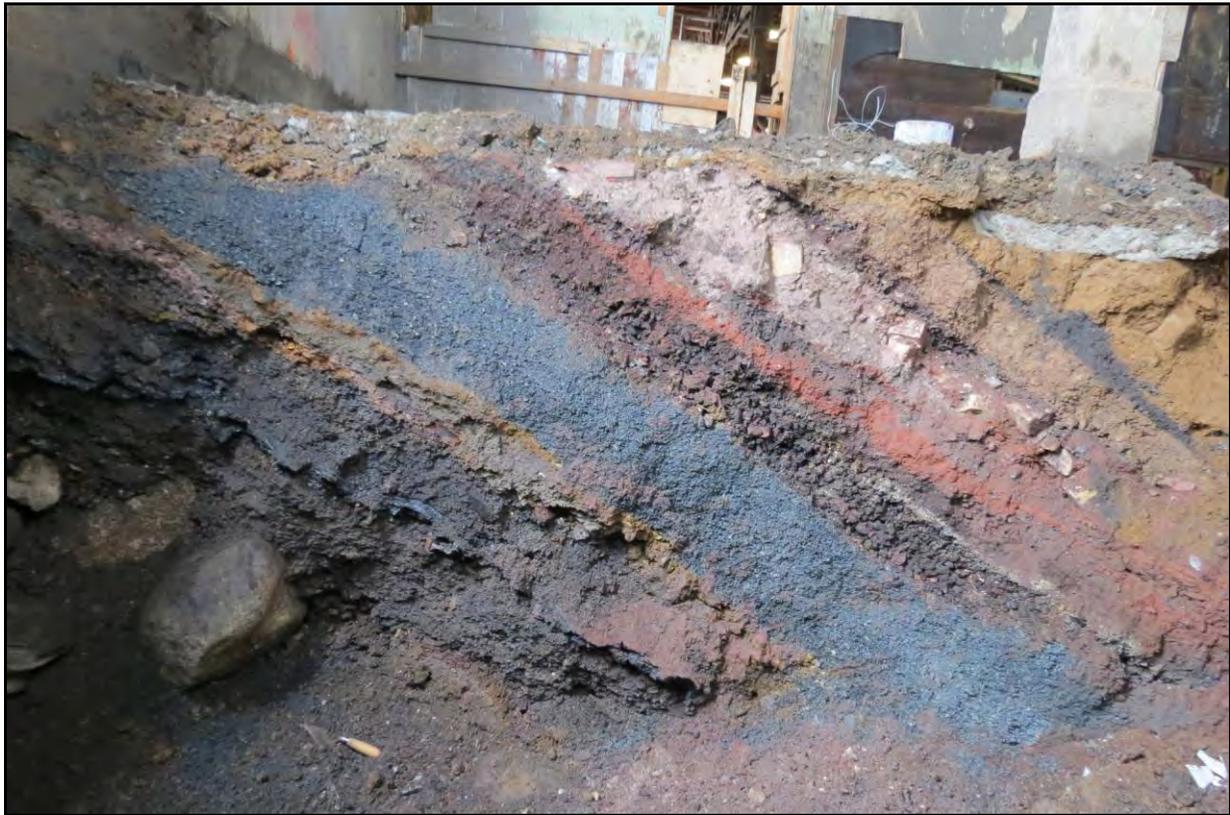
Excavation in 2014 was also conducted in the Dory Shop of the FMA. Excavation pits for concrete piling caps were excavated in the north of the building, closest to Bluenose Drive. The excavation pits were dug to a depth of approximately 2 metres below the surface of the fill in this part of the building for the base of a scissor lift. Again, since the excavation was nearer to the street (and former railway bed), the excavation cut revealed a series of twentieth century infilling events (*Plate 22*). Like excavations in the north side of the Inshore Fisheries Display Building, the fill represents twentieth century infilling events. The fill consisted of layers of medium brown gravelly fill, coal and coal ash, brick and brick debris, pea gravel, and a layer of tar roofing shingles. At the bottom of the excavation pit, the fill contained large cobbles and small boulders. The entire soil column, based on the artifacts identified, was from a twentieth century context. The majority of artifacts were modern glass bottles and bottle fragments, including a threaded-finish colourless jar and an olive green flask bottle (*Plate 23*). A number of bricks with manufacturing stamps were identified in the fill (*Plate 24*). Bricks stamped "DOURIE" are a product of the P & M Hurll Brickyard, Glenboig, Scotland, 1887-1980 (McMillan 2012).

PLATE 22: East profile of excavation pit in the north end of the Dory Shop, showing stratified twentieth century fill; facing east; April 2, 2014.

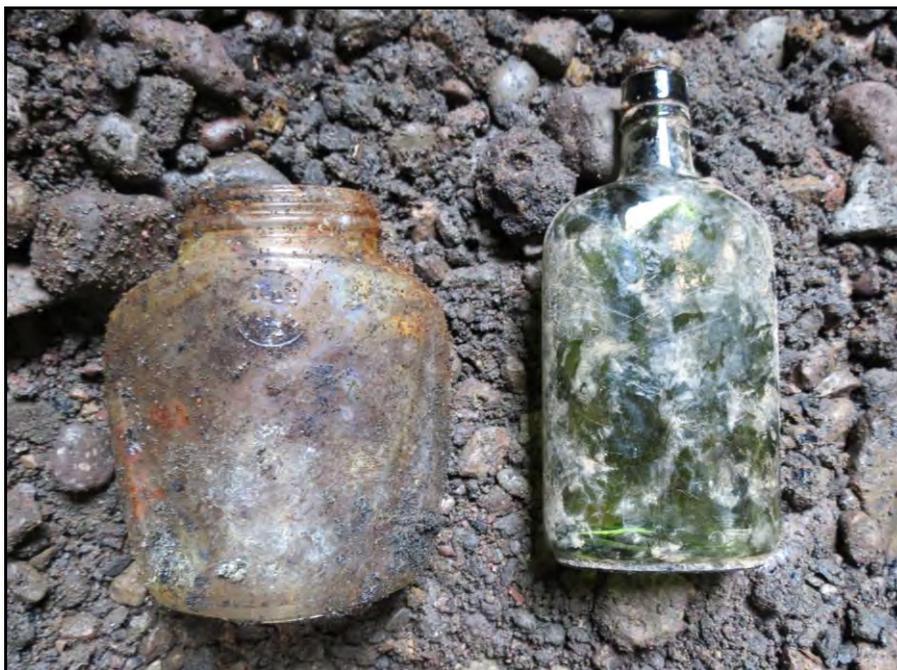
PLATE 23: Sample of glass bottles recovered from excavations in the Dory Shop; April 2, 2014.

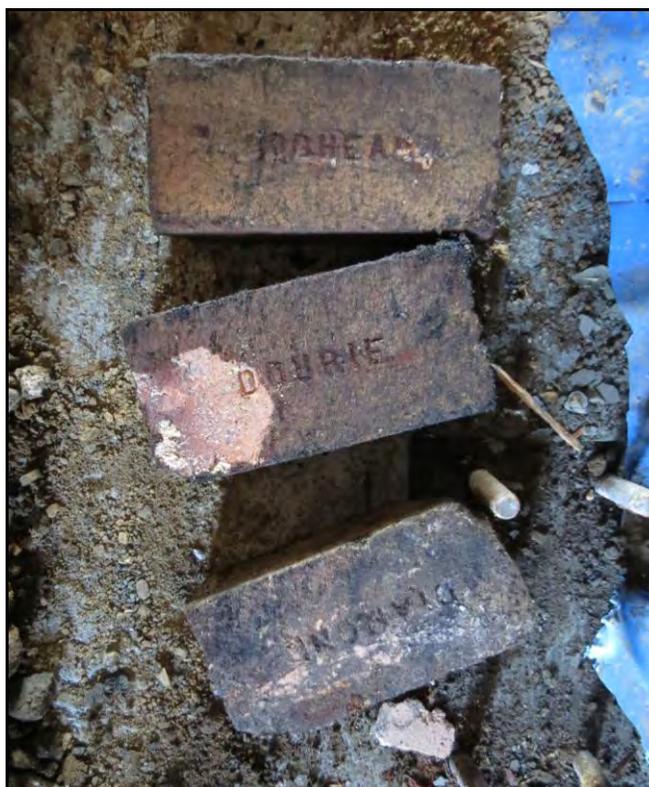
PLATE 24: Sample of bricks recovered from the excavation pit at the north end of the Dory Shop; April 7, 2014.

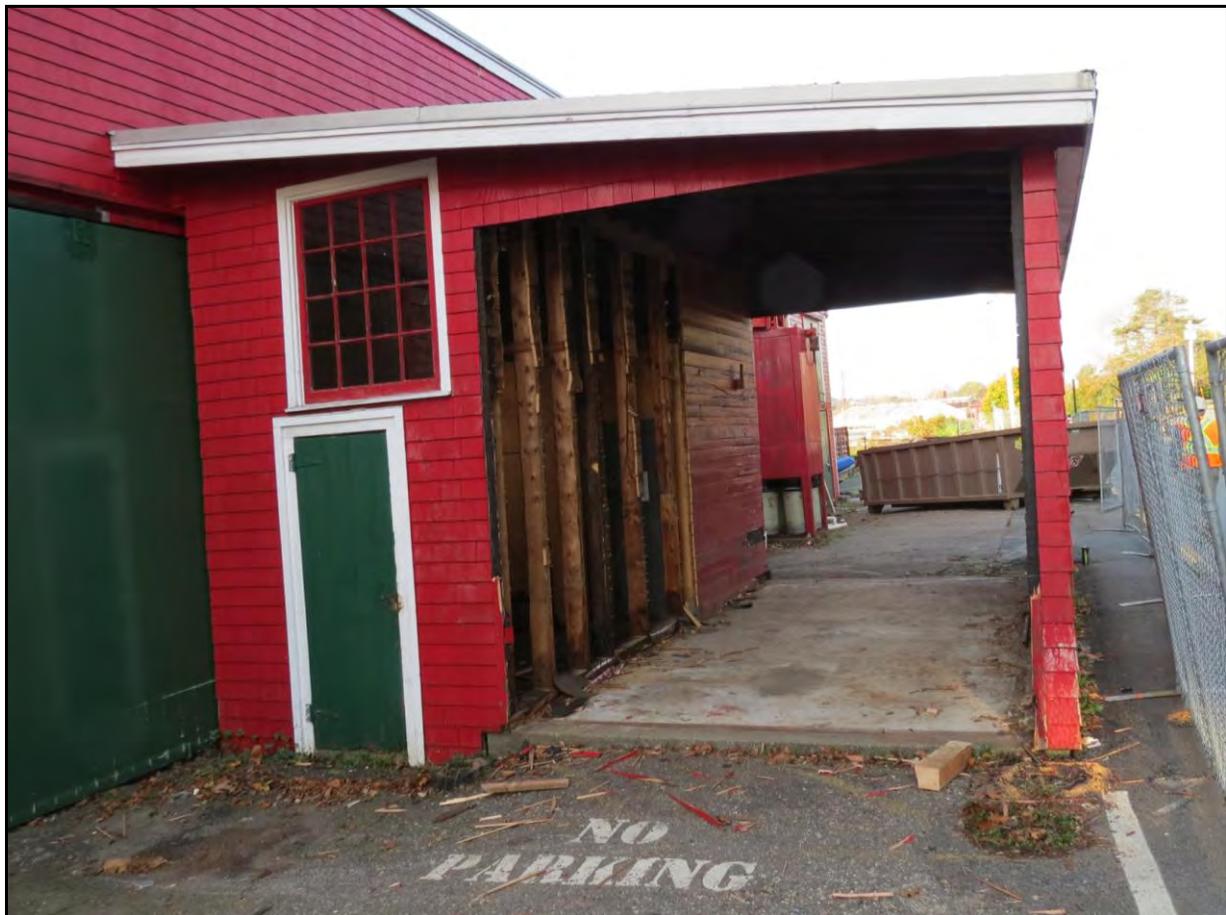
PLATE 25: Mechanical room during early stages of demolition; facing west; October 22, 2013.

Demolition of the mechanical room began in 2013 with the dismantling of the wooden frame of the structure (*Plates 25 & 26*). The building extension was also the site of a weigh station that had been capped in concrete on November 8, 1996 (date etched into concrete). Following the dismantling of the wooden structure, the concrete cap and weigh scale housing were demolished. A ceramic drainage pipe (ca. 1848-present) was identified underlying the concrete weigh scale housing (Miller 2000: 11). The weigh station apparatus was manufactured by Fairbanks Scales Inc. of Kansas City, Missouri.

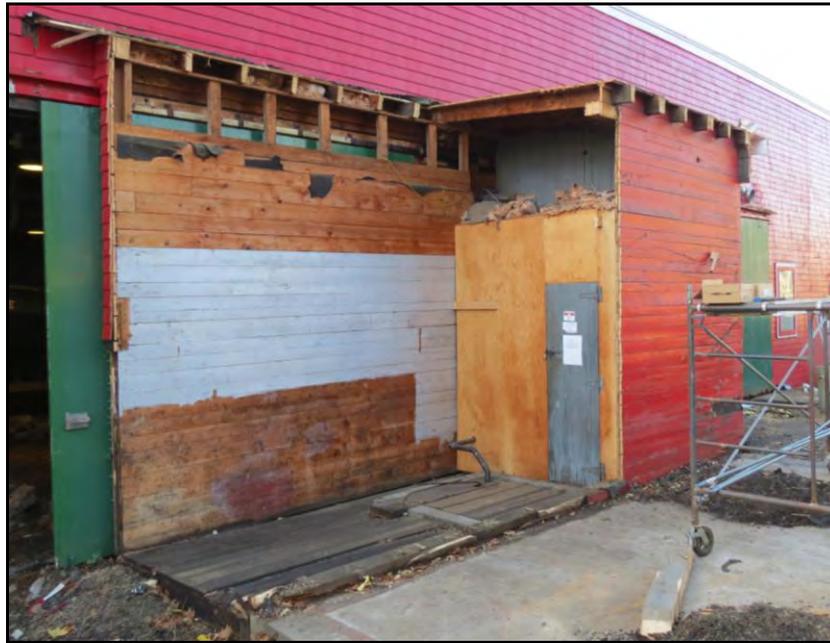
PLATE 26: Mechanical room following the dismantling of the wooden structure; facing southwest; October 25, 2013.

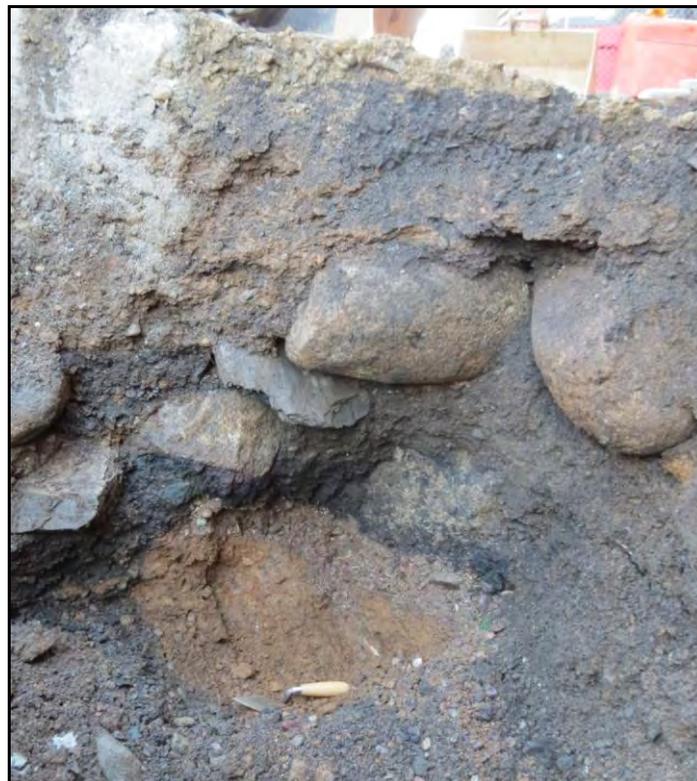
Following the removal of the concrete weigh station housing, the soil profile was cleaned. It revealed a layer of medium brown fill overlying a dark grey sandy soil with large cobbles, which in turn overlay beach sand and cobbles, which finally over lay apparent natural subsoil (*Plate 27*). The medium brown fill appeared consistent with the soil from beneath the Fisheries Building's floor. The dark grey sandy soil had an oily texture and is likely associated with the twentieth century use of the Fisheries Buildings as a storage shed. The construction of the weigh station housing appears to have impacted the original shoreline of the Lunenburg waterfront, as evidenced by the beach sand and cobbles. No artifacts or other archaeological deposits were identified in the profile. Upon completion of demolition, the pit was backfilled with fill. No other work was conducted outside of the Fisheries Buildings during 2013 renovations.

PLATE 27: East soil profile following removal of concrete weigh scale housing; facing east; November 5, 2013.

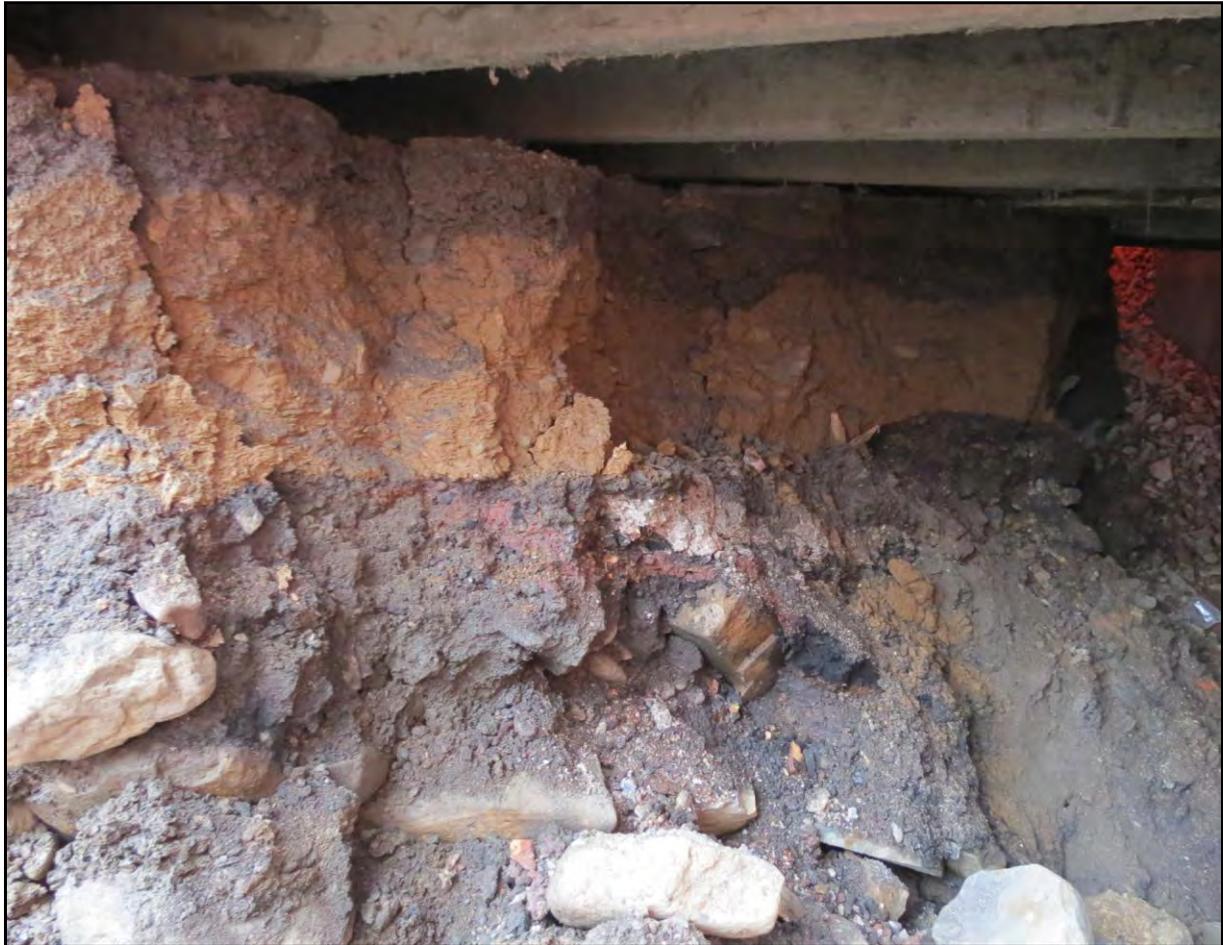
Archaeological monitoring in the area of the mechanical room in 2014 included the removal of material underlying the existing mechanical room floor (**Plate 27**). The excavation revealed the same stratified layers of twentieth century fill identified along the north end of the Inshore Fisheries Display Building (**Plate 20**). The fill included brick debris and contained large cobbles. Artifacts identified within the fill included modern bottle glass fragments and tar roofing shingles (not collected).

PLATE 28: Stratified twentieth century fill beneath the existing FMA mechanical room; facing northeast; January 20, 2014.
