**Propagation and transplanting techniques for native plant species:
Living shorelines applications in Atlantic Canada**

A Thesis Submitted to
Saint Mary's University, Halifax, Nova Scotia
in Partial Fulfillment of the Requirements for
the Degree of Master of Science in Applied Science.

August, 2016, Halifax, Nova Scotia

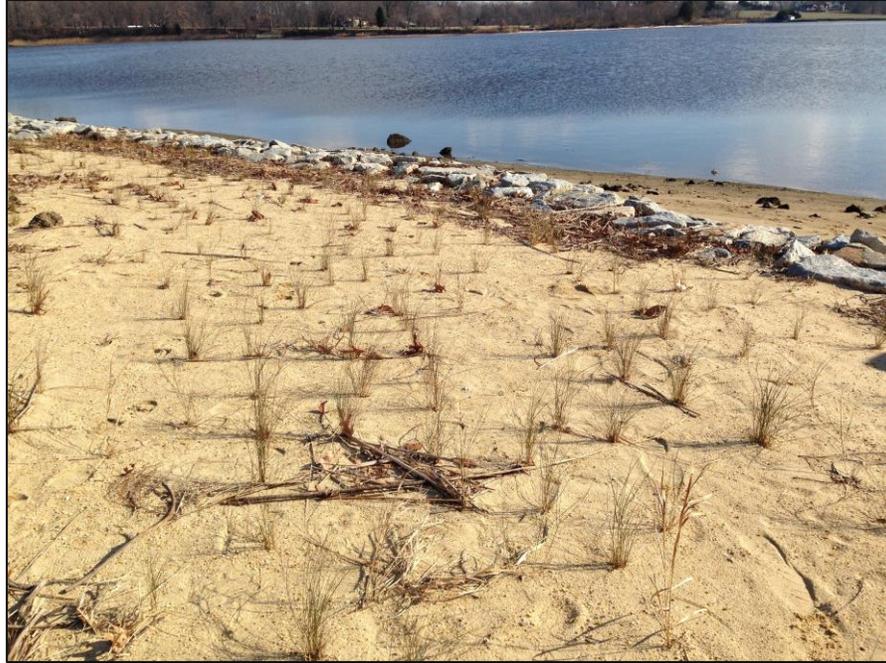
Figure 2.6: Rows of *Spartina patens* plugs transplanted into an eroding sand bar in Maryland, USA

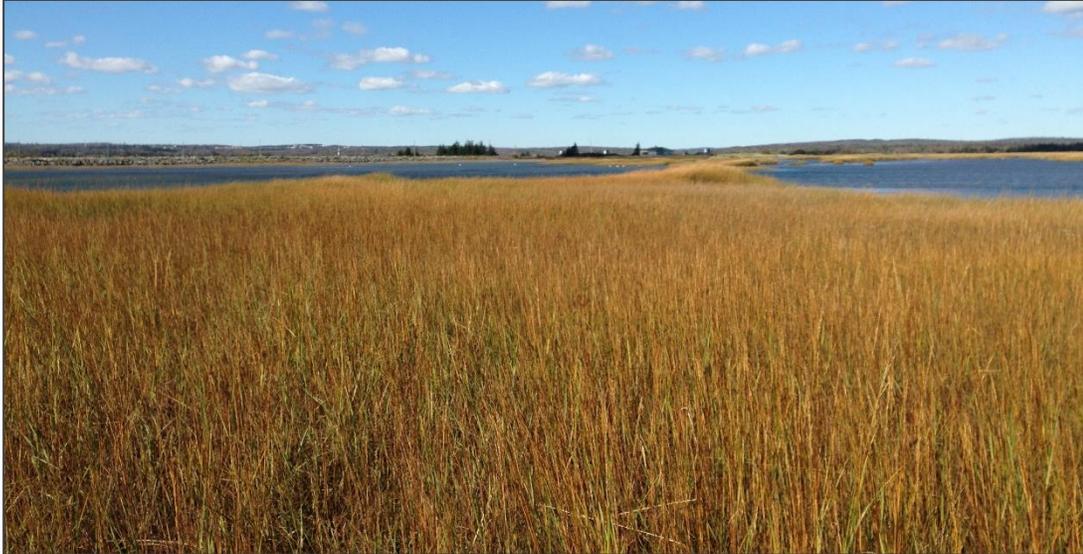
Figure 3.2: Seed collection site at Rainbow Haven, Spartina alterniflora pictured

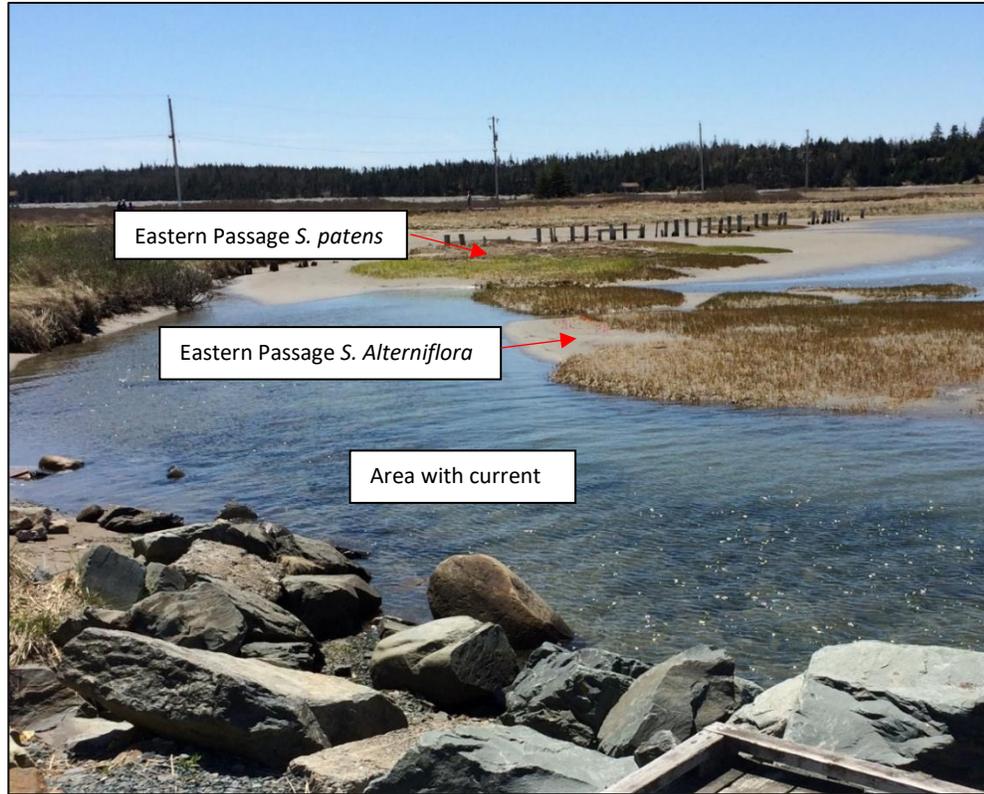
Figure 3.5: Eastern passage showing the location of both the *Spartina alterniflora* and *Spartina patens* plots. Pictured here is also the extent of the existing vegetation

There are two experiment sites at McCormack's beach which, for the field trials, have been designated Eastern Passage- *S. alterniflora* plots and Eastern Passage- *S. patens* plots (Figure 3.5). The Eastern Passage- *S. alterniflora* plots are low marsh and dominated by only *S. alterniflora* and the Eastern Passage- *S. patens* plots are located in a mid-high marsh area with a mix of *S. alterniflora* and high marsh/upland species (there is no *S. patens* present at the site). This was done so that both *S. alterniflora* and *S. patens* could be used at this site. The average fetch at this site is 0.9km (low wave energy), except in the northwest direction where the fetch is much longer at 8.7km (high wave energy). Both study sites are located behind existing vegetation to further reduce any exposure to wave energy, and therefore minimizing the adverse impact of wave energy at both sites within McCormack's Beach. However, there is an evident current when the tide ebbs and flows that lies to one side of the plots (Figure 3.5)

There were two microsites at Eastern passage, the Eastern Passage- *S. alterniflora* site, and the Eastern Passage- *S. patens* site (Figure 3.5). A 20 by 20 cm quadrat was used at both the Eastern Passage *S. alterniflora* and *S. patens* sites. The quadrat was placed in unvegetated areas, and a wooden dowel was used to mark the location. A designated treatment was assigned to each plot. This was done using a randomized design for the 4 treatments. A total of 20 plots were used at the Eastern Passage- *S. alterniflora* plots (Figure 3.9). At the Eastern Passage- *S. patens* plots, the same method was used for 10 plots (Figure 3.10).

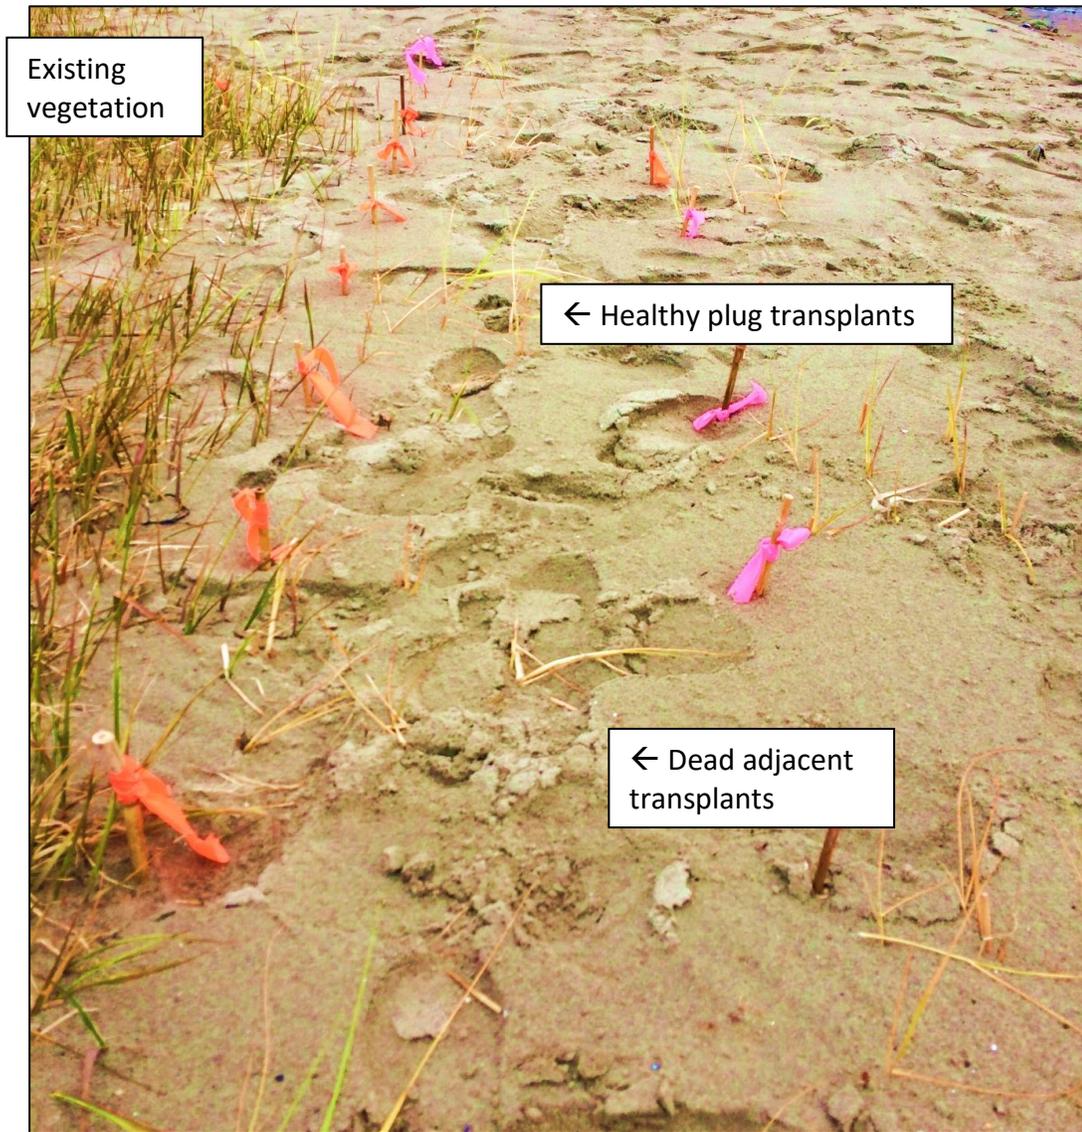
Figure 3.7: The 19 Eastern Passage- *S. alterniflora* plots also showing human impact at site (foot prints)

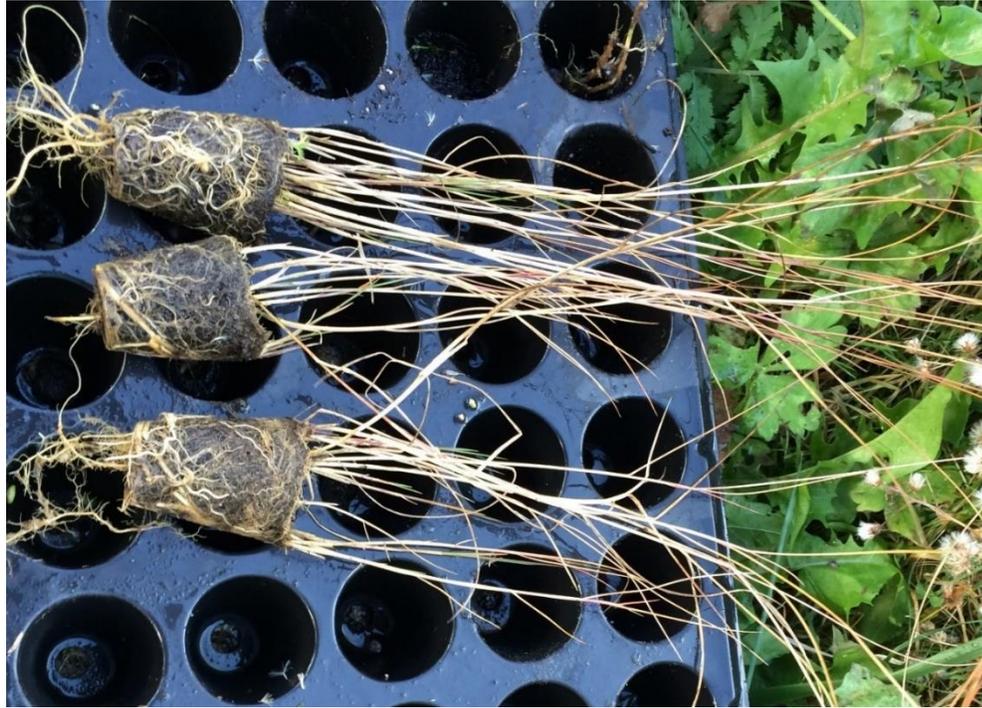
Figure 3.20: Spartina patens after spending the growing season in plug trays on the green roof at Saint Mary's University (Pictured here in early November, 2015)

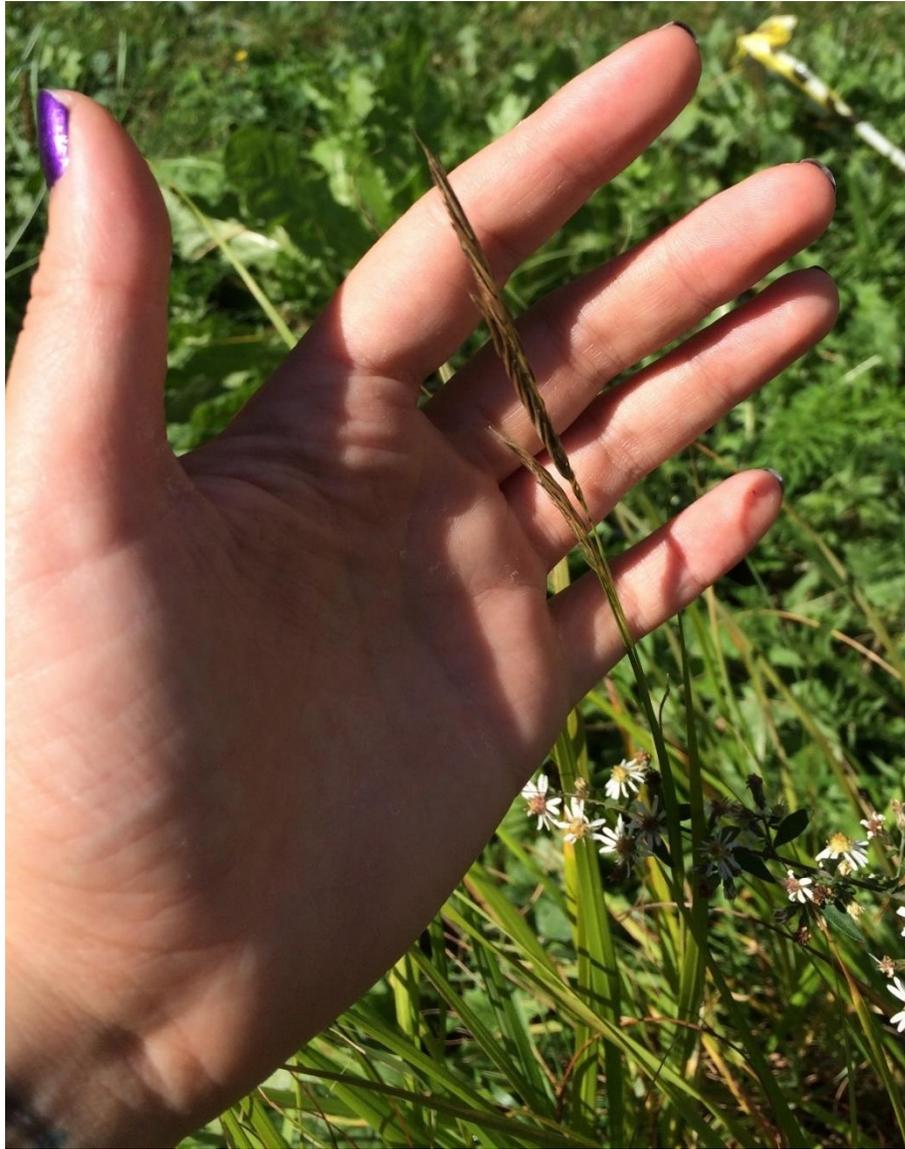
Figure 3.21: *Spartina pectinata* flowering on a green roof at Saint Mary's University in early October, 2015

germination in salt water and 25-75% germination in fresh water. For growing plugs, it is still possible to use seeds of *S. alterniflora*, although lower germination rates greatly increases the amount of seeds needed. *Spartina patens* and *S. pectinata* on the other hand had higher rates of germination and may be more likely to colonize and germinate via seeds than *S. alterniflora*, although rhizomes are still the dominant way both species colonize (Kim et al. 2012). *Spartina patens* seeds had high germination rates in both populations and when the observed growth rate was much quicker for both above and below ground biomass compared to *S. alterniflora*. Approximately 40 *S. patens* seedlings were kept alive in plug trays (not used in the field experiment) for the growing season (Figure 3.20), and what was observed by the mid growing season was that they had significant above ground biomass and very large, densely packed root masses, which is characteristic for *S. patens* growing naturally (Anastasiou and Brooks, 2004). *Spartina pectinata* seedlings were also kept alive in plug trays for the growing season, and grew to approximately 70 cm tall, with significant belowground biomass as well, and two seedlings flowered in September (Figure 3.21).

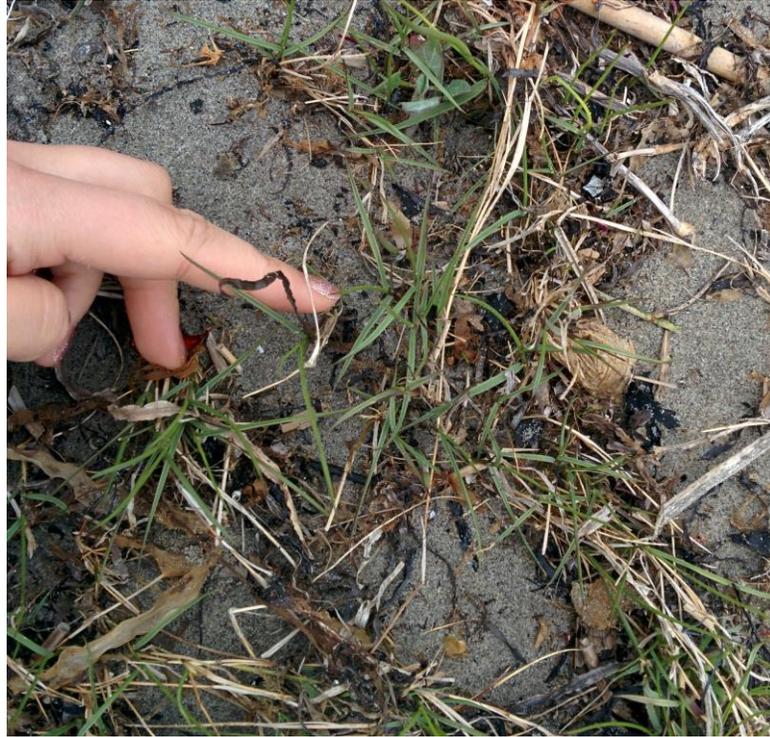
Figure 3.22: Showing the survival of *S. patens* at the Eastern Passage- *S. patens* site 1-year post transplanting

Observation of the plots one year later (June 2016) indicates that the *S. patens* pugs and seedlings did survive the winter and continue to grow one year later (Figure 3.22)!

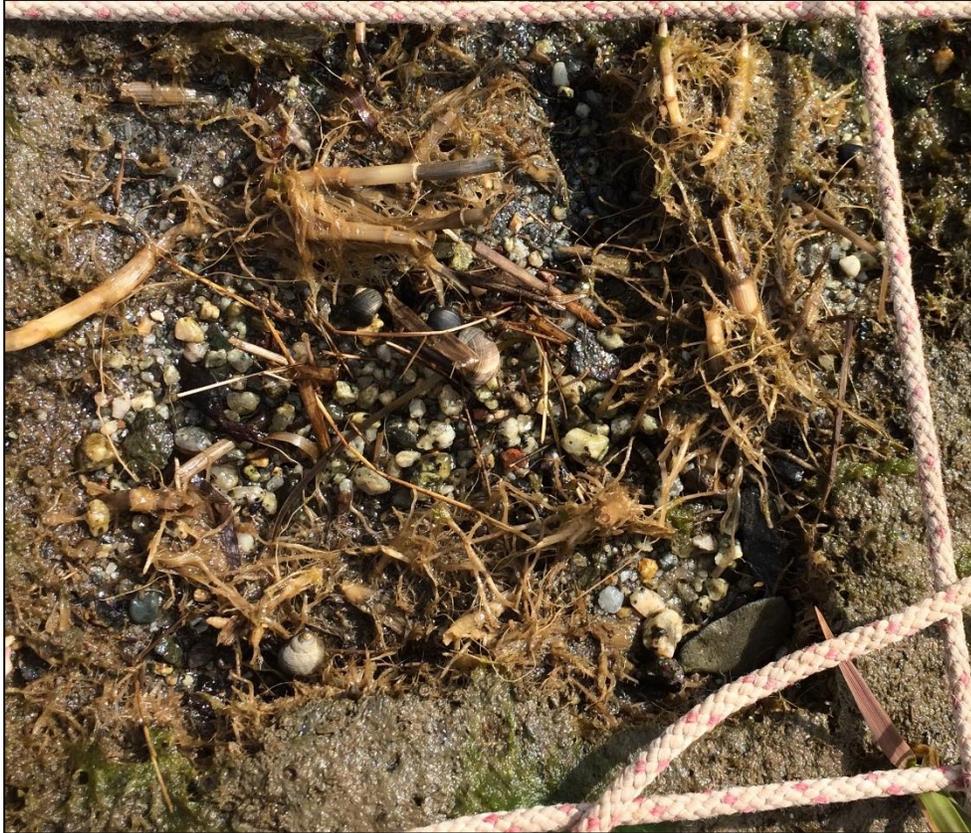
Figure 3.23: Scouring of seed plots at Lawrencetown Lake from high wave energy (1-week post construction)

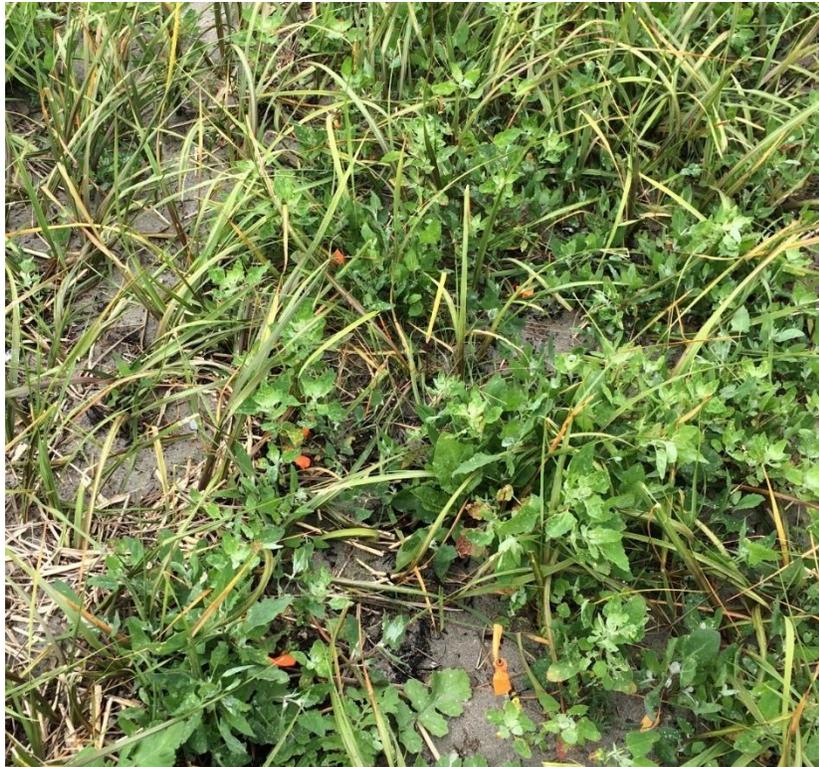
Figure 3.24: Plug transplant and seed plots at the Eastern Passage- S. patens site growing in amongst the existing vegetation

At the Eastern Passage- *S. patens* plots both transplant and seeding plots were very weakly correlated, indicating that elevation may have a small impact on health indices. However, it is likely that because elevations were within the range for *S. patens* to thrive, that the regression analysis does not tell us much about the relationship. *Spartina patens* survived and thrived because the elevations were within the range for this plant to be competitive and establish. This site was also more protected from both wave energy and human impact as it is located in amongst existing vegetation (Figure 3.24). As of June 2016, one-year post planting, both the transplant and seedling plots at this site are continuing to thrive.
