**COASTAL CLIMATE CHANGE VULNERABILITY AND ADAPTATION  
IN FUNDY NATIONAL PARK, NEW BRUNSWICK**

by Jenna Miller

Submitted in fulfillment of the  
requirements of GEOG 4526

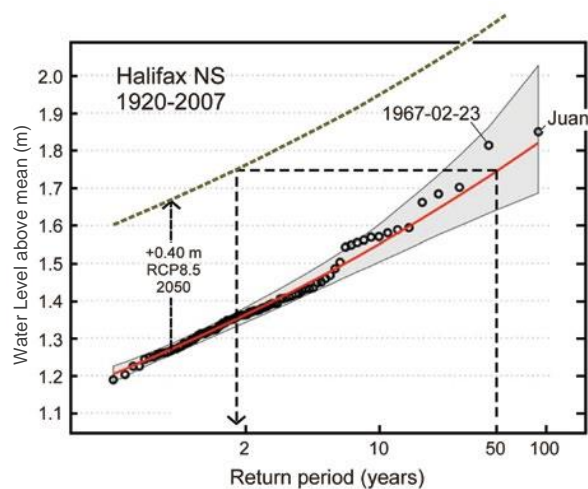
Figure 1.1. Changes in storm return period with the addition of SLR (Modified from Lemmen and Warren, 2016)

probability scale based on how often a surge of a particular size could occur in a century. Smaller surges occur more frequently, so could occur on a 1-in-5-year frequency for example while larger surges that occur very infrequently might have a 50 or 100-year return period and are viewed as worst case scenarios (Daigle, 2012). As sea level rises, surge residuals must be added on top of these higher water levels in the prediction of return periods. This means that as water levels rise, storms with high return periods become more probable so a storm that once had a 1 in 50-year probability could be increased to a 1-in-2 year return (Atkinson et al., 2016; Bernier and Thompson, 2006). Figure 1.1 depicts the linear relationship between sea level rise and increased storm surge height.

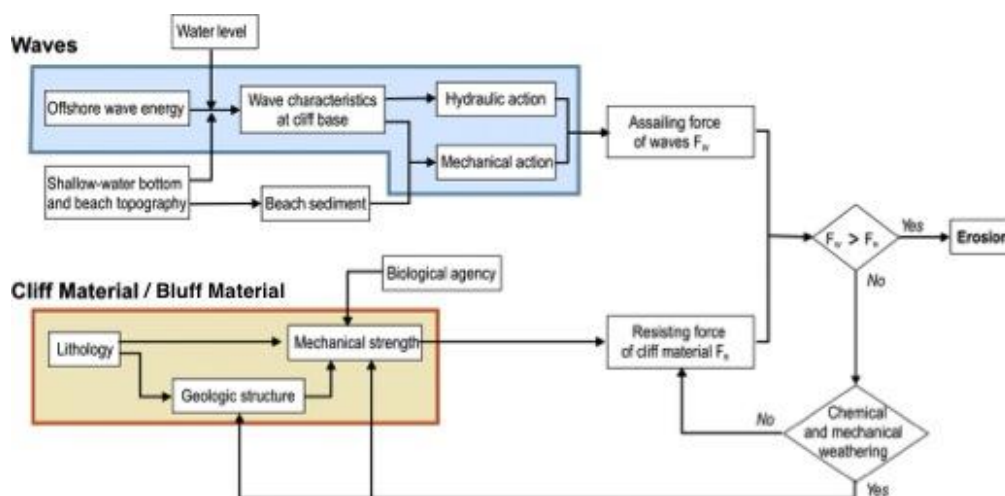
Figure 1.2. Assailing and Resisting Forces of Cliff and Bluff Erosion  
(Modified from Sunamura, 1983 in Davidson-Arnott, 2010)

Figure 1.2 demonstrates that assailing forces consist of wave energy and that resisting forces include the cliff material and its condition. When the strength of assailing forces is greater than the strength of resisting forces, erosion occurs (Davidson-Arnott, 2010).

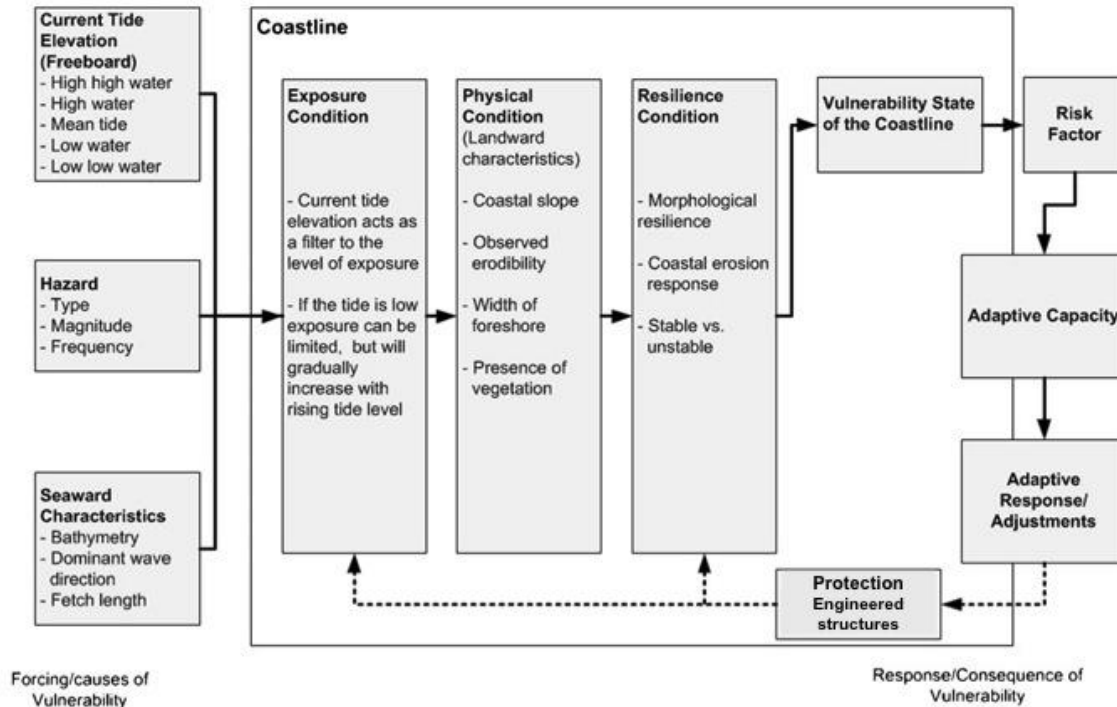
Figure 1.3. Vulnerability Assessment Conceptual Model  
(Modified from Tibbetts and van Proosdij, 2013)

The conceptual model in Figure 1.3 was designed by Tibbetts and van Proosdij (2013) to describe both causes and consequences of vulnerability and their relationships with coastal characteristics. The outlined characteristics of vulnerability are consequentially important to deduce when undertaking a vulnerability assessment. Causes of vulnerability include tide elevation, hazards, and seaward characteristics within a coastal region while consequences of and responses to vulnerability include measuring adaptive capacity and risk factors and the undertaking of a particular response in order to adapt to identified vulnerability. Characteristics of the coastline itself that can affect its vulnerability include its exposure (e.g. higher tide height causes increased vulnerability), physical characteristics (e.g. shore width and slope), and resilience (e.g. stability). The addition or existence of protective structures can be a response to identified vulnerability, and it can affect the exposure and resilience of the coastline (both positively and negatively).

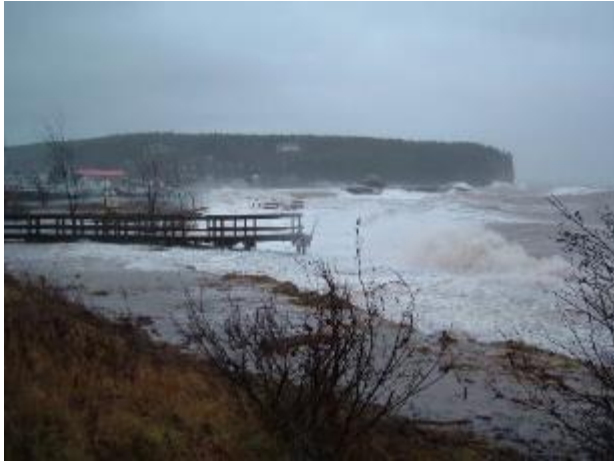
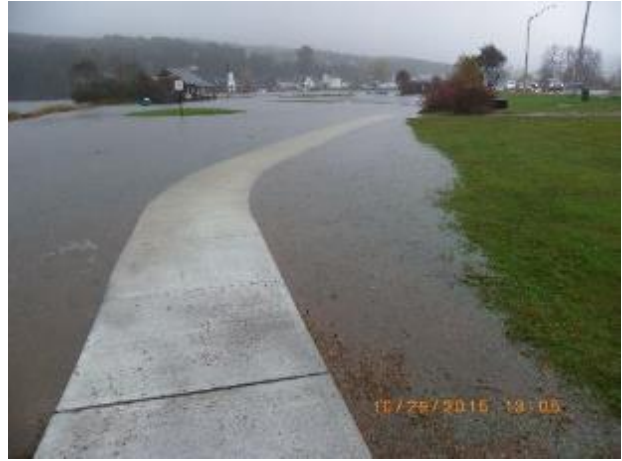
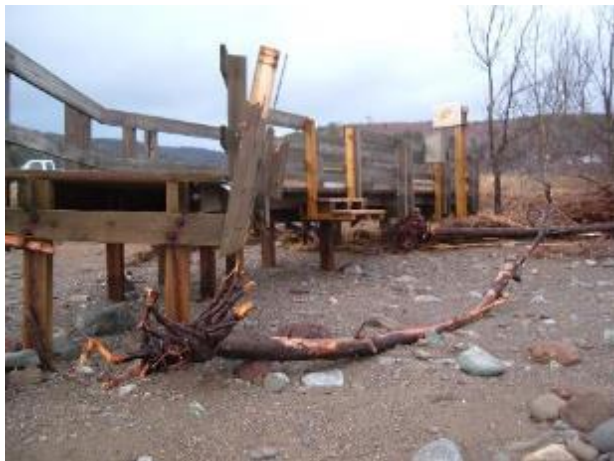
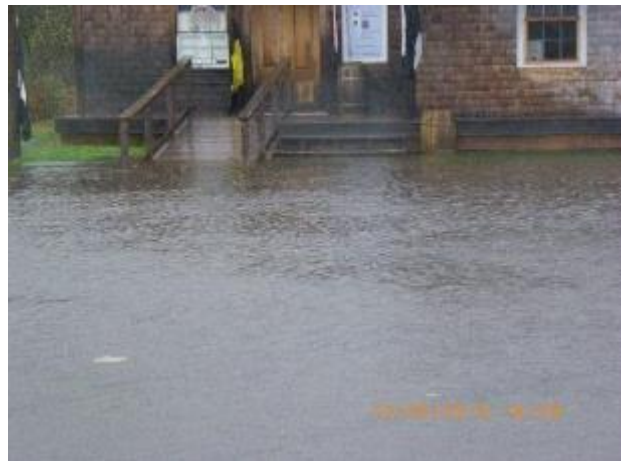
*Figure 2.4. Recent Storm Surges  
(Photos courtesy of Parks Canada, 2010-2015)*

The Alma region has been hit by many storm surges over the years, including multiple events in the last 10 years. Most recently, on October 20, 2015 a surge flooded the Alma beach parking lot up to the top step of the Molly Kool Heritage Centre's deck (as can be seen in Figure 2.4), washed over a dune on the beach, and eroded and damaged the bank behind the revetment that protects the highway. This revetment has been in place for many years and is currently failing due to erosion occurring behind it. In 2010, a different surge event damaged and broke off a section of the previous staircase and exhibit in the area and it washed down the beach in the process (as can also be seen in Figure 2.4). Large rain events can also cause damage to the area when the river level rises. Two fishing boats were ripped from the wharf and run aground at low tide in November 2013 due to powerful river currents amplified by a storm (MacInnis, 2013).

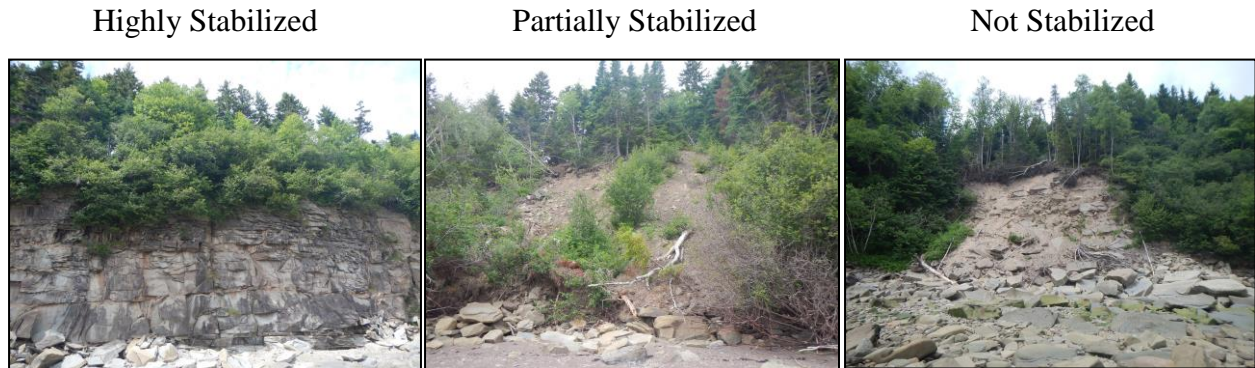
*Figure 3.3. Examples of Coastal Stability Characterizations  
(June 2016)*

One important component of the field characterization process was to assess the stability of the coastal segment being observed. In this study, stability could be characterized as highly stabilized, partially stabilized, or not stabilized (see Appendix A for further definitions and see Figure 3.3 for examples of each). The stability of the backshore was assessed with the use of a method termed a rapid geomorphic stability assessment, which utilizes a combination of geoindicators including slope angle and topography, and the presence of vegetation (Bush et al., 1999). The presence of vegetation can be an indication of the length of time that has elapsed since erosion occurred; if there is no vegetation present then erosion was likely recent whereas the presence of dense vegetation could demonstrate long-time stability, and if vegetation is beginning to regrow after an erosion event, the current slope could be moderately or partially stable. The angle and topography of a bluff or cliff could also be an indication of its stability; an even slope on a low angle demonstrates high stability whereas a steep or oversteep angle and the presence of large gullies and slump scars illustrates high instability, and a more moderate slope with an irregular or stepped topography potentially including minor gullies can indicate moderate stability (Bush et al., 1999). Overall knowledge of the stability of a coastline segment and whether it is actively eroding was important to the later assessment of its vulnerability.

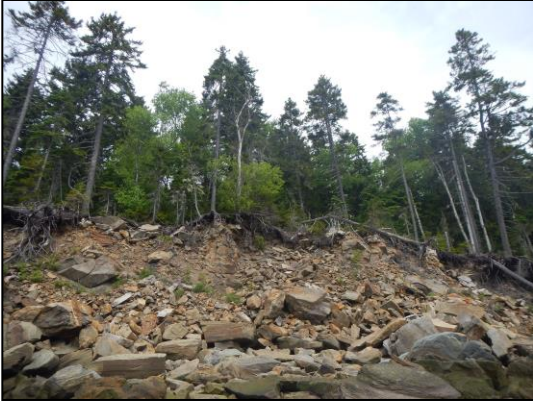
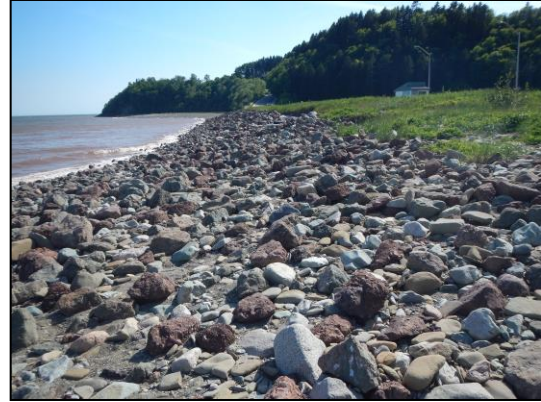
*Figure 3.4. Examples of Shoreline Segment Photographs  
(Images June 2016)*

Geotagged photographs were taken with either a Nikon COOLPIX AW110 or an Olympus TG-4 for each segment that was characterized as well as other additional features. This allows them to be further observed and compared and also allows the photos to be spatially integrated into GIS by the location and direction that they were taken. For shoreline segments, the photos were taken primarily perpendicular to the shore if the area was smaller and parallel to the shore if the segment was larger (see Figure 3.4 for examples).

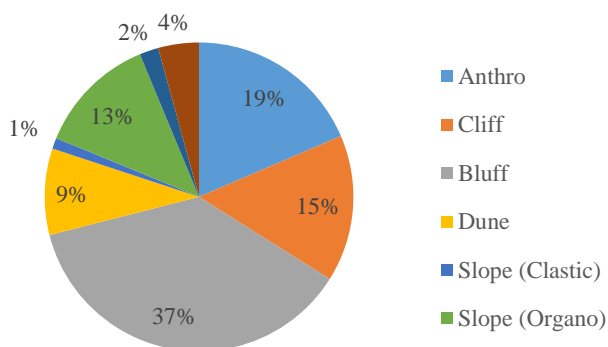
Figure 4.1. Prevalence of Backshore Characterizations - Alma to Herring Cove

Overall, the backshore of the coastline from Alma to Herring Cove has a highest proportion of bluff with that making up 37% of its total length. This is followed by anthropogenic features (18%), cliffs (15%), and organogenic slope (12.5%). The remaining backshore characterizations are illustrated in Figure 4.1. Half of the backshore is partially stabilized or damaged<sup>1</sup>, 26% is not stabilized or failing, 20% is highly stabilized or intact, and the final 4% is representative of a waterbody.

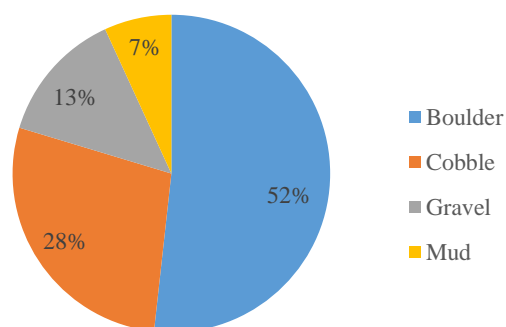
*Figure 4.2. Nearshore Beach Characterizations - Alma to Herring Cove*

From Alma to Herring Cove, there is no foreshore along 58% of the coastline. Of the remainder, beaches are the dominant landform (82%) with organogenic wetlands occupying 18% of the coastline. The beach primarily consists of cobbles (41.7%), sand (31.7%), and boulders (26.6%). The nearshore between Alma and Herring Cove is predominantly (97%) coastal flat with a small section (3%) of platform. The flat can be separated largely into boulders (52%) and cobble (28%) (Figure 4.2).

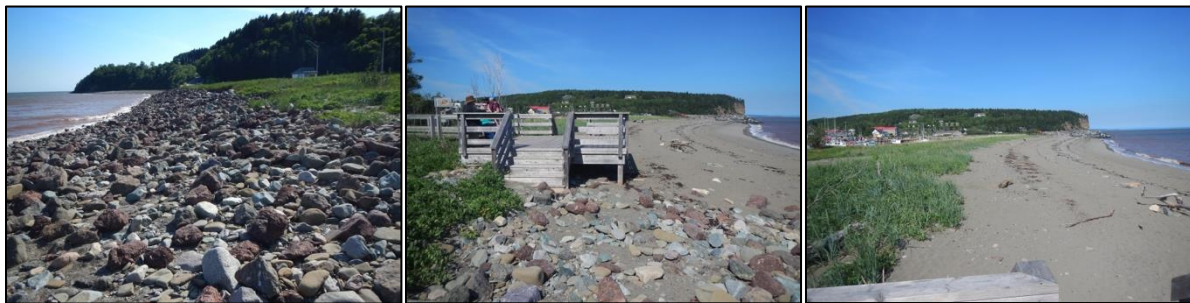
*Figure 4.4. Alma Beach access stairs on June 27, 2016 and extent of boulders from the damaged revetment at the time*

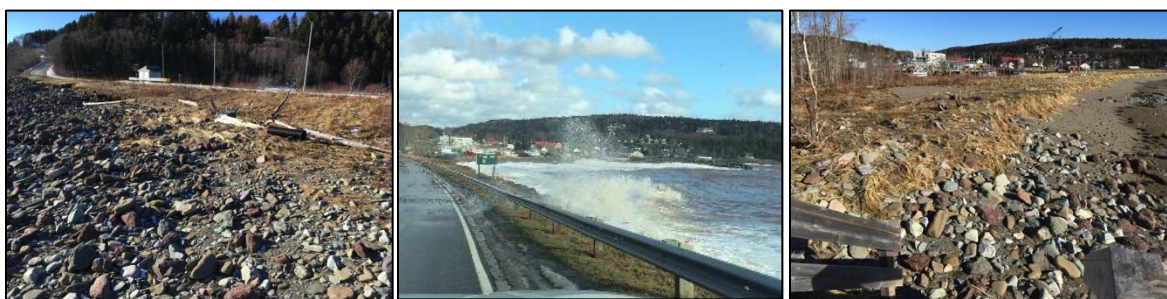
*Figure 4.5. Gale-force winds on December 30, 2016 caused large waves that further damaged the Alma Beach revetment. Boulders from the revetment have been pushed beyond the beach access stairs (Jan. 2017). (centre photo courtesy of Robin Stuart, 2016)*

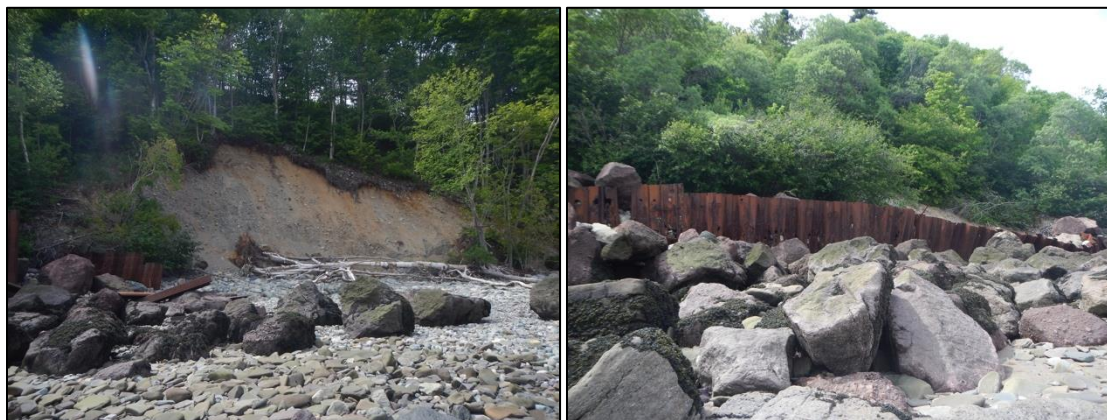
*Figure 4.6. Unstable slope and riprap revetment placed in front of a rusted bulkhead (June 2016)*

The first portion of the Alma to Herring Cove segment spans from the Village of Alma along the Park's coastline to an area of backshore marsh (Figure 4.3). The first unstable and a portion of the first partially unstable section consists of impeded sand dunes. These dunes border a failing riprap revetment that is pounded by waves during high wind events that coincide with high tide. Erosion is evident landward of the revetment, undermining the structure, and with each new minor storm event, rocks are pushed further along the beach and have now surrounded the beach access point as of January 2, 2017 (Figure 4.4 and Figure 4.5). The other portion of highly unstable backshore is a 20 m section of steep organogenic slope that has suffered a large amount of recent erosion (Figure 4.6), which threatens a lookout overlooking the Bay that is frequented by tourists. Beyond that section of unstable bluff, the base of the bluff is somewhat protected with failing revetment that is in front of an old, rusted and broken metal bulkhead (Figure 4.6) that spans into the second portion of the coastline in Figure 4.7.

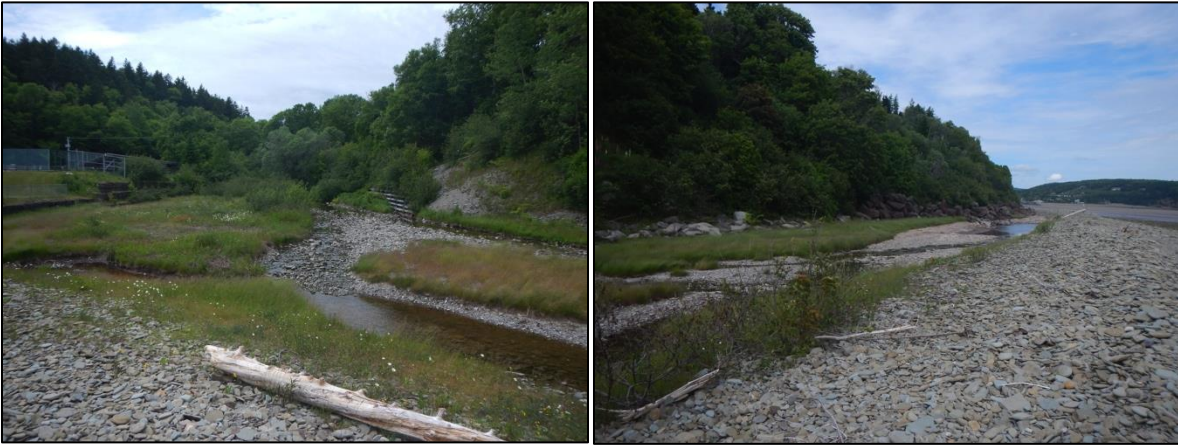
*Figure 4.8. Barachois behind a shingle barrier  
(June 2016)*

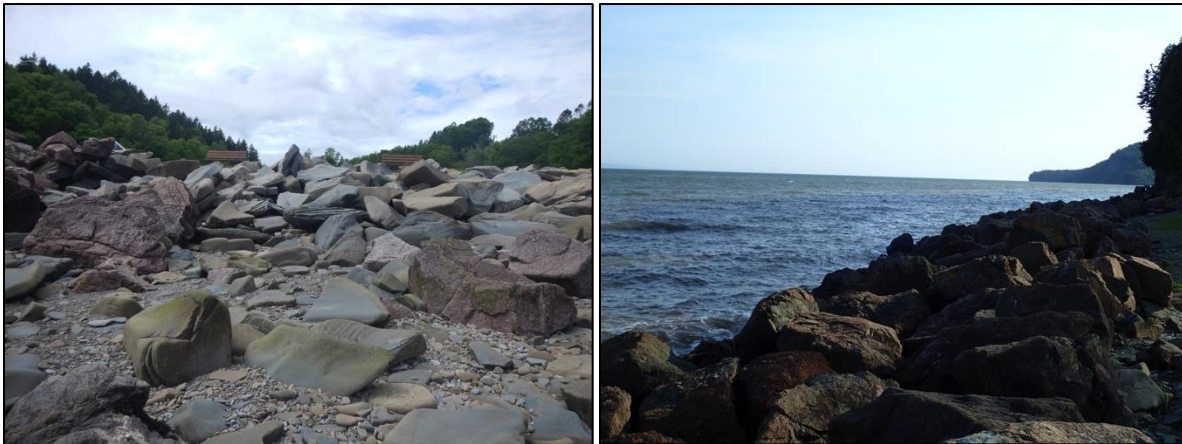
*Figure 4.9. Intact riprap revetment at Cannontown Beach  
(L: June 2016, R: August 2016)*

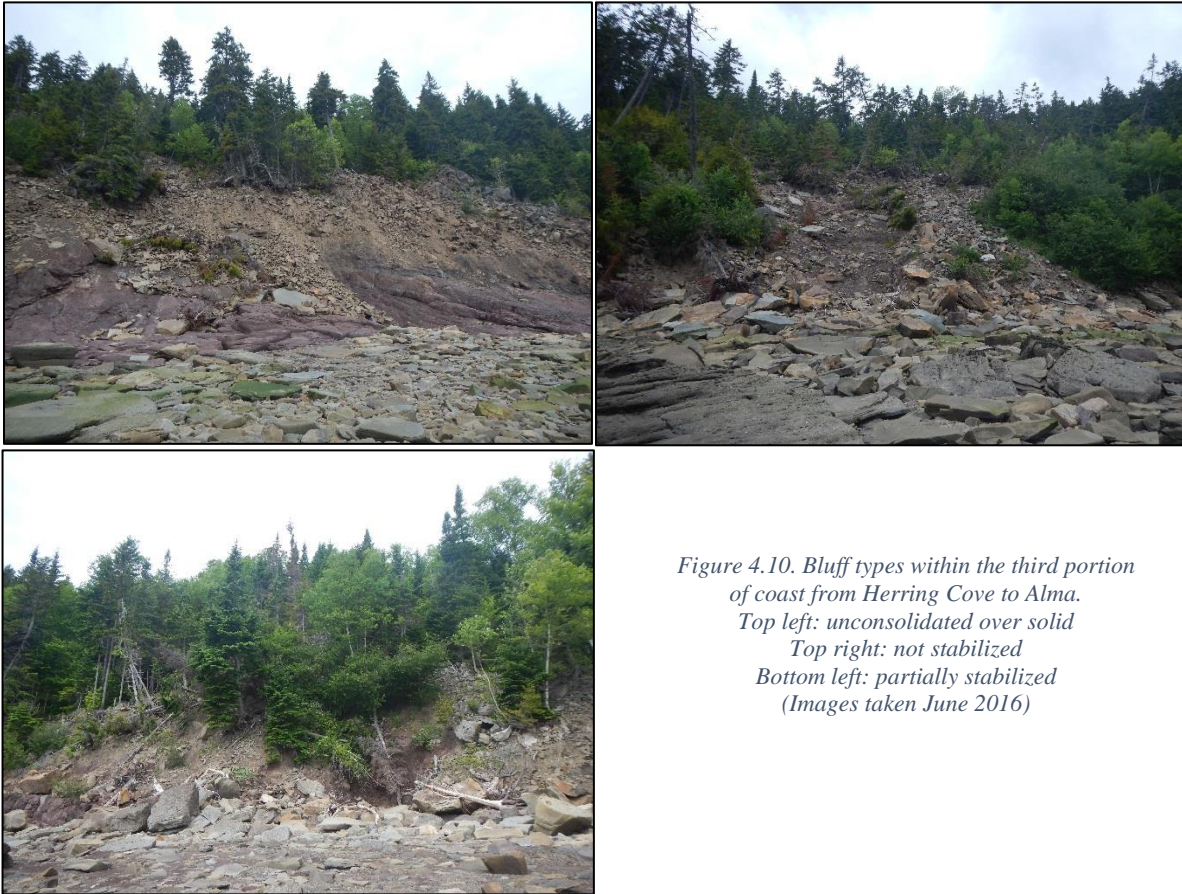
*Figure 4.10. Bluff types within the third portion of coast from Herring Cove to Alma.  
Top left: unconsolidated over solid  
Top right: not stabilized  
Bottom left: partially stabilized  
(Images taken June 2016)*

The third subsection of the coastline between Alma and Herring Cove (Figure 4.11) consists solely of high cliff and bluff, and there are no access points. The majority of the backshore within this portion is unstable or partially unstable with large amounts of recent and less recent erosion evident by the growth of vegetation within the eroded portions. Those that have vegetation re-growing along eroded portions have been deemed partially unstable (Figure 4.10). Beyond the far reach of the now-closed Devil's Half Acre hiking trail, there are no assets along this portion of the coastline, so its instability is not a negative attribute. A small percentage of the coast in this portion is what is referred to as unconsolidated over solid (Figure 4.10), which consists of a bluff on top of a bedrock base. The majority of these are unstable overall with large amounts of eroded material in front of the solid base.

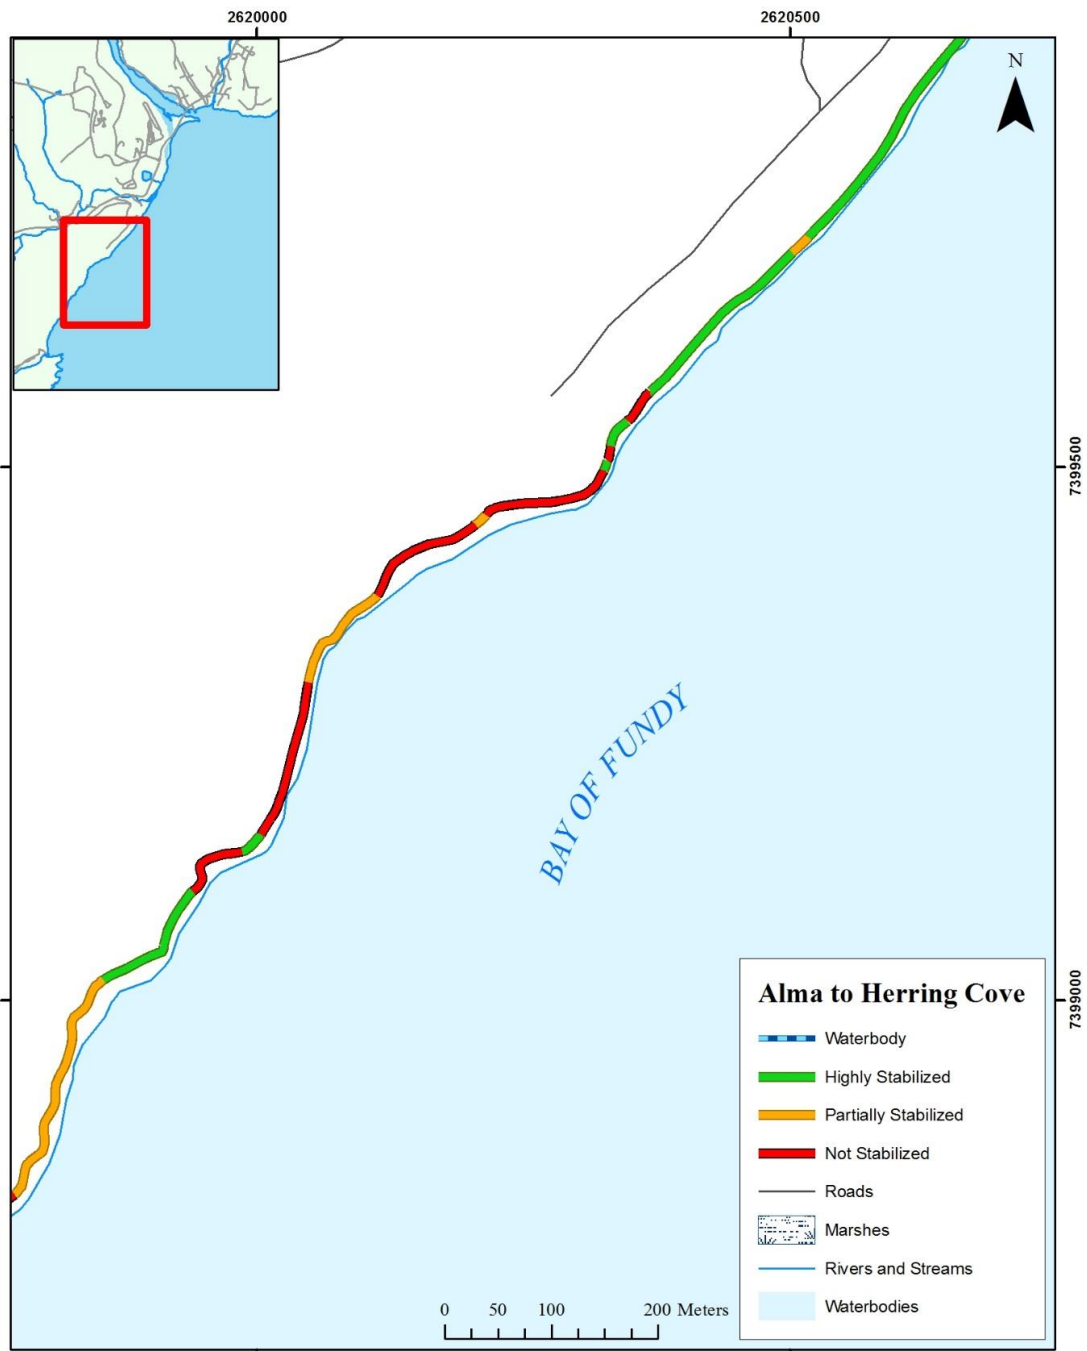
Figure 4.11. Stability in the third portion of the Alma to Herring Cove segment

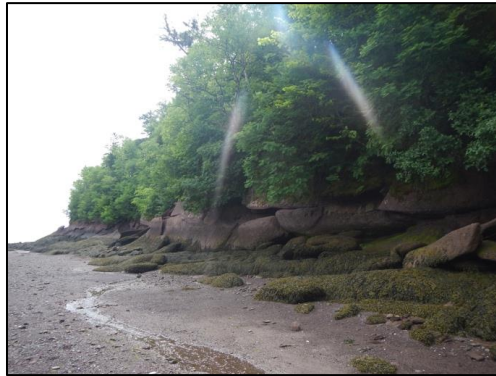
*Figure 4.12. Red sandstone cliffs at Herring Cove  
(June 2016)*

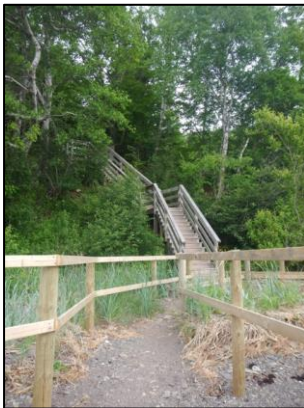
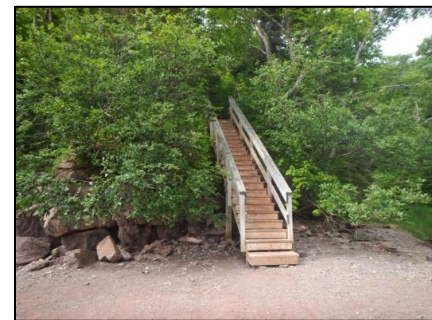
*Figure 4.13. Access  
stairs at Herring Cove  
Left: main access stairs  
Right: access to Coastal  
West trail  
(June 2016)*

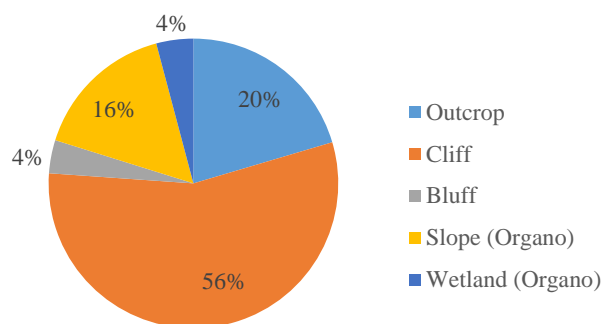
Figure 4.15. Prevalence of Backshore Characterizations - Point Wolfe

The backshore in the Point Wolfe Estuary is dominated by high cliffs, which make up 56% of its length, while a 20% portion of its length consists of outcrop (Figure 4.15 and Figure 4.18). The vast majority of the backshore is highly stabilized at 91%, and the remaining unstable (6.5%) and partially stable (2.5%) sections are found only within the bluff and organogenic slope sections at the back left and central portions of the estuary as can be seen in Figures 4.16 and 4.17. The single section of organogenic wetland is highly stabilized. As was discussed in Chapter 2, the cliffs on the western and eastern sides of the estuary are from different geologic time periods with those on the west being from the Pre-Cambrian era (specifically the Middle Neoproterozoic) and those on the eastern portion being part of the Hopewell Conglomerate (Figure 4.18), like the red sandstone cliffs at Herring Cove (Figure 4.12). It is important to note that there is a short, highly-used hiking trail at the top of the eroding bluff. This trail, named Shiphaven, has many lookoffs overlooking the estuary that are very close to the top edge of the unstable bluff. This bluff is eroding due to subaerial processes, so it could pose a danger to visitors. There are multiple signs along the length of the trail warning visitors of dangerous cliffs and to remain on the trail for their safety (Figure 4.20).

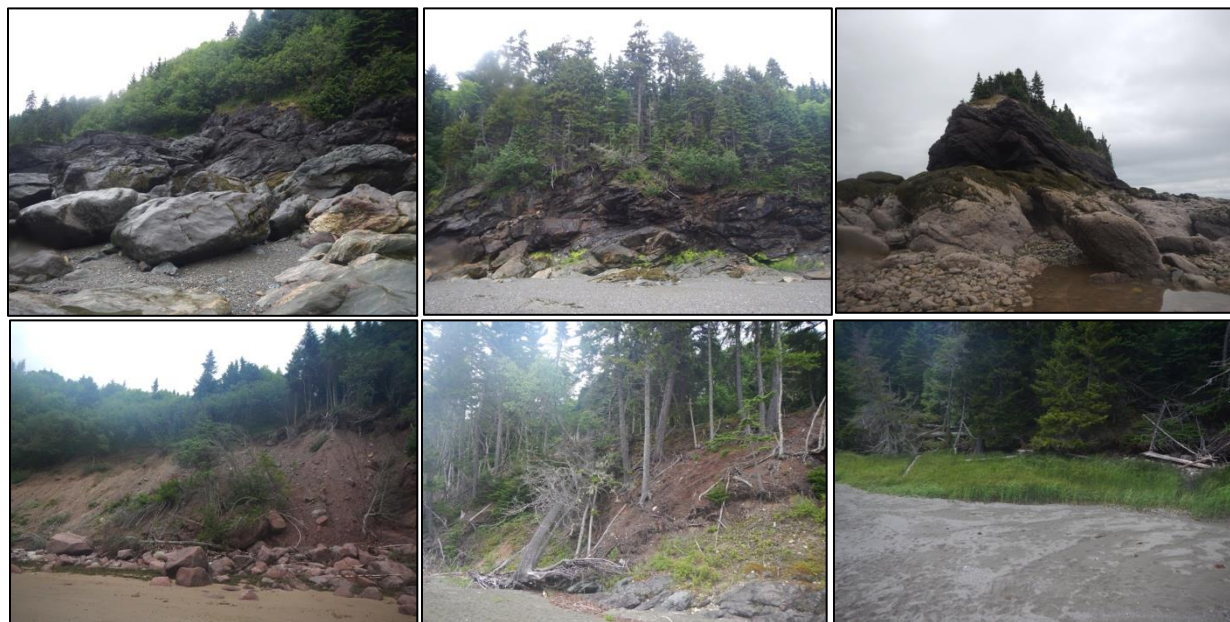
*Figure 4.18. Backshore types in the Point Wolfe Estuary*

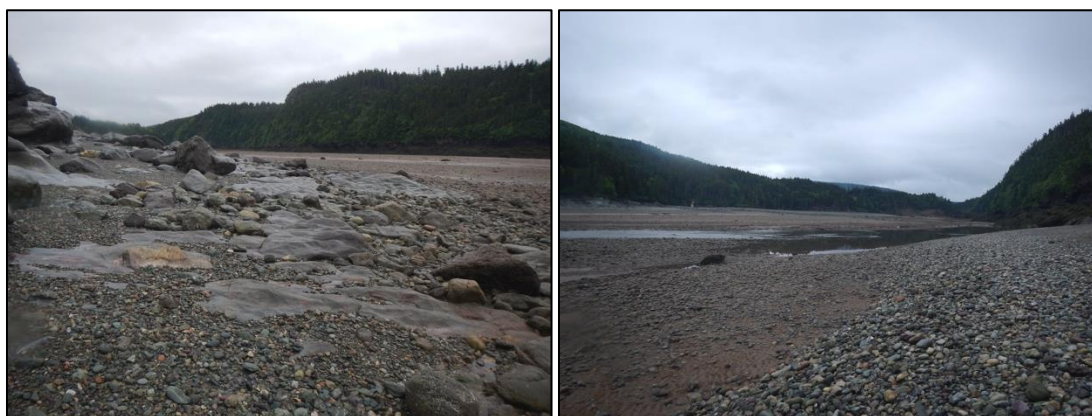
*Figure 4.19. Point Wolfe Nearshore types*

*Left: platform*

Within the Point Wolfe Estuary, there is no foreshore along 78% of the segment. The remainder is characterized as beach with sediments split between sand (59%), cobble (26%), and boulder (15%). The nearshore in the estuary consists of flats (81%) and platform (19%). The flats are a great mixture of sediment types with large patches throughout the estuary. These patches are made up of boulder (43%), cobble (24%), gravel (17%), and sand (16%). These nearshore characterizations are what are nearest to the cliffs, representing the patches immediately at their feet. This does not account for larger portions of the intertidal zone within the estuary where there are large patches of mud and less boulders. Examples from the nearshore are visible in Figure 4.19.

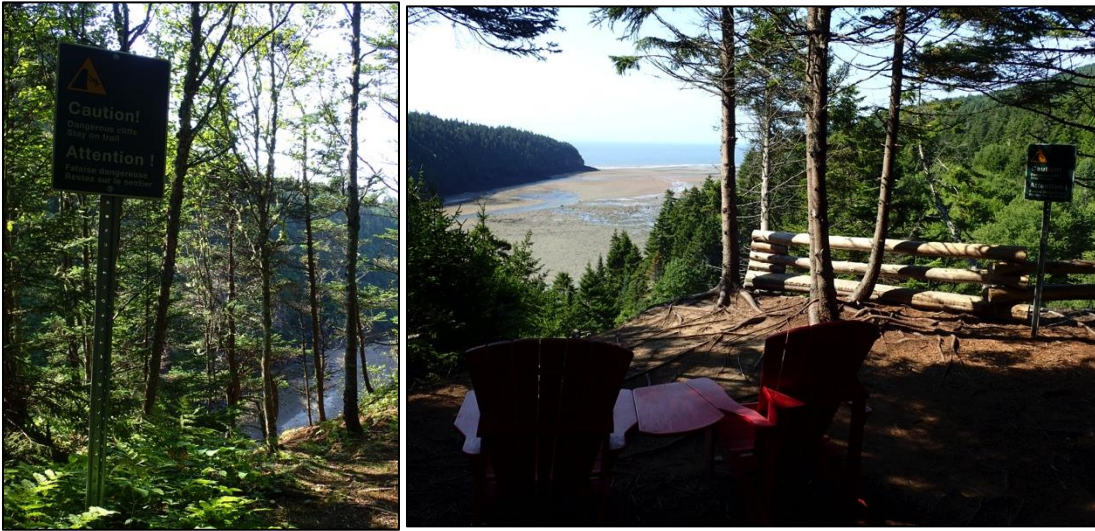
*Figure 4.20. Signs warning visitors of dangerous cliffs below at various points along the Shiphaven trail overlooking the Point Wolfe estuary. There are trees falling to the bottom of the bluff just behind the fence in the photo on the right.  
(Photos taken August 2016)*

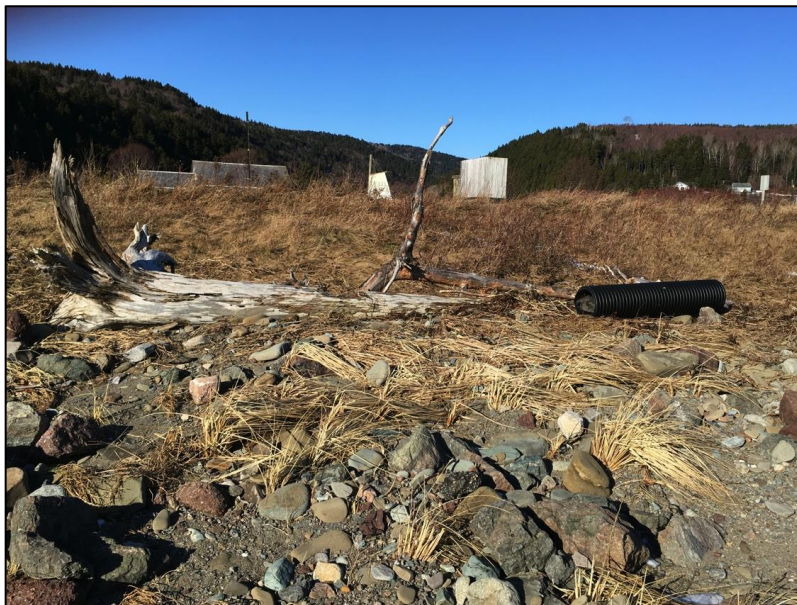
*Figure 5.1. Resting place of a pipe washed out of the Alma beach revetment in a storm on December 30, 2016 (Jan. 2, 2017)*

The most vulnerable areas that were identified in FNP are mostly low-lying areas that are currently susceptible to erosion and flooding issues and will be increasingly vulnerable as sea level rises. Low-lying areas that will be inundated by sea level rise in the future consist of the Alma beach parking lot containing the Molly Kool Heritage Centre, the Highway 114 behind Alma beach, the Park entrance booth, and the shared parking lot of the swimming pool and Cannontown beach. The riprap revetment protecting the highway along the top of Alma beach is failing, becoming undermined as it suffers from erosion. Four drains placed at intervals along the revetment are also at risk and being damaged; one of them was washed out of its location and down the beach from large, damaging waves on December 30, 2016.
