**CANAL GREENWAY ENVIRONMENTAL TESTING
ARCHAEOLOGICAL MONITORING
DARTMOUTH, NOVA SCOTIA**

FINAL REPORT

Cultural Resource Management Group Limited

AUGUST 2014

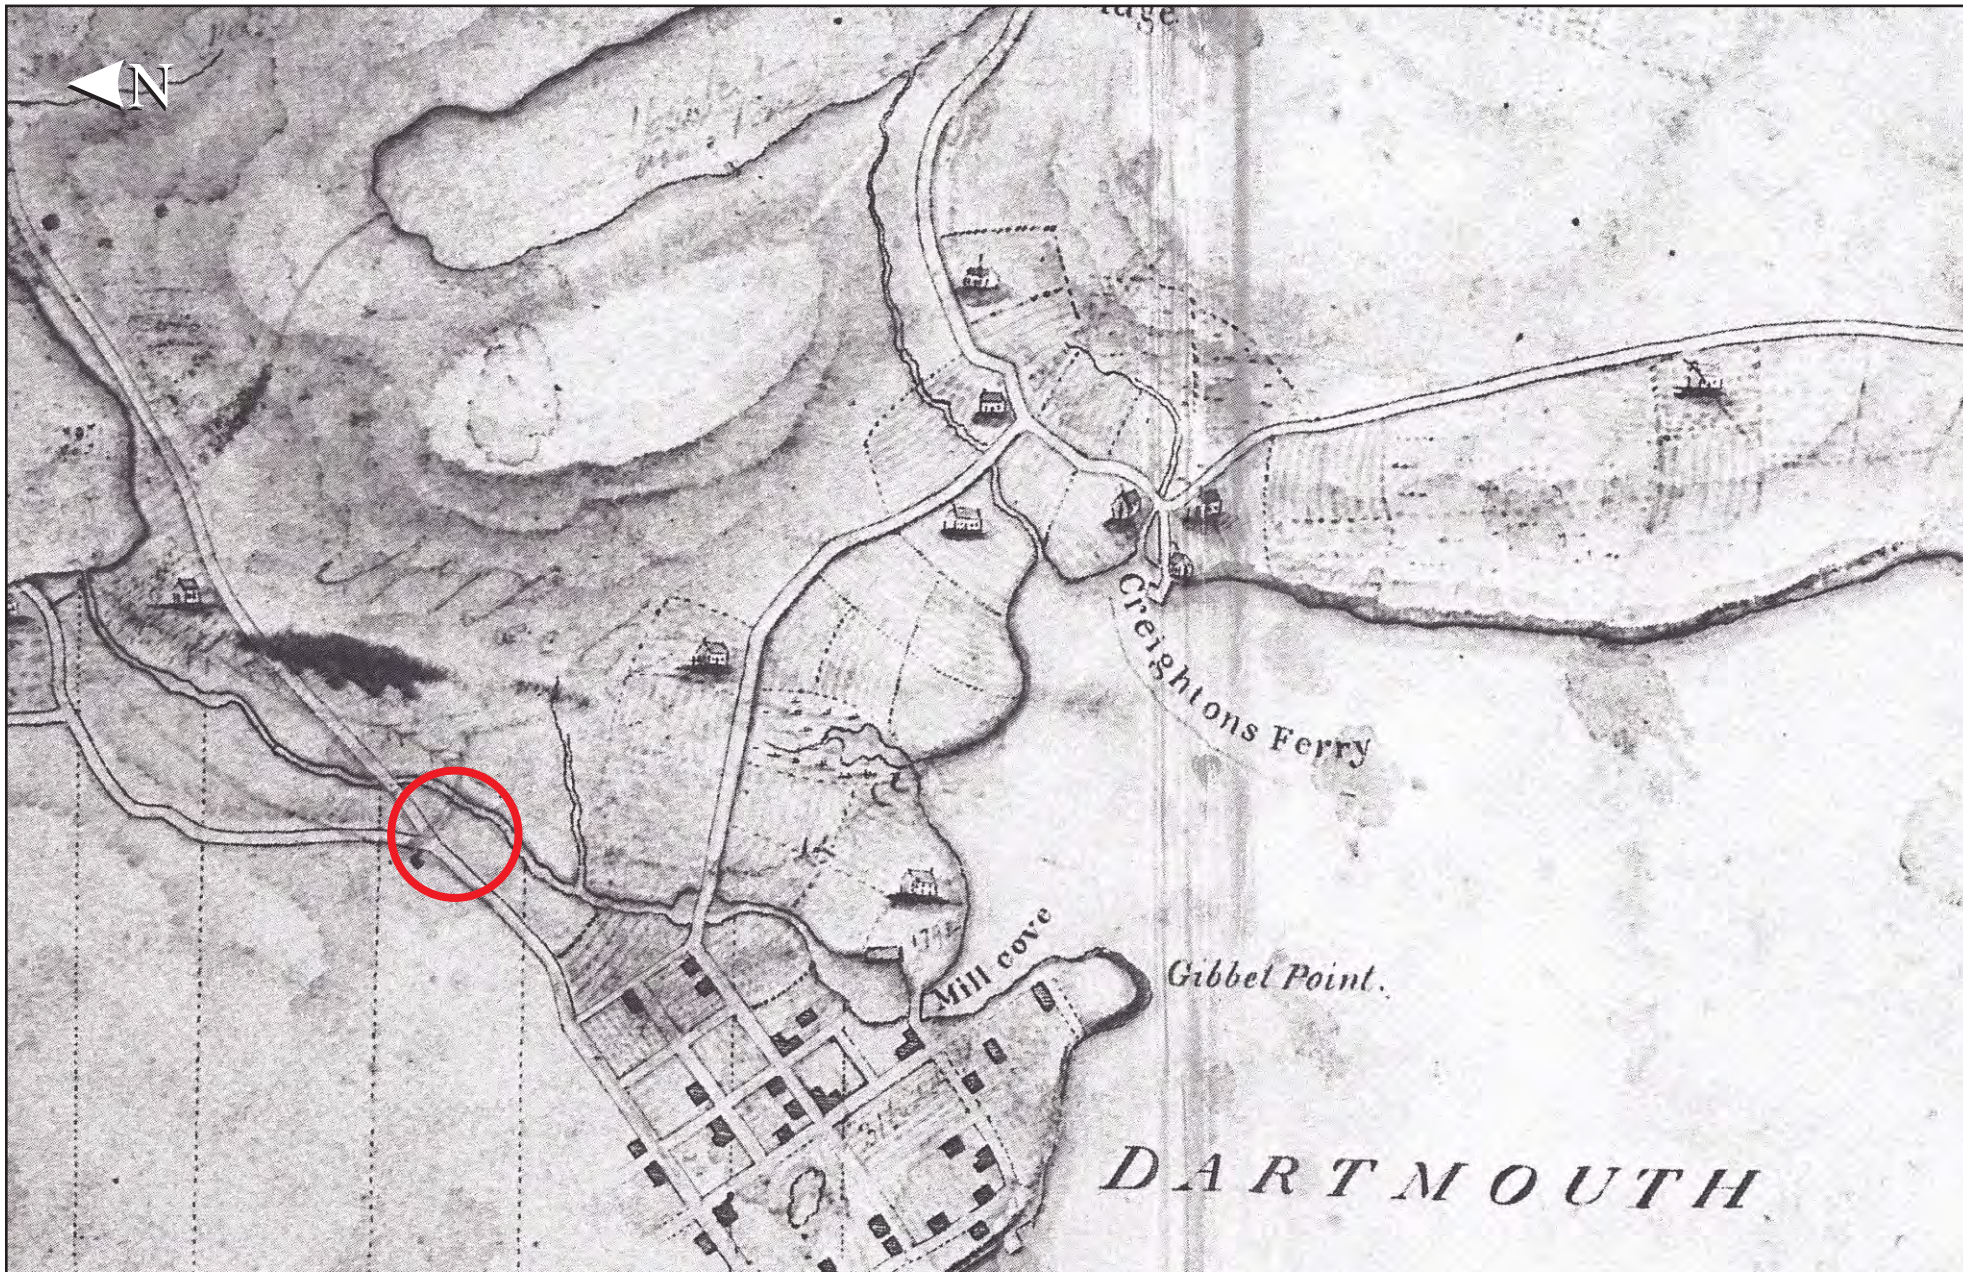
Figure 3

Prior to construction of the canal system, the Dartmouth Lakes were connected to Dartmouth Cove by a small stream (*Figure 3*). Note the absence of Sullivans Pond, as it was a creation of the canal system. In addition to depicting the alignment of the stream, the 1815 map by Valentine Gill includes an early depiction of Ochterloney Street (Preston Road) and Crichton Avenue. The relative positioning of Ochterloney Street, Crichton Avenue and the stream, help to identify the general location of the Starr Park property.

Area of Starr Park c. 1815

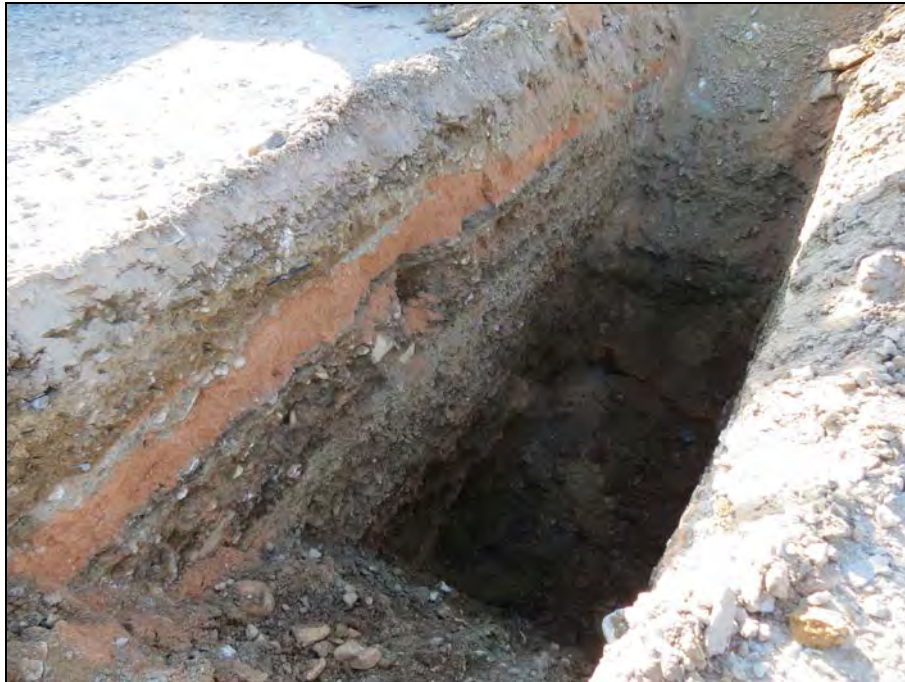
This pit was located near the southeast boundary of the property, positioned on a diagonal to Prince Albert Road. Measuring approximately 3 metres long and 70 centimetres wide, it reached an approximate depth of 1.7 metres below surface (*Plate 2*). The stratigraphy exposed by the test pit consisted of several layers of gravel, interspersed with sand and a loose ironstone mix. It is anticipated that the layers were laid down at different times through the site's history. The gravel deposit encountered at the base of the test pit was composed of a dark brown silt and was looser than the overlying layers.

Plate 2: Profile of Test Pit 1; facing east. August 13, 2014.

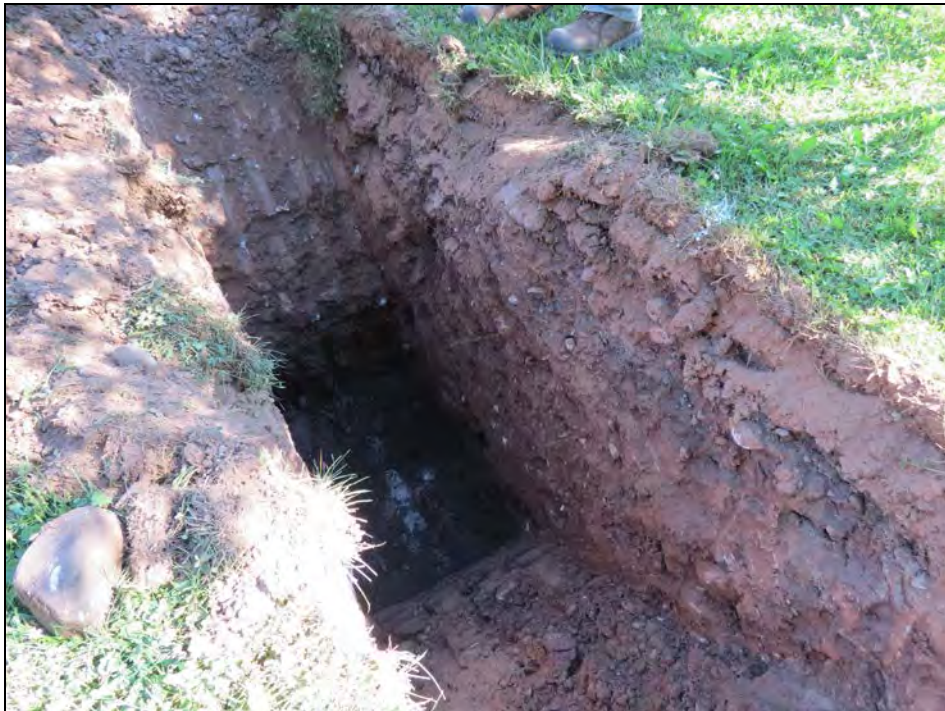
This pit was located in the southeast section of the property, positioned perpendicular to Prince Albert Road. Measuring approximately 3 metres long and 70 centimetres wide, it reached an approximate depth of 2 metres below surface (**Plate 3**). Excavation of the test pit was halted when a concrete pad was encountered. As with the previous test pit, it may be connected with the concrete wall running along Prince Albert Road. Immediately under the landscaped grass, was a fill layer comprised of an orange-brown silty sand with cobbles. At about 1.52 metres, a black ashy layer was reached that contained deteriorated wood, some rusted miscellaneous iron and fragments of mortar and brick. This layer overlay the concrete pad.

Plate 3: Profile of Test Pit 3; facing west. August 13, 2014.

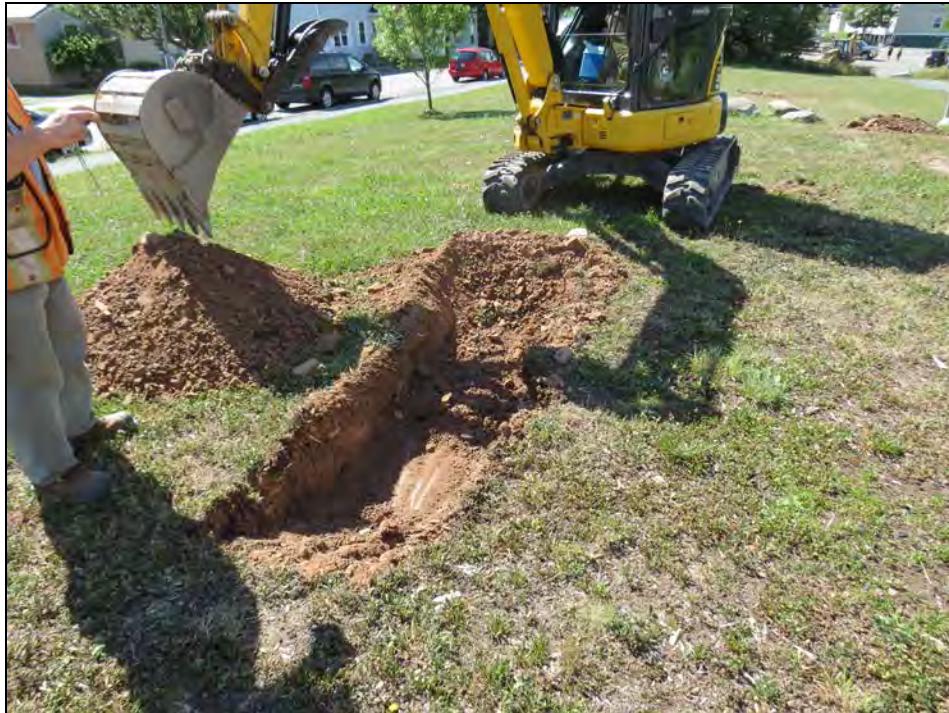
This pit was located in the centre of the property, positioned parallel to Prince Albert Road. Measuring approximately 3 metres long and 70 centimetres wide, it reached an approximate depth of 30 centimetres below surface (**Plate 4**). A concrete pad was immediately encountered below a thin layer of loose orange-brown gravelly silt so the excavation was halted.

Plate 4: Profile of Test Pit 6; facing south. August 13, 2014.

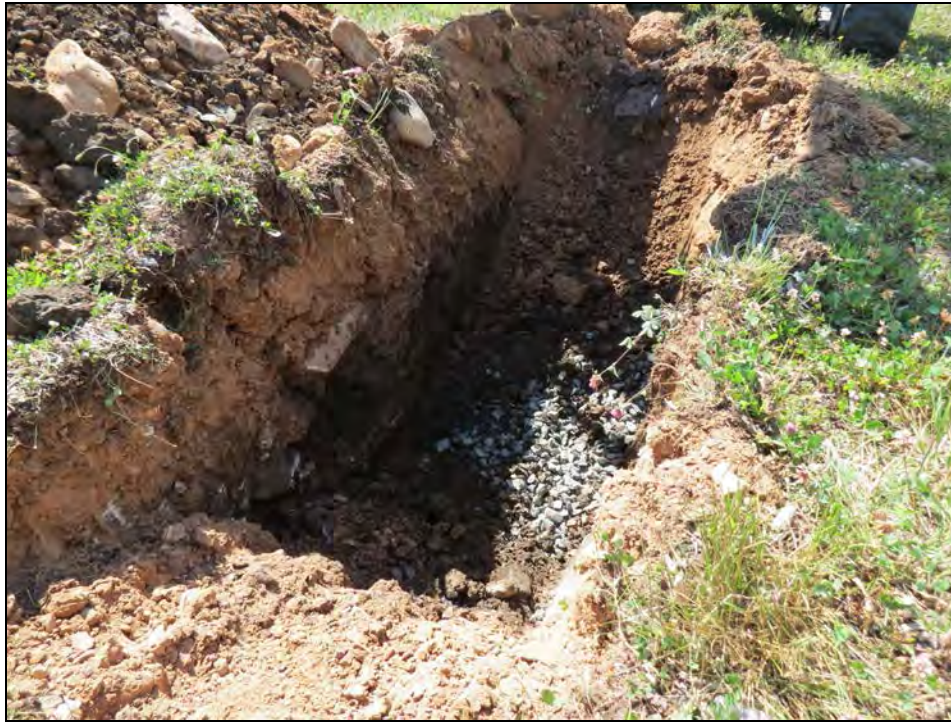
This pit was located in the centre of the property, positioned parallel to Prince Albert Road and immediately south of the turbine chamber. Measuring approximately 3 metres long and 70 centimetres wide, it reached an approximate depth of 90 centimetres below surface (**Plate 5**). The test pit was halted when it reached a layer of imported gravel that had been laid down to protect, and signal the close proximity to, the features related to the Shubenacadie Canal and Starr Manufacturing that had been exposed in 2007. This gravel was overlain by a mixed fill layer and then an orange loose clay/sand cap. The fill, a dark brown gravelly sand, contained scrap metal, and fragments of glass, wood and brick (**Plate 6**).

Plate 5: Profile of Test Pit 7; facing south. August 13, 2014.

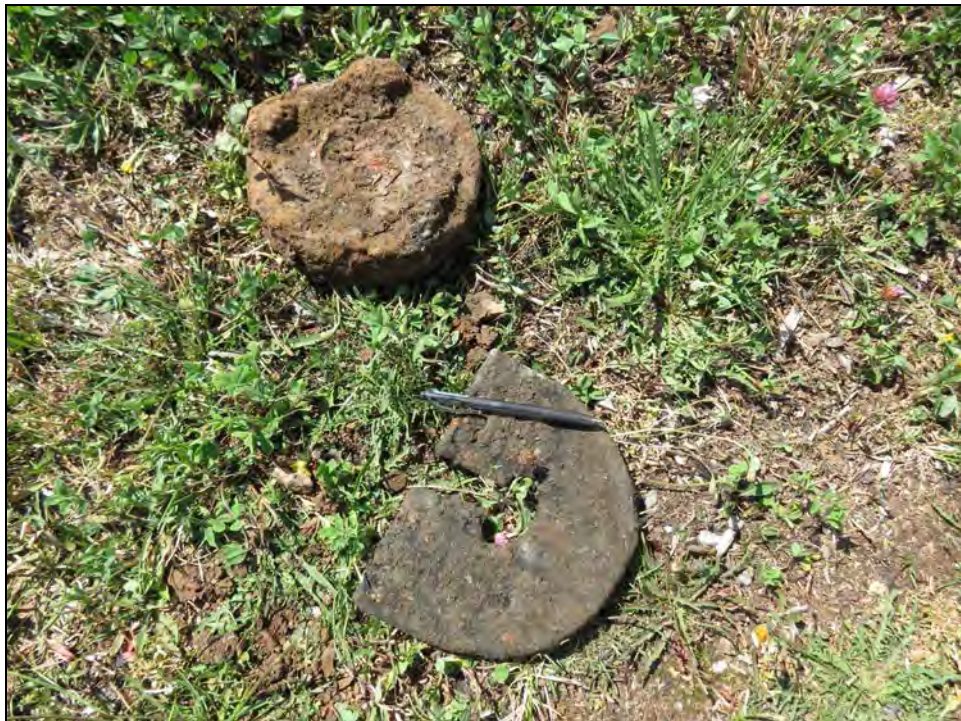
Plate 6: Examples of metal noted in Test Pit 7. August 13, 2014.

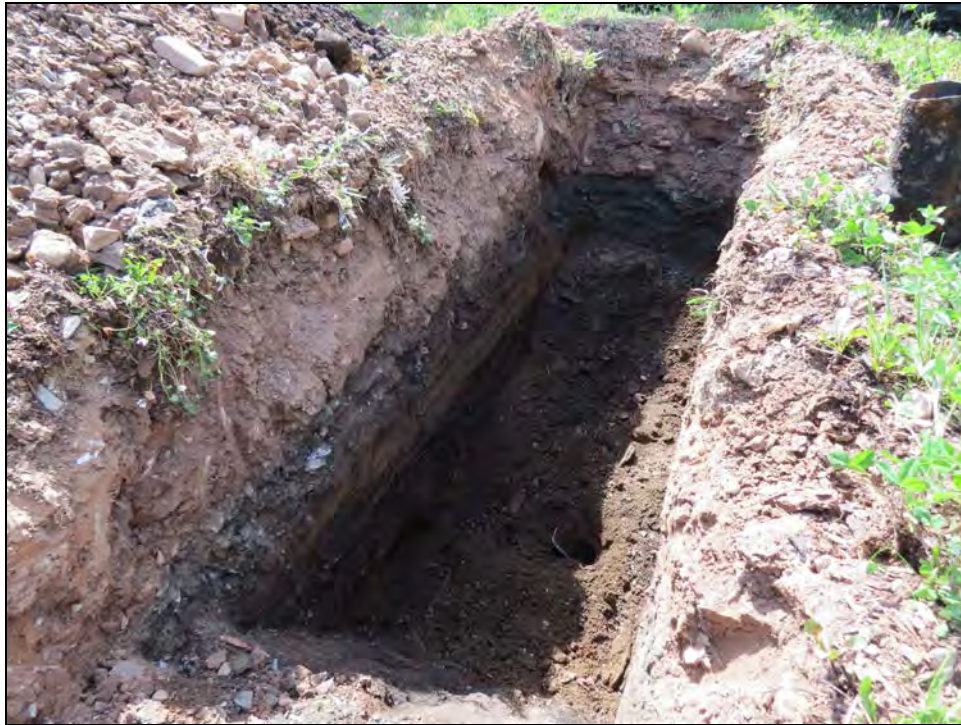
This pit was located in the centre of the property, positioned parallel to Prince Albert Road and to the north of the turbine chamber. Measuring approximately 3 metres long and 70 centimetres wide, it reached an approximate depth of 1.2 metres below surface (**Plate 7**). Excavation was halted when an old vertical floor drain pipe was encountered *in situ*. Immediately under the landscaped grass was a thick layer of a light brown silty sand. This was followed by several layers of alternating black to yellow ashy silt. The ash contained charcoal, coal and slag in addition to the floor drain pipe, first noted at 90 centimetres below surface. A tile was also noted with a section cut out for the pipe.

Plate 7: Profile of Test Pit 9; facing south. August 13, 2014.

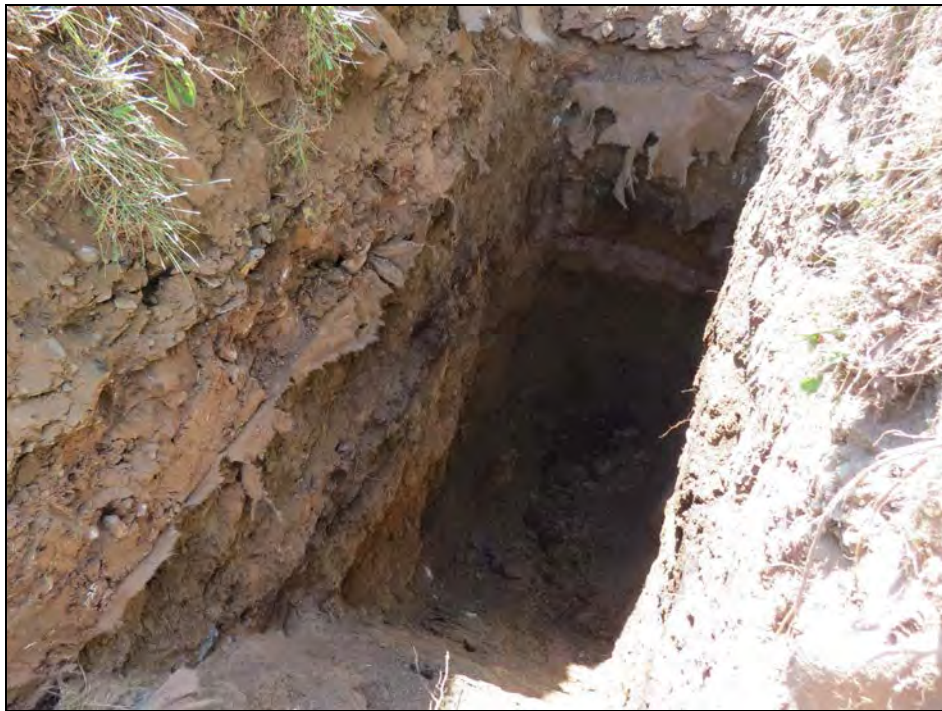
This pit was located in the northern section of the property, positioned on a diagonal to Prince Albert Road and to the west of the inclined plane. Measuring approximately 3 metres by 70 centimetres, it reached an approximate depth of 2.1 metres below surface (**Plate 8**). Excavation was halted when no more soil testing was required. Under the landscaped grass was a dark brown gravelly sand mixed fill containing fragments of brick, some miscellaneous metal and scrap pieces of leather. At approximately 1.5 metres into the test pit, the soil changed to a yellow-brown silt which contained no artifacts. It may have represented subsoil.

Plate 8: Profile of Test Pit 12; facing south. August 13, 2014.
