Evaluation of the Erosion Reduction Potential, Stability, and Resilience of Living Shorelines in Nova Scotia

A Thesis Submitted to Saint Mary's University, Halifax, Nova Scotia in Partial Fulfillment of the Requirements for the Degree of Master of Science in Applied Science.

March, 2017, Halifax, Nova Scotia

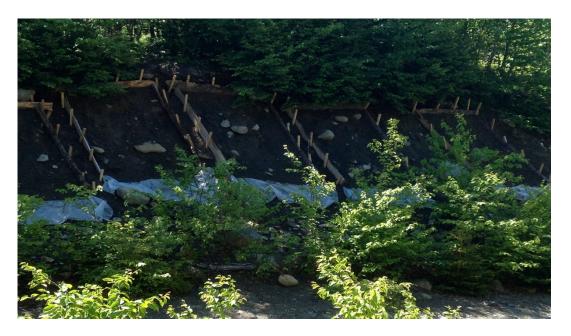
Figure 2) Some of the primary experimental plots during construction in July 2015.

The treatments evaluated were; planting native species into the slope, brush weaving, mulching with hay, and a combination of all the three aforementioned techniques that was meant to simulate a Living Shoreline. A list of plant species used can be found in Appendix Table 1. The effectiveness of the treatments was evaluated through comparison with untreated controls. Point scale measurements of soil level within the plots were measured using a profile gauge to determine sediment movement processes within the plots (See Appendix Figure 1). The secondary experiment consisted of twelve open plots

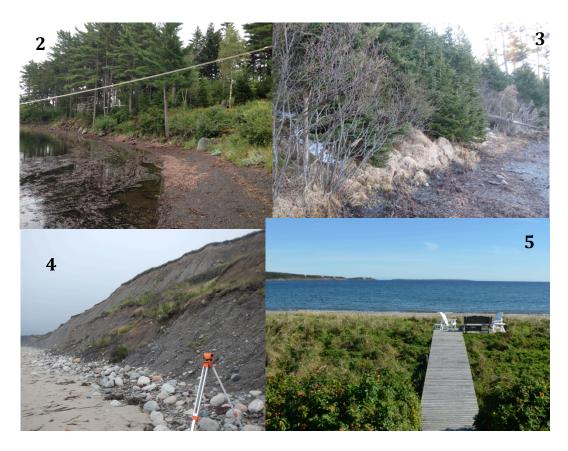
Figure 3) The four sites used for Living Shoreline monitoring. Two coastal bluff sites (2 and 3), cliff site (4), and dune site (5).

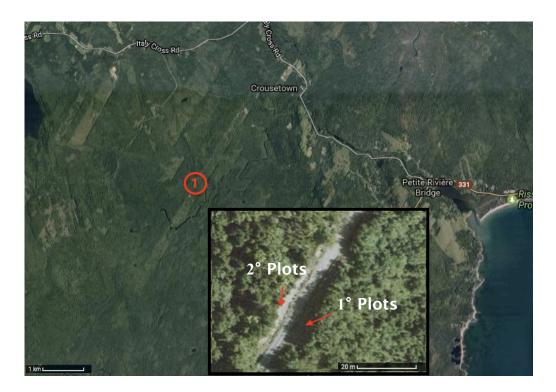
Figure 1) Satellite image of primary and secondary experimental plots along a road cut in Crousetown, NS. Imagery © 2017 Cnes/Spot Image, DigitalGlobe, Landsat/Copernicus, Province of Nova Scotia, map data © 2017 Google.

The primary and secondary experimental plots are located at the same site in Crousetown, Lunenburg Co., Nova Scotia (44°14'11.3"N 64°29'59.0"W)(Figure 1). The soil in this area is classified as humo-ferric podzol (Agriculture and Agri-Food Canada 2013 (b), Agriculture and Agri-Food Canada 2015). This area is dominated by slate till of meguma group origin and the regions drumlins, such as the one experimental plots are at the top of, are formed from Hartlen till (Province of Nova Scotia 2013). Hartlen till is a locally derived till consisting mainly of slates and greywackes (Stea 1982). The composition of Hartlen till is typically 40% gravel, 40% sand, and 20% silt and clay (Webster et al. 2014). Data from the Environment Canada weather station in Bridgewater, NS shows the average annual rainfall from 1981-2010 is 1535.7 mm and the mean temperature varies from 19°C in July to -5.3°C in January with an average yearly temperature of 7.5°C (Government of Canada 2015).

The primary and secondary experimental plots were located on slopes on either side of a road cut (Figure 1 inset). The mean slope gradients for the primary and secondary experimental plots were 63.5% and 72.2% respectively, making them excessively steep (Agriculture and Agri-food Canada 2013). At the time when experimental set up began in May 2015, the slopes were approximately 100% bare soil and appeared to be experiencing active erosion based on a lack of vegetation and prevalence of small rills. According to SEDMODL (a GIS based sediment delivery model that identifies the erosion potential of road segments) outputs, a road cut with a slope gradient of 47.3±7.6 % and a vegetation cover of 28.7±7.8 % falls into the category of

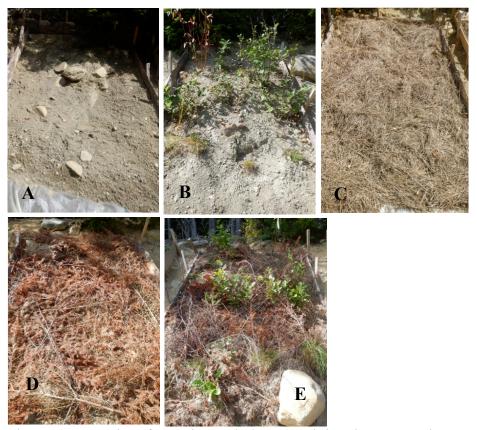
Figure 2) Examples of experimental plots containing the untreated control (A) and the four experimental treatments; native plants (B), hay mulch (C), brush weaving (D), and all combined (E).

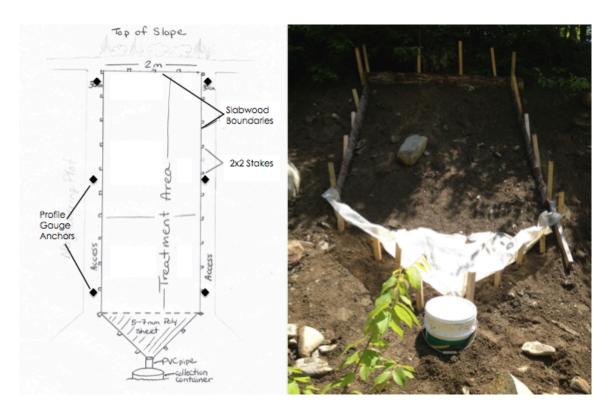
Figure 4) Closed plot design for primary experimental plots (left) and photo of closed plot in the field after installation (right).

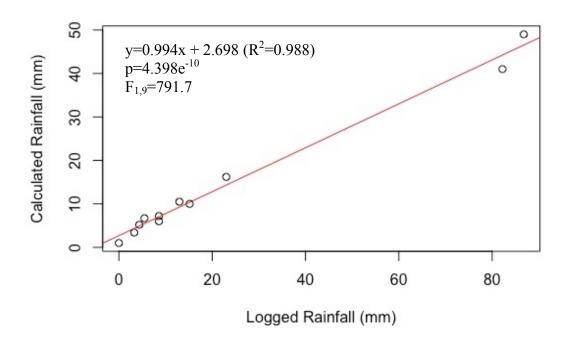
Figure 5) Regression analysis of the relationship between calculated rainfall (mm) and logged rainfall (mm) with Pearson correlation line of best fit. Residual standard error = 1.8 on 9 degrees of freedom.

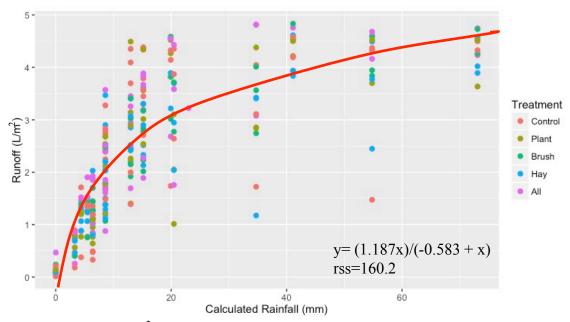
Figure 6) Runoff (L/m^2) from each primary experimental plot produced during natural rainfall events, plotted against the calculated rainfall (mm) for each runoff-generating event. Fitted with a Michaelis-Menten curve. Residual standard error = 0.8 on 271 degrees of freedom. Residual sum-of-squares (rss) = 160.2.

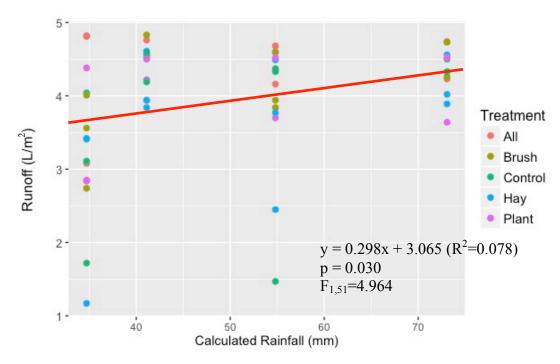
Figure 7) Linear regression of the effect of calculated rainfall (mm) on runoff (L/m^2) for the five largest rainfall events runoff data was collected for (34.7 mm < 73.1 mm). Residual standard error = 0.8 on 51 degrees of freedom.

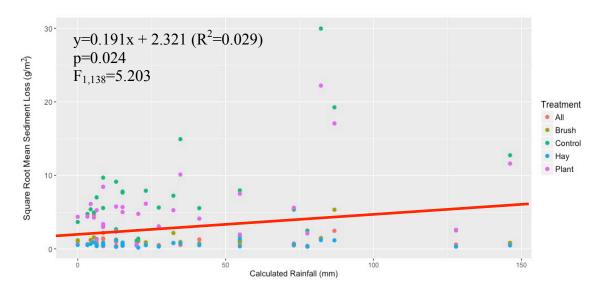
Figure 8) Regression analysis of the effect of calculated rainfall (mm) on sediment loss (g/m^2) . The square root mean sediment loss per treatment per rainfall event was used to improve the readability of the graph. Residual standard error = 4.4 on 138 degrees of freedom.

A significant, although weak, positive relationship between calculated rainfall (mm) and sediment loss (g/m²) was found (Figure 8). From Figure 8 there appeared to be trends in the amount of sediment loss from the different treatments. This raised the question of whether the relationship between calculated rainfall and sediment loss was consistent across treatments or if the treatments were affecting the relationship. Linear regressions of the effect of calculated rainfall on sediment loss were done for each of the treatments separately to determine if there was any treatment effect. There was a significant positive relationship between sediment loss and calculated rainfall for the Control plots and Plant treatment (Appendix Figures 4 and 5). There was no significant

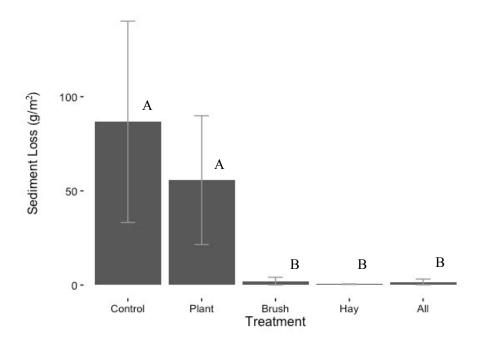
Figure 9) Sediment loss (g/m²) from each of the treatments from natural rainfall during the entire monitoring period. Error bars represent 95% confidence intervals.

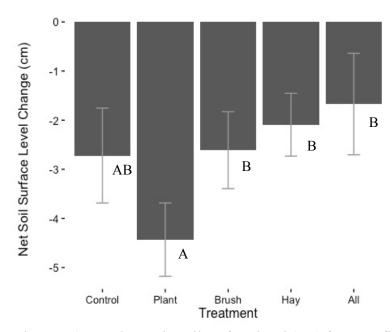
Figure 11) Net change in soil surface level (cm) from profile gauge measurements for each of the treatments between November 2015 and August 2016. Error bars represent 95% confidence interval.

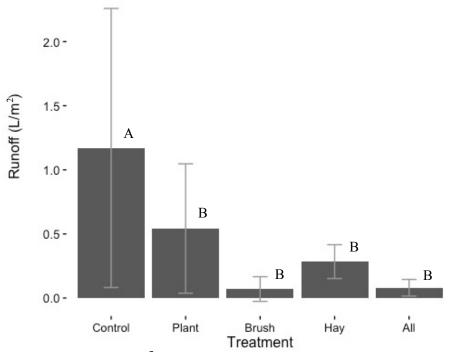
Figure 13) Runoff (L/m²) generated from each of the treatments during the two controlled watering experiments. Error bars represent 95% confidence interval.

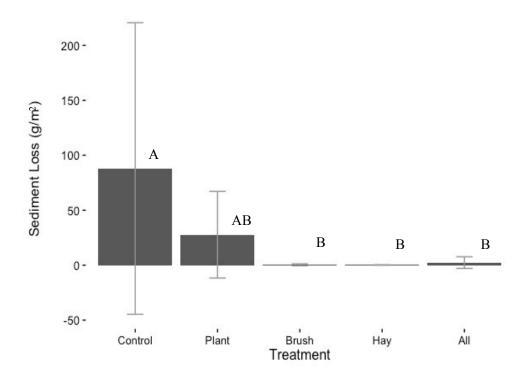
Figure 14) Sediment loss (g/m²) during the controlled watering experiments for each of the treatments. Error bars represent 95% confidence interval.

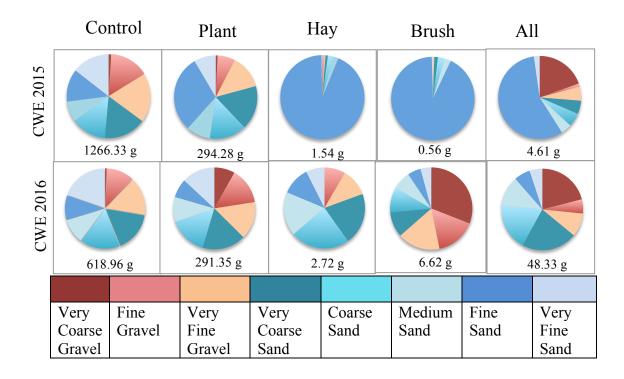
Figure 15) Mean proportion of sediment grain sizes (defined by GRADISTAT) for sediment lost from each treatment from the primary experimental plots during two controlled watering experiments (CWEs). Total weight of sediment sample (g) used for grain size analysis for each of the treatments and CWEs noted under each chart.

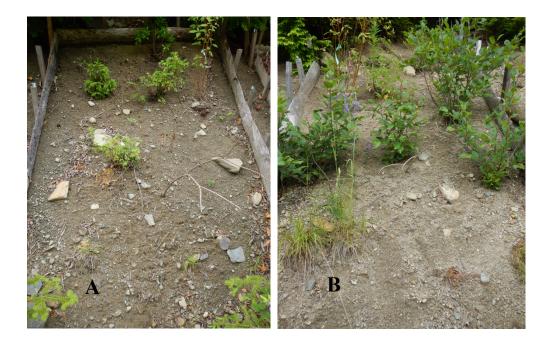
Figure 16) Images of two Plant treatment plots showing lowest (A) and highest (B) amount of soil cover provided by the Plant treatment.

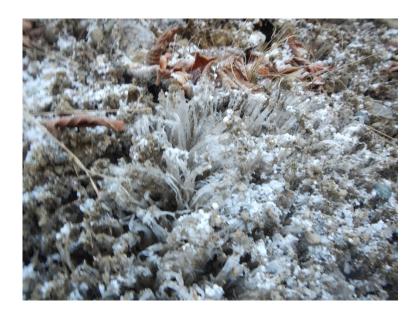
Figure 17) Example of sediment on top of ice crystal formation on the surface of exposed soil in Plant treatment taken November 30, 2015.

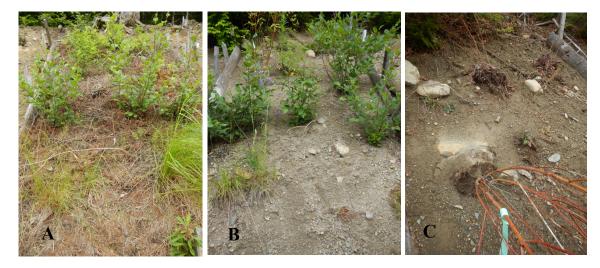
Figure 18) Comparison of plant health between the All (A) and Plant (B) treatments on June 30, 2016. C) Exposed roots of plants in the Plant treatment on April 18, 2016 after winter erosion.

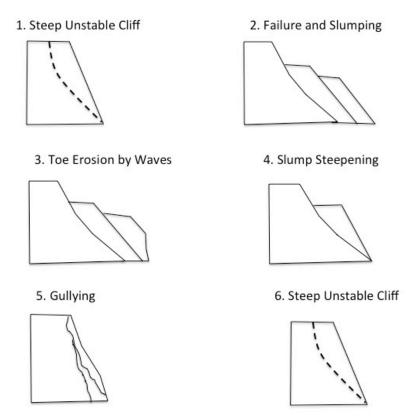
Figure 1) Cycle of erosion and episodic crest recession of a large (>10 meters) cohesive glacial till cliff. Adapted from Brown et al. [2005] and Himmelstoss et al. [2006].

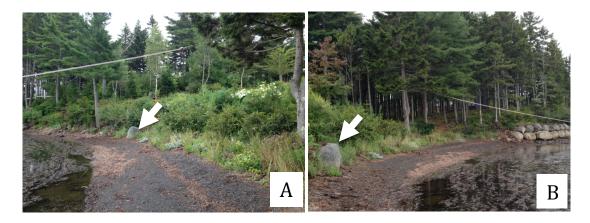
Figure 2) Images showing the eastern (A) and western (B) ends of Site 1. The same rock is indicated in both photos by an arrow.

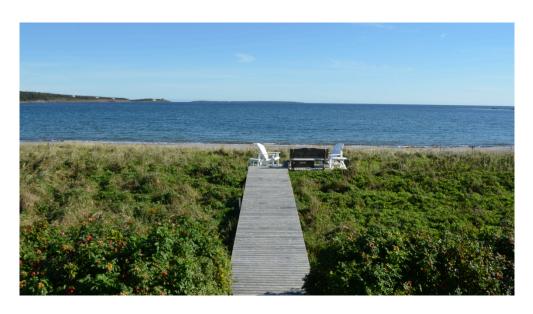
Figure 6) Image of the center section of Site 4.

Site 4 is a sand dune above the sandy beach in Kings Bay (Figures 6 and 7). Kings Bay faces the open ocean although it does receive some protection from Rose Point to the north and Enrage Point to the south. The southern corner of Kings Bay, where Site 4 is located, typically experiences lower intensity wave activity than the northern corner of the bay therefore Site 4 can be considered a moderate energy site, although it is very likely that it does experience high energy conditions on occasion (Personal observation). Site 4 did not receive the same combination of hay mulch, woven brush, and native plantings that the other sites received. Native beach pea (*Lathyrus japonicus* var. *maritimus*) and dune grass (*Ammophila brevigulata*) plantings were used to revegetate and stabilize the dune nine years prior to the beginning of this study. These plants were fed using kelp concentrate inoculated with mycorrhizal fungi seasonally during the first two growing seasons.

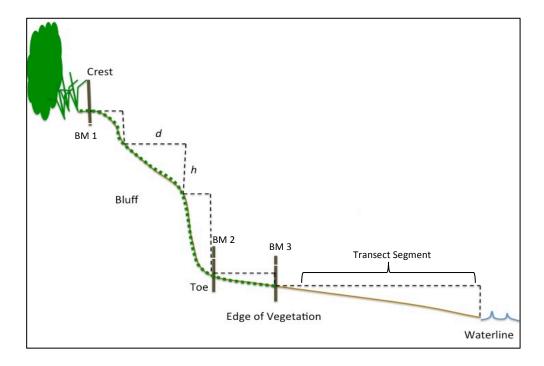
Figure 8) Idealized schematic of small coastal bluff showing the parts of the bluff and the locations of the benchmark (BM) stakes. Dashed lines represent how transect segments were surveyed using the Emery Survey Method to measure horizontal distance (d) and height (h). Not representative of scale or vegetation density.

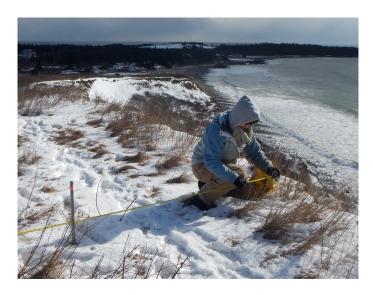
Figure 9) Measuring crest transects at Site 3, February 2016.

Due to the large size and steep slope of the cliff at Site 3 and the dangers associated with working at height, crest and toe measurements were determined to be the safest, most practical way to measure crest recession and toe erosion at Site 3. Five transects were installed at equal distances across the section of the cliff crest that we had homeowner permission to work on, this happened to be the tallest section of the cliff. Transects 1 and 2 were above the steep gullied part of the cliff face while transects 3, 4, and 5 were above the slump block. The slope above the slump was not as steep as the gullied section of the cliff and no large gully formations were present.

The transects consisted of two wooden stakes installed perpendicular to the cliff crest and crest measurements were taken by measuring the distance from the first stake, across the second stake, and out to the cliff edge (Figure 9). Five transects perpendicular to the cliff toe that roughly corresponded to the locations of the crest measurements were

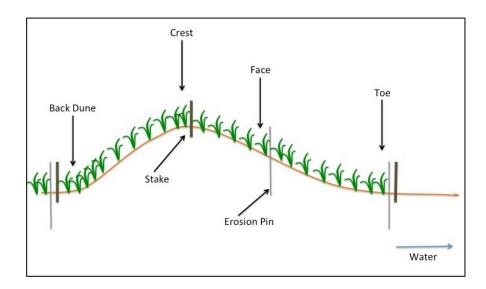
Figure 10) Idealized schematic of dune transect highlighting the parts of the dune and locations of stakes and erosion pins. Not representative of scale or actual vegetation density.

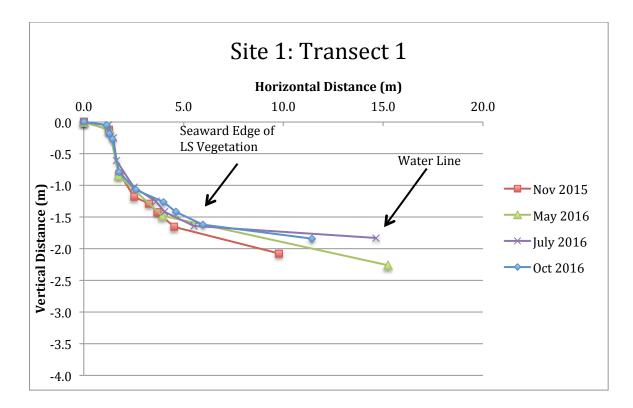
Figure 11) Site 1 seasonal bluff and beach profiles at transect 1 generated from survey data. Point 0.0, 0.0 corresponds with benchmark stake 1 at the bluff crest. The seaward edge of Living Shoreline vegetation corresponds approximately to mean high water.

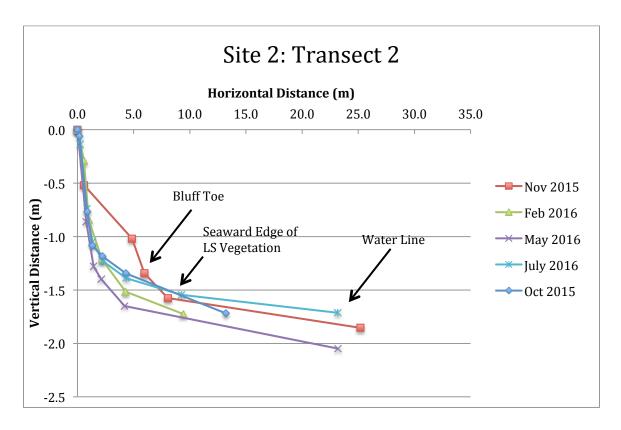
Figure 12) Site 2 seasonal bluff and beach profiles at transect 2 generated from survey data. Point 0.0, 0.0 corresponds with benchmark stake 1 at the bluff crest. The seaward edge of Living Shoreline vegetation corresponds approximately to mean high water.

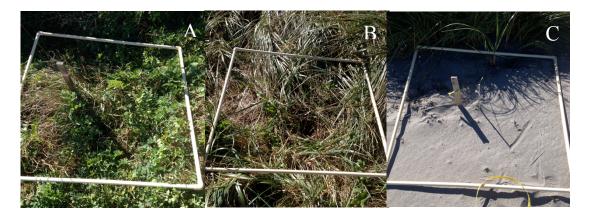
Figure 13) Estimating vegetation cover and species richness in square 1 m² quadrats around the erosion pins at the back of the dune (A), the dune face (B), and dune toe (C). Photos are of transect C and were taken during October 2016 monitoring visit.

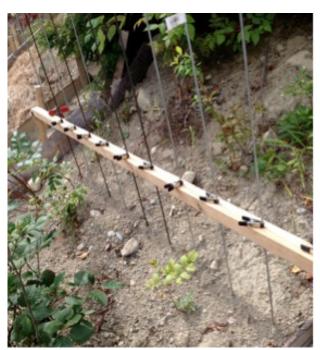
Figure 1) Measuring soil surface position in a Plant treatment plot using profile gauge.

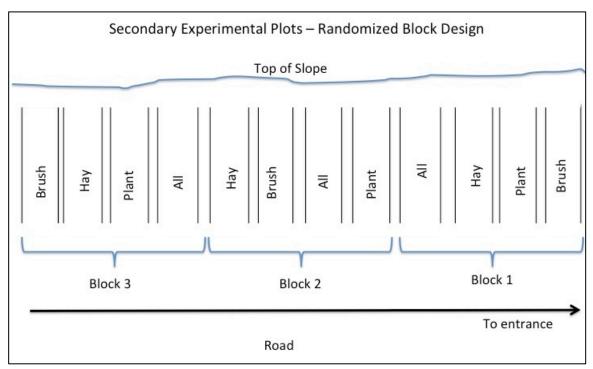
Figure 2) Open plot design and treatment layout of secondary experimental plots.

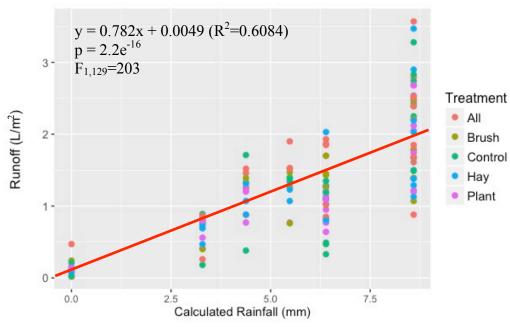
Figure 3) Linear regression of the effect of calculated rainfall (mm) on runoff (L/m^2) for small rainfall events (< 10 mm). Residual standard error = 0.5 on 129 degrees of freedom.

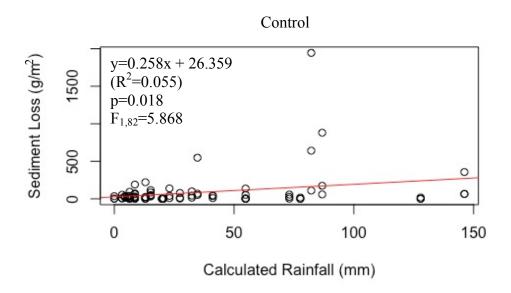
Figure 4) Regression analysis of the effect of calculated rainfall (mm) on sediment loss (g/m^2) for the control plots. Residual standard error = 239.5 on 82 degrees of freedom.

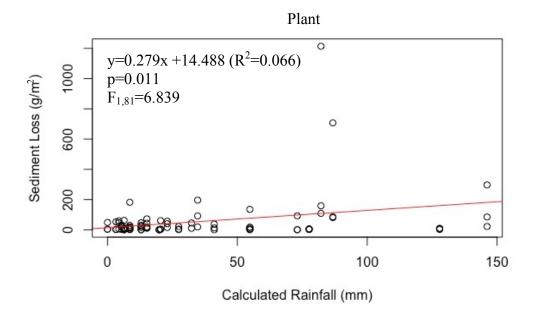
Figure 5) Regression analysis of the effect of calculated rainfall (mm) on sediment loss (g/m^2) for the plant treatment. Residual standard error = 151.4 on 81 degrees of freedom.

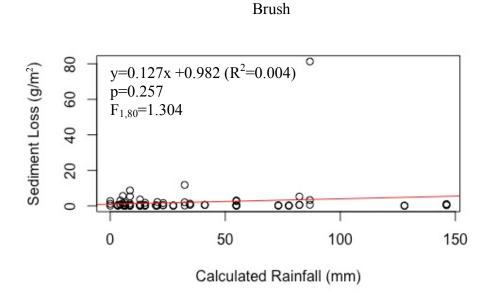
Figure 6) Regression analysis of the effect of calculated rainfall (mm) on sediment loss (g/m^2) for the brush treatment. Residual standard error = 9.1 on 80 degrees of freedom.

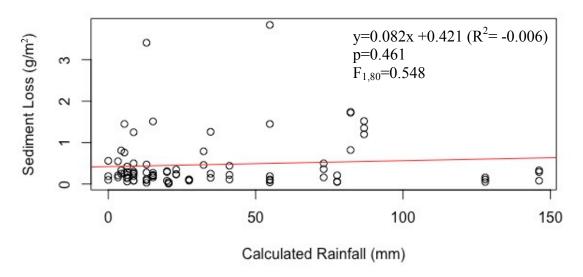
Figure 7) Regression analysis of the effect of calculated rainfall (mm) on sediment loss (g/m^2) for the hay treatment. Residual standard error = 0.7 on 80 degrees of freedom.

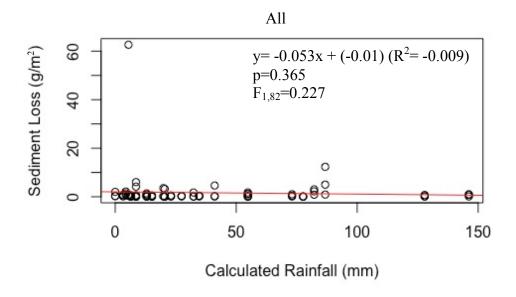
Figure 8) Regression analysis of the effect of calculated rainfall (mm) on sediment loss (g/m^2) for the all combined treatment. Residual standard error = 7.0 on 82 degrees of freedom.

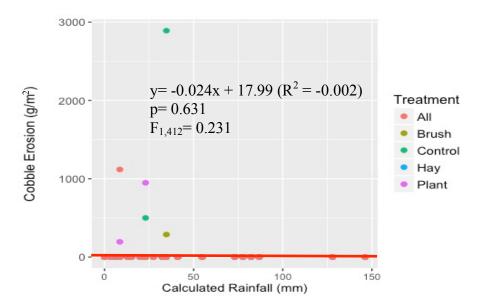
Figure 9) Regression analysis of the effect of calculated rainfall amount (mm) on weight (g/m^2) of eroded cobbles (65 mm < 256 mm) from natural rainfall. Residual standard error = 161.8 on 412 degrees of freedom.

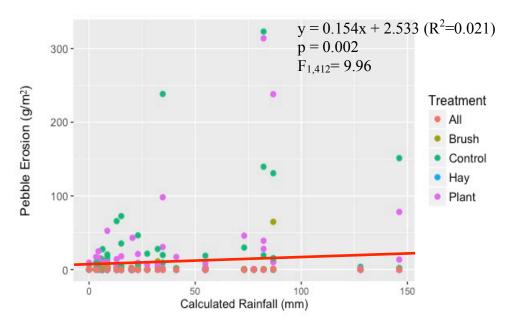
Figure 10) Linear regression of the effect of calculated rainfall (mm) on weight (g/m^2) of eroded pebbles/granules (2 mm > 65 mm) from natural rainfall. Residual standard error = 31.1 on 412 degrees of freedom.

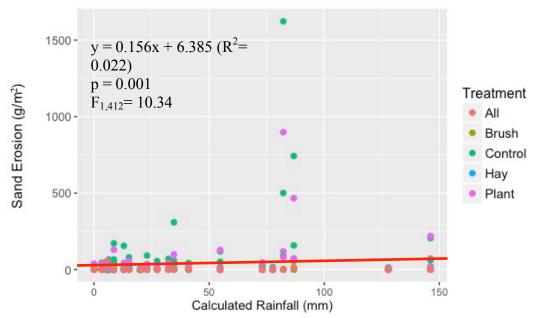
Figure 11) Linear regression of the effect of calculated rainfall (mm) on weight (g/m^2) of eroded sand (< 2 mm) from natural rainfall. Residual standard error = 31.1 on 412 degrees of freedom.

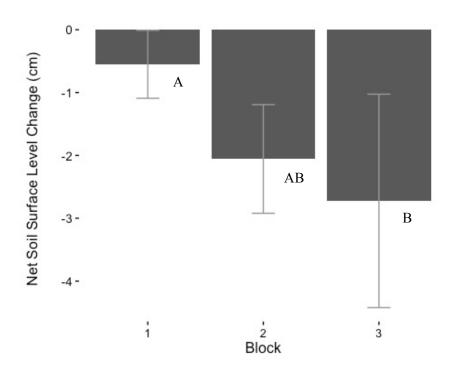
Figure 12) Net change in soil surface level (cm) for plots within primary experimental blocks. Error bars represent 95% confidence intervals.

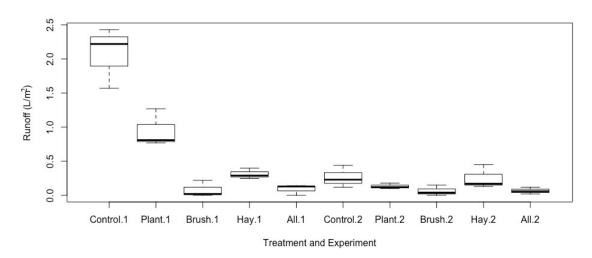
Figure 14) Runoff (L/m^2) from each treatment for controlled watering experiments 1 and 2. Bars represent data range.

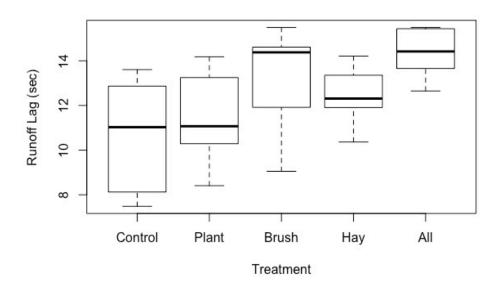
Figure 15) Runoff lag time (sec) for each of the treatments. Bars represent data range.

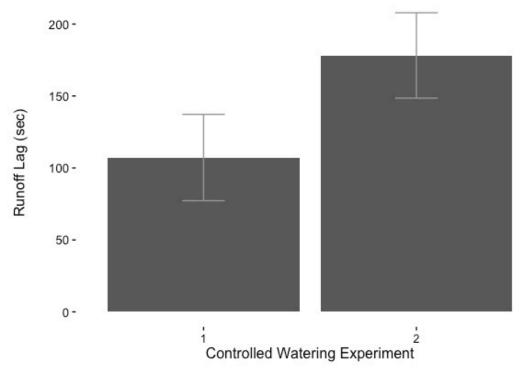
Figure 16) Mean runoff lag time (sec) for the controlled watering experiments. Error bars represent 95% confidence intervals.

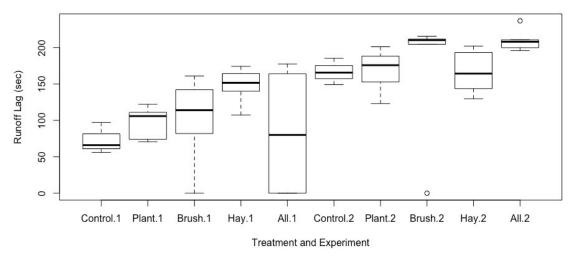
Figure 17) Runoff lag time (sec) for each treatment from controlled watering experiments 1 and 2. Bars represent data range, dots represent outliers.

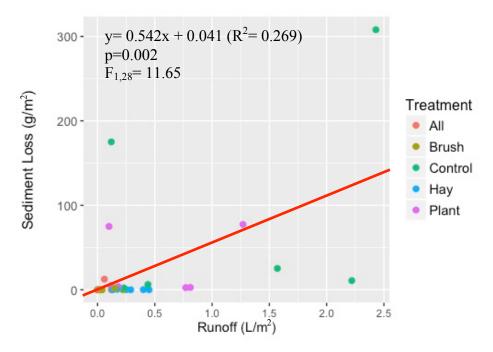
Figure 18) Linear regression analysis of the effect of runoff (L/m^2) on sediment loss (g/m^2) for controlled watering experiments. Residual standard error = 55.3 on 28 degrees of freedom.

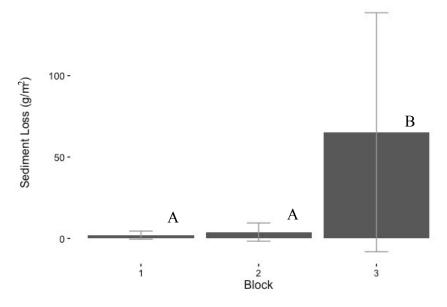
Figure 19) Sediment loss (g/m^2) from primary experimental blocks for the controlled watering experiments. Error bars represent 95% confidence intervals.

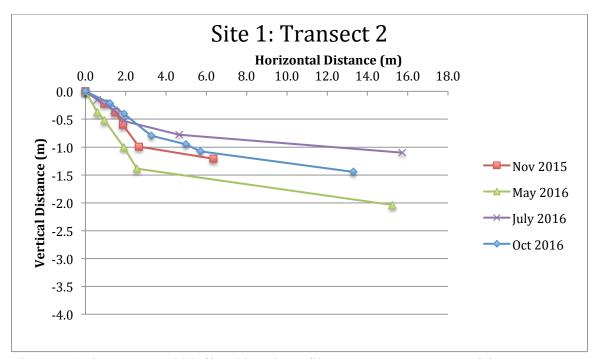
Figure 37) Site 1 seasonal bluff and beach profiles at transect 2 generated from survey data. Axis values are in meters. Point 0.0, 0.0 corresponds with benchmark stake 1 at the bluff crest.

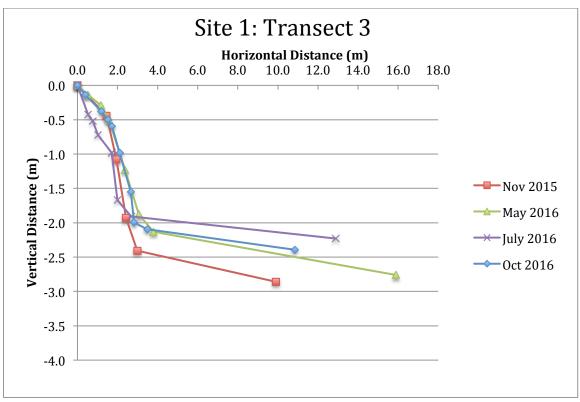
Figure 39) Site 1 seasonal bluff and beach profiles at transect 3 generated from survey data. Axis values are in meters. Point 0.0, 0.0 corresponds with benchmark stake 1 at the bluff crest.

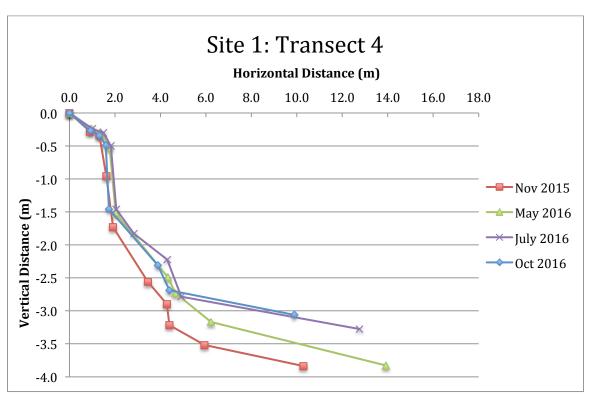
Figure 40) Site 1 seasonal bluff and beach profiles at transect 4 generated from survey data. Axis values are in meters. Point 0.0, 0.0 corresponds with benchmark stake 1 at the bluff crest.

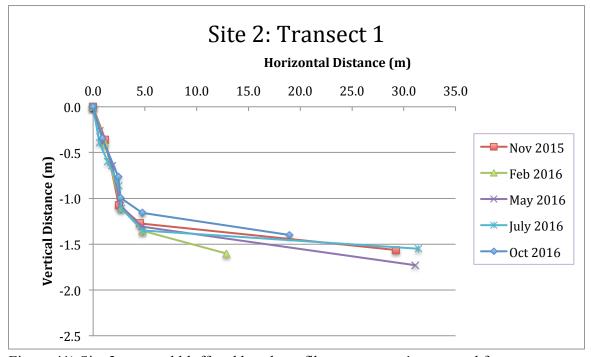
Figure 41) Site 2 seasonal bluff and beach profiles at transect 1 generated from survey data. Axis values are in meters. Point 0.0, 0.0 corresponds with benchmark stake 1 at the bluff crest.

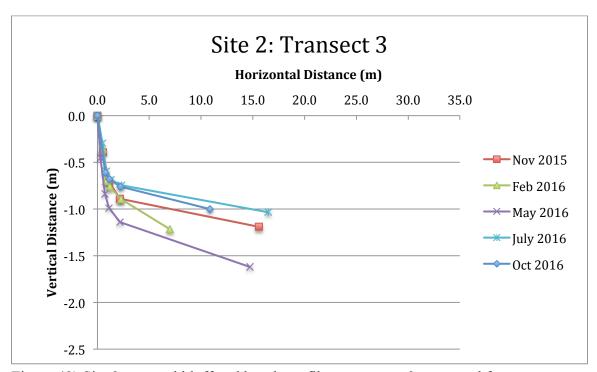
Figure 42) Site 2 seasonal bluff and beach profiles at transect 3 generated from survey data. Axis values are in meters. Point 0.0, 0.0 corresponds with benchmark stake 1 at the bluff crest.

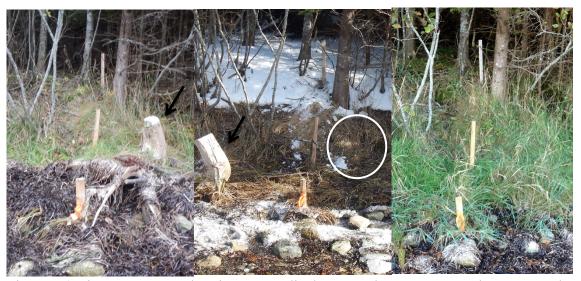
Figure 43) Site 2 transect 3 showing stump displacement between November 2015 and February 2016. Vegetation cover in October 2016 also shown.
