ASSESSING THE SUITABILITY OF LIVING SHORELINE TECHNIQUES FOR COASTAL EROSION IN PRINCE EDWARD ISLAND, CANADA.

A Thesis Submitted to
Saint Mary's University, Halifax, Nova Scotia
in Partial Fulfillment of the Requirements for
the Degree of Bachelor of Science

April, 2022, Halifax, Nova Scotia

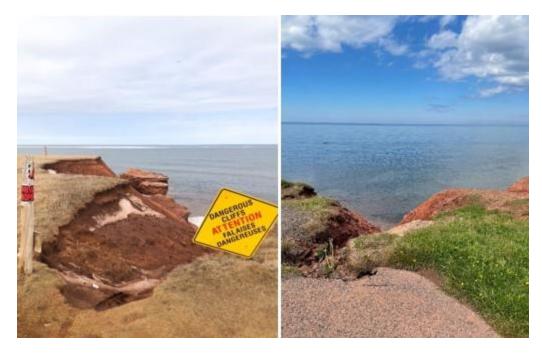
Figure 1.1. Sites in Prince Edward Island experiences high rates of erosion. The left photo was taken at Thunder Cove Beach in Darnley, PEI. The right photo was at the parking lot of the East Point Lighthouse in East Point, PEI.

Prince Edward Island (PEI), a province located on the east coast of Canada, is experiencing high rates of coastal erosion. Nationally, when reviewing the economic impacts in regard to the percentage of total land area, PEI is the most at-risk province for coastal erosion (Lemmen *et al.*, 2016). PEI is primarily composed of soft rock – sandstone and mudstone (Holman & Robb, 2021), and glacial till soils nearing the surface (Whiteside, 1950). These materials erode at a fast rate, more so when there is weathering action acting on the material, such as freeze thaw cycles and wave action (Figure 1.1).

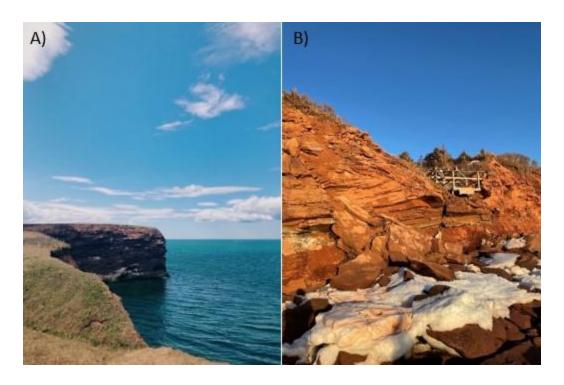
Figure 2.4. A) Orby Head formation at Cape Tryon, PEI. B) Kildare Capes formations at Rice Point, PEI.

The entirety of the geology of north shore within Queens County on PEI is part of the Orby Head formation (van de Poll, 1989) (Figure 2.4.a.). The best view of this formation is along the northern coast at Cape Tryon. The age of this formation is not well documented as fossil evidence is lacking. It is suggested to be within the Artinskian age, and that the youngest sedimentary rocks found are from no later than the late Early Permian. The basal contact of this formation is not exposed on PEI, and is arbitrarily set just below the basal conglomerates (van de Poll, 1989).

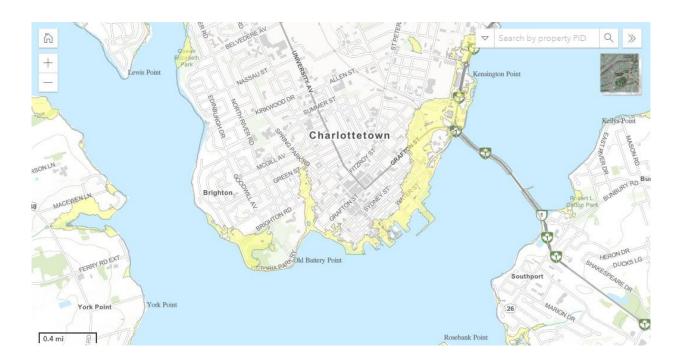
Figure 2.8. A spatial map showing a moderate-low hazard flooding scenario for 2100, coloured in yellow (Government of Prince Edward Island, n.d.c).

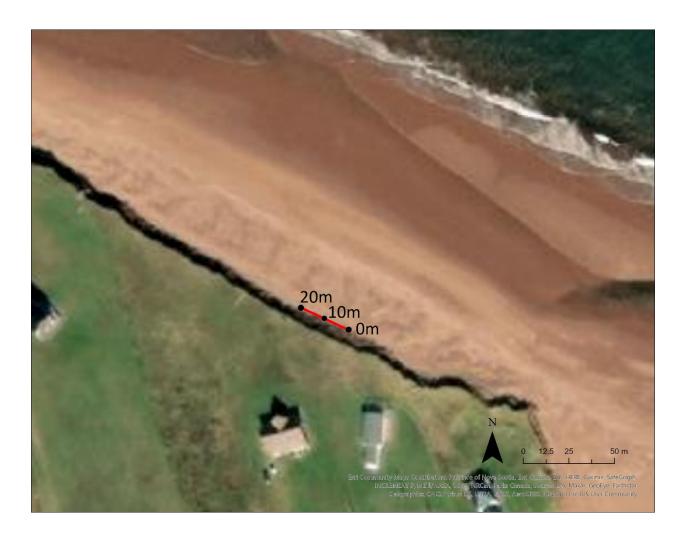
Figure 3.2. Example of a 20m transect. Sub-transects measured at 0m, 10m, and 20m.

Sites were visited within two hours of low tide to analyse the greatest portion of shoreline. At each site, a 20m transect was measured parallel to the shoreline (Figure 3.2) that exhibited similar characteristics throughout to determine consistency. The characteristics were bank height, bank slope, bank material, and the amount of vegetation on the bank face (Figure 3.3.). Three shore-perpendicular subsections were then established per site, arranged along the 20m transect of the shoreline at 0 m, 10 m, and 20 m intervals.

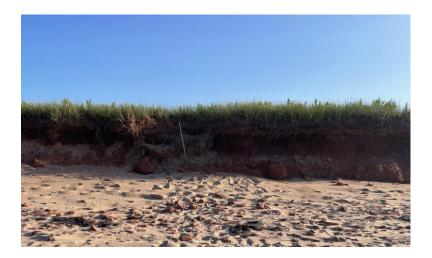
Figure 3.3. A coastal bank showing consistent conditions throughout the 20m transect.

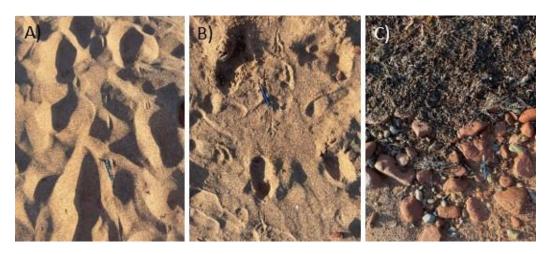
Figure 3.5. An example at the Cavendish Campground West site of grain size and grain characteristic photos taken at three sites within the perpendicular subsection of shoreline. Note the blue pencil in each photo. A) Backshore B) Foreshore C) Intertidal zone.

A 15cm pencil was placed in the sediment on the backshore, nearshore (if present), foreshore, and intertidal zone and photos were taken at each shoreline zone (Figure 3.5). The pencil was used as a qualitative measure to determine sediment size differences along the shoreline and between sites. As the size of the pencil is uniform throughout the photos, the sediments can be compared between the pencil in the photos and different sediments from different sites.

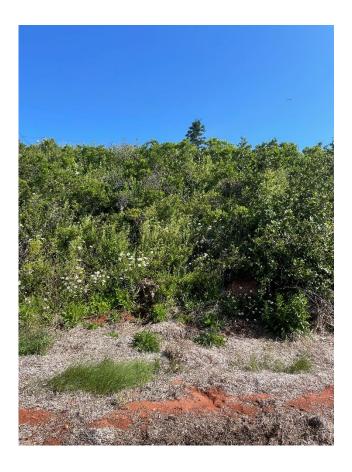
Figure 3.6. A bank located in Rustico Bay Centre composited of till that has vegetation growing in the bank, known as a reference site.

Qualitative observations at each subsection of the transect during the site visits were made. The observations noted were shoreline vegetation, nearshore submerged aquatic vegetation (SAV), presence of animals, presence of endangered/threatened species, and sediment grain size. Another important qualitative observation that was made was if the bank itself had vegetation growing on it – vegetation that was part of the bank and stabilized (Figure 3.6). These sites were noted as being "reference" sites. If pieces of sod from higher elevations were present on the bank face due to erosion or slumping, but not originally established on the bank face, it was not referred to as being a reference site.

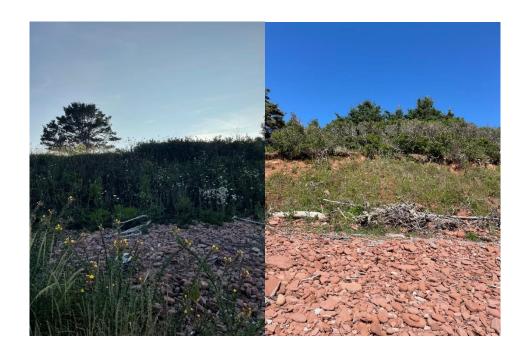
Figure 4.4. Both reference sites due to the vegetation growing within the bank face. A) Doyles Cove Centre; B) Rustico by the Gate South

Site names followed by "*REFERENCE*" acknowledged that the majority of the bank face was vegetated. These sites should have the ability to host living shorelines as the vegetation shows that the bank is stable. Doyles Cove Centre, Rustico by the Gate South, and Argyle Shore Centre, should all be suitable for living shorelines according to the site visits. In the both the desktop and on-site GIS analysis, both Doyles Cove Centre and Rustico by the Gate South were analyzed to be impossible/unnecessary (Table 4.13 and Figure 4.4). Argyle Shore Centre was analyzed as being moderate in both desktop and on-site GIS analysis (Table 4.14 and Figure 4.5). Backshore material was not considered when classifying locations in the field as reference or not.

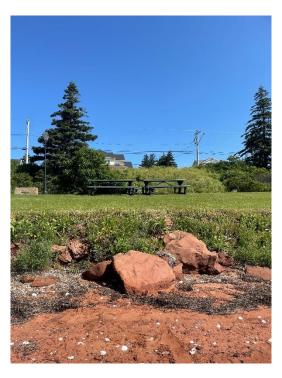
Figure 5.1. Rustico Bay West location showing the infrastructure and uses of the area beyond the shoreline, not suitable for dune building as stated by ACASA and Woods Hool Group.
