Examining Drivers of Ecomorphodynamic Change in the Avon River Estuary

By  
Macy Giles

A Thesis Submitted to  
Saint Mary's University, Halifax, Nova Scotia  
in Partial Fulfillment of the Requirements for  
the Degree of Bachelor of Science with Honours in Geology.

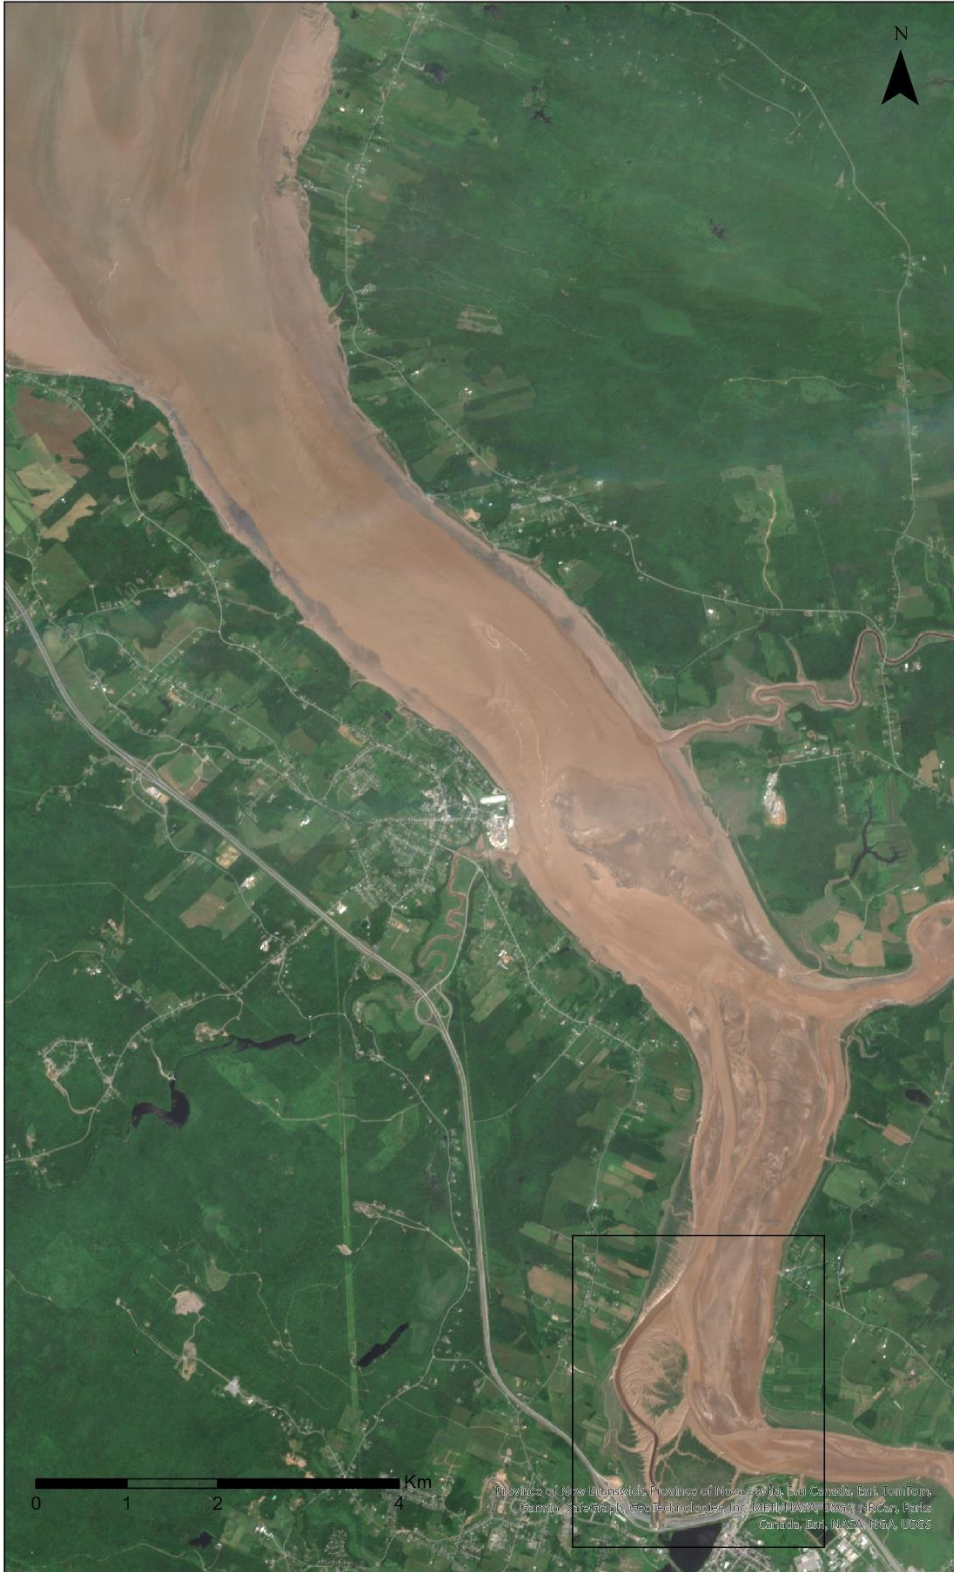
Figure 1.1: The Avon River downstream of the Windsor Causeway. Study area is outlined by a black box, the intertidal zone extends approximately 8km downstream of the causeway.

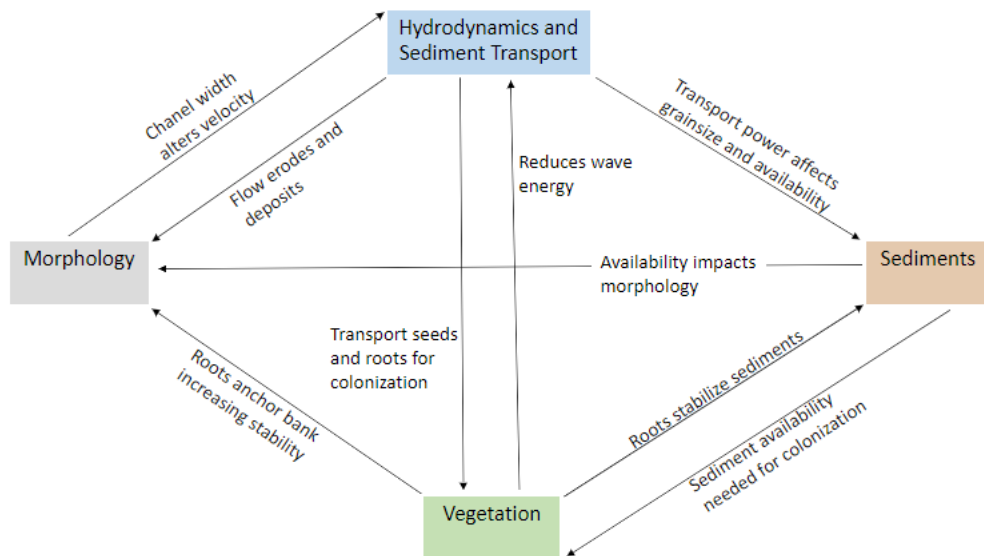
Figure 1.2: Connectivity of hydrodynamics, sediment, vegetation, and channel morphology and descriptions of how each factor influences the other.

Estuaries are controlled by multiple feedback loops. The most influential inputs are dynamic processes, sediments, morphology, and vegetation (Figure 1.2). Considering all these variables and their interaction, while also quantifying how the estuarine system has changed is the study of ecomorphodynamics, allowing for consideration of the entire system, as opposed to more traditional studies on morphology without considering the effects of vegetation and other biota (Fagherazzi et al., 2005).

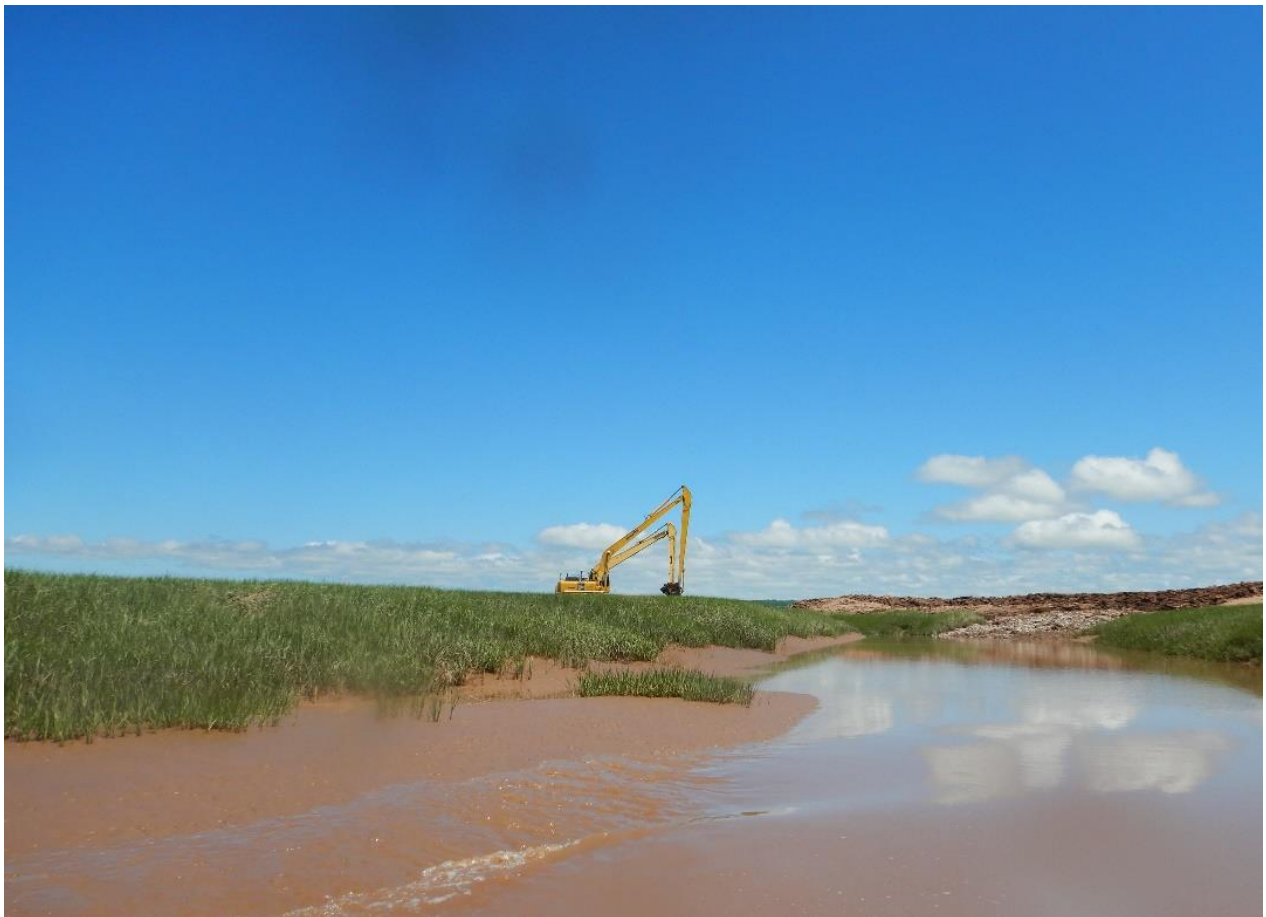
*Figure 2.3: Excavation of the Windsor marsh on June 22<sup>nd</sup>, 2020. Photo used with permission from Lachlan Rihel of the Confederacy of Mainland Mi'Kmaq (Appendix A).*

Since 2019 however, there has been a shift towards increased anthropogenic activity (section 1.5). In 2019, construction activities increased as the Department of Public Works started to twin Highway 101 from Three Mile Plains to Falmouth. The new highway extended onto the Windsor marsh which meant that dredging and subsequent infilling was required to build a stable foundation (Figure 2.3). Both the dredging and infilling affected the channel morphology, by increasing the channel cross-sectional profile, then decreasing it. In addition to increased construction activity, the management of the tide gate was altered on March 19, 2021 when the Department of Fisheries and Oceans (DFO) issued a Ministerial Order (Palmer, 2021). This called for the aboiteau gate to be opened constantly on outgoing tides and for at least ten minutes on incoming tides to allow for adequate fish passage in accordance with the Federal Fisheries Act. This action was also to provide an opportunity to end the mass die-off events that were occurring downstream of the causeway when the tide retreated (Government of Canada, 1985). This

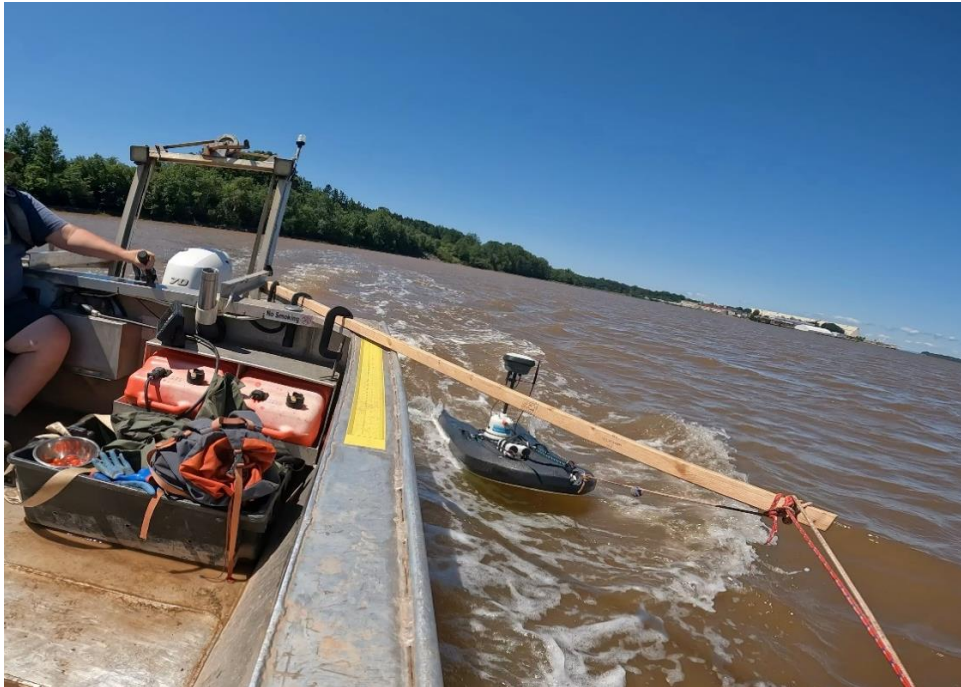
*Figure 3.1 M9 ADCP attached to a fishing boat to complete the bathymetric surveys along transect lines.*

Fieldwork for the 2023 dataset was conducted August 2<sup>nd</sup> – 4<sup>th</sup>. It was broken up into three main tasks, bathymetric surveys, RPAS, and sediment sampling. Bathymetric surveys were conducted on all three days during high tide using a SonTek RiverSurveyor M9 Acoustic Doppler Current Profiler (ADCP) which has a reported accuracy of 0.5cm. This was mounted to a board which was attached to a fishing boat piloted by Darren Porter, a local fisher familiar with the area (Figure 3.1). The fishing boat provided stability and guided the M9 ADCP along targeted transect lines which were predetermined from historical surveys. The setup was calibrated according to the SonTek RiverSurveyor M9 ADCP manual (SonTek, 2011), and offsets were manually entered into the Hypack processing software to account for the difference in elevation between the Leica Geosystems GS18T global navigation satellite system (GNSS) unit and M9 ADCP unit (Appendix C). The survey lines from previous studies were uploaded to a Garmin GPS prior to entering the field. The M9 ADCP was connected to a Leica Geosystems GS18T GNSS unit via a custom-made splitter cable which allowed for connection from the M9 ADCP and GNSS unit to the Hypack processing software using Bluetooth. During data logging along transect lines, GPS coordinates as well as depth from five acoustic beams were measured and recorded in the Hypack software.

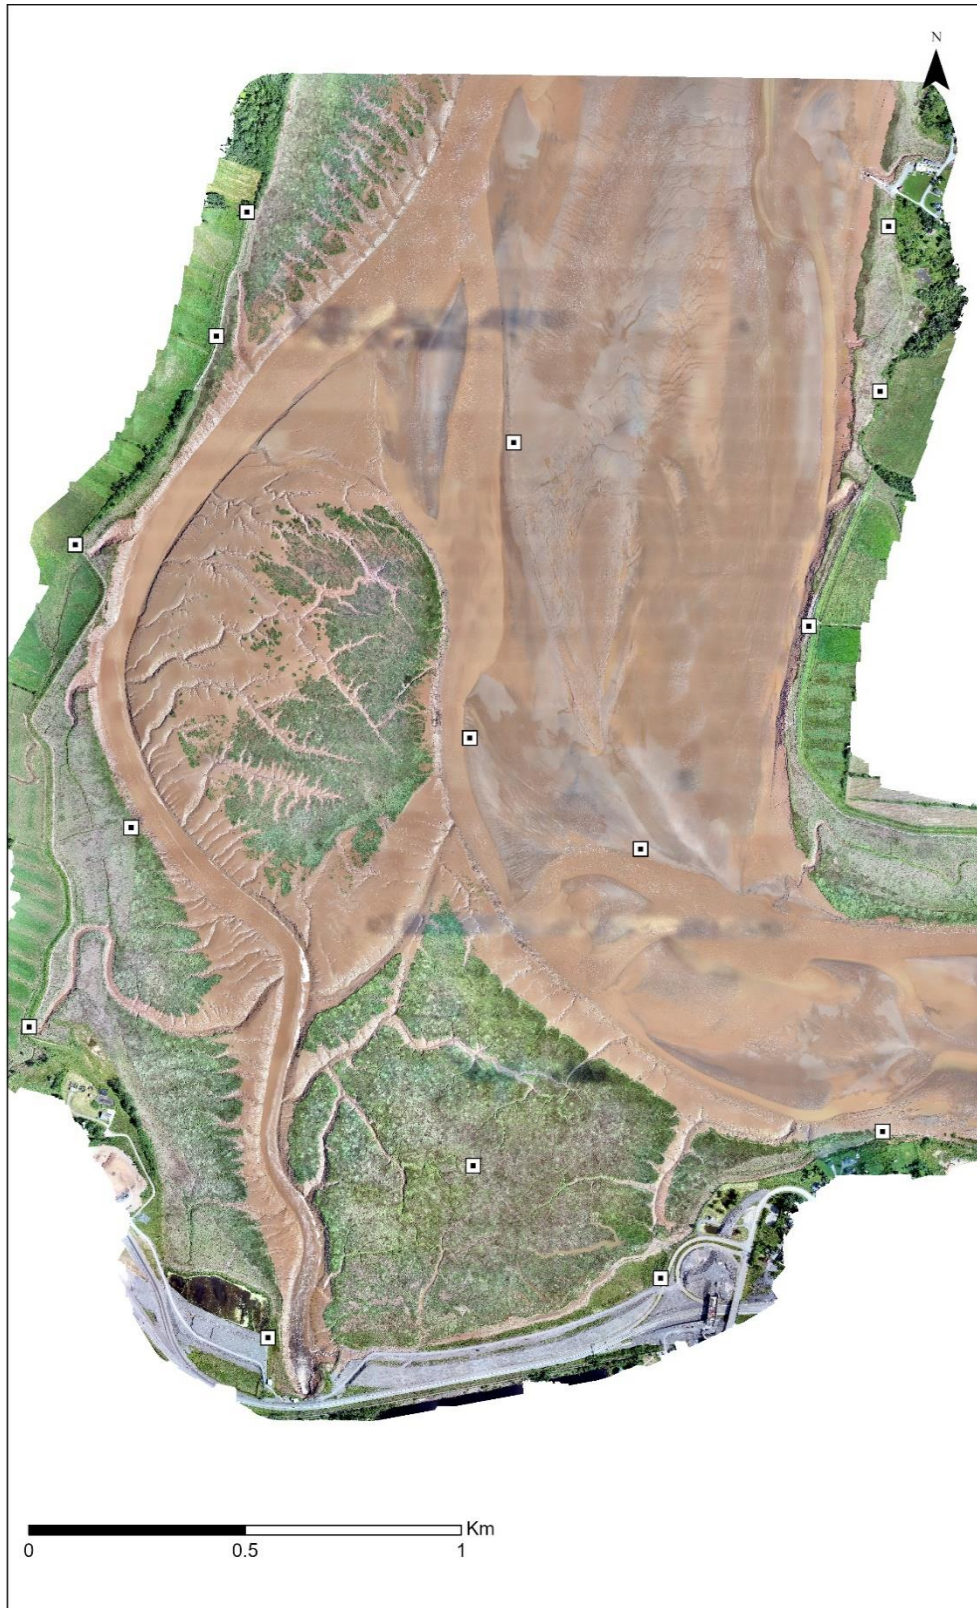
Figure 3.2: Locations of GCPs deployed during RPAS. Base image is the orthomosaic collected during RPAS on August 4th, 2023, basemap provided by ESRI Canada.

RPAS were conducted on August 4<sup>th</sup> when there was minimal cloud cover and wind, while at low tide. The flight was conducted by Greg Baker from MP\_SPARC (SMU) and Sam Lewis from CBWES Inc., who are both certified with advanced RPAS certification from Transport Canada. The flight was conducted simultaneously using a DJI Matrice 300 with real-time kinematic (RTK) positioning. One pilot was responsible for flying the north half of the study area, the other for flying the south half. This was done to maximize efficiency and area covered before the tide came in. The flight was conducted at 120m above ground with a 68% side overlap and an 80% front overlap. The images collected were used to create a study area orthophoto and digital surface model (DSM) with a ground resolution of 4cm. Before the flight occurred, 15 ground control points (GCPs) were deployed on the bed of the river and the dykes. Their location was the marked with a Leica Geosystems GS18T GNSS which has an accuracy of up to 5.1cm and a reliability of up to 99.4% (Luo et al., n.d.) (Figure 3.2). The coordinates measured with the Leica Geosystems GS18T GNSS unit were used as validation points when processing to correct any distortion in imagery.

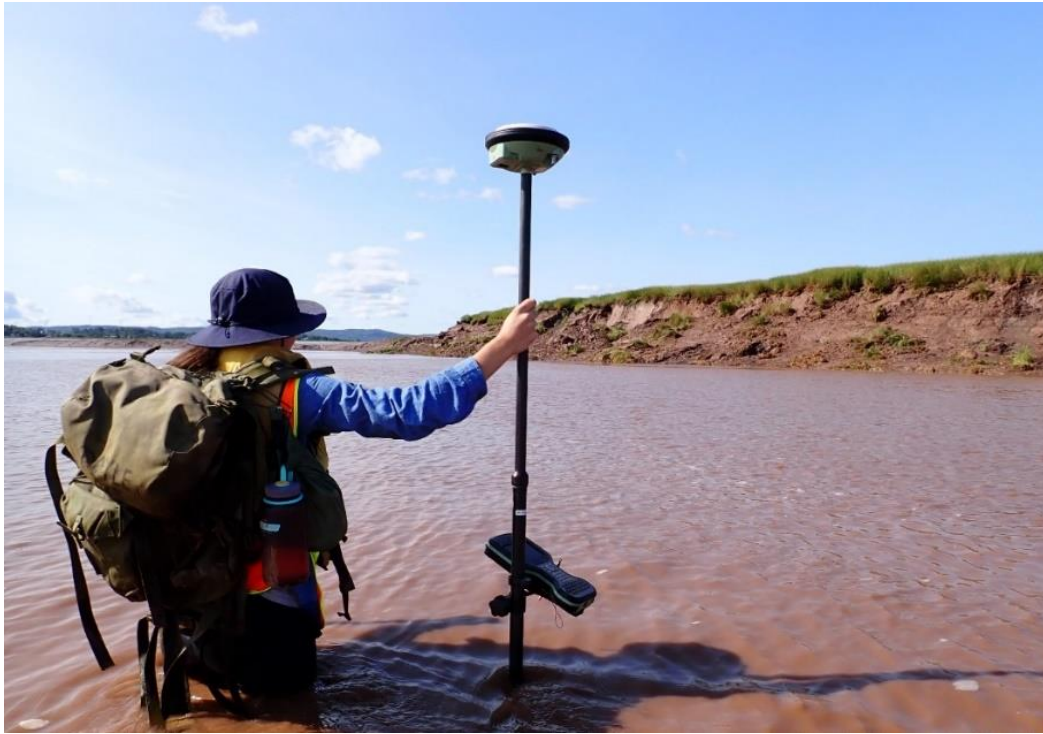
*Figure 3.4: Deep water preventing sediment sampling on the Newport Bar on August 4<sup>th</sup>, 2023.*

Sediment sampling was conducted on August 3<sup>rd</sup> and 4<sup>th</sup> during low tide for maximum sediment exposure, and to make sure that people on the riverbed did not get stuck in an unsafe position on a rising tide. Field teams were divided into two groups so that everyone had a partner. Everyone was equipped with high visibility vests and life jackets, and each group carried a walkie talkie which was connected to the teams conducting RPAS on the marsh in accordance with safety protocol. Before conducting field work, coordinates of samples collected in 2019 were uploaded to a Garmin GPS. Sampling locations were adjusted in the field based on accessibility since some sample locations had been eroded, particularly those located on the Newport Bar, while others were not safe to access due to deep water (Figure 3.4). Once a sampling location was reached, the coordinates of the sample were recorded using a Leica Geosystems GS18T GNSS surveyor and field notes correlated sediment names on the sample bottles to point names stored in the Leica Geosystems GS18T GNSS unit database. A 250ml Nalgene bottle was filled approximately three quarters full of sediment that was scrapped from the surface layer of the riverbed. Five sample locations from 2019 were not able to be resampled in 2023 due to safety concerns, but eight new locations located near transect lines were added in 2023. This resulted in an overlap of six samples between the two sampling periods.

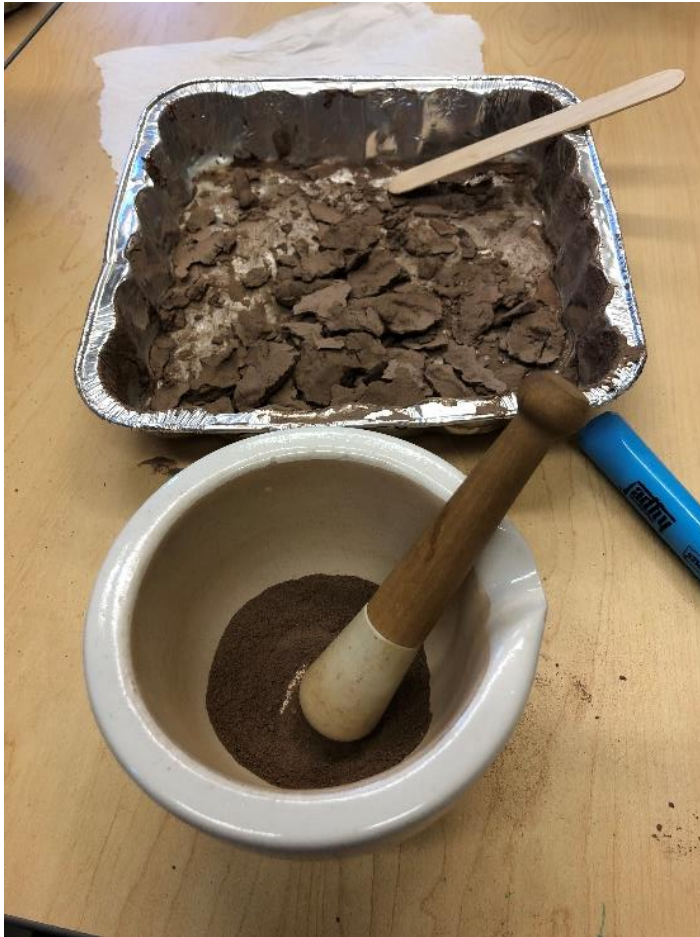
*Figure 3.7: Sediment samples dried in aluminum trays then powdered using a mortar and pestle.*

Grain size analysis was completed by first drying the collected sediment in an Isotemp oven at 45°C for at least five hours in washed aluminum trays. Sediments were then lightly ground with a mortar and pestle (Figure 3.7). Once the sediments were prepared, the initial weight of each sample was recorded to the nearest hundredth of a gram. Sediments were then sieved at half phi intervals using a vibrating sieve stack for ten minutes (Blott & Pye, 2001). The largest sieve was -1Φ and the smallest was 4Φ, everything smaller was collected in the bottom pan. After the ten minutes, sediment within each sieve was weighed and recorded. The final weight of the entire sample was measured and compared to the final weight. The initial weight, final weight, and weight within each individual sieve was entered into Gradistat which delivered information on sieving error, textural group, mean grain size, sorting, skewness and kurtosis (Blott & Pye, 2001). Data from 2023 was compared to data from samples taken during field work conducted in 2019.

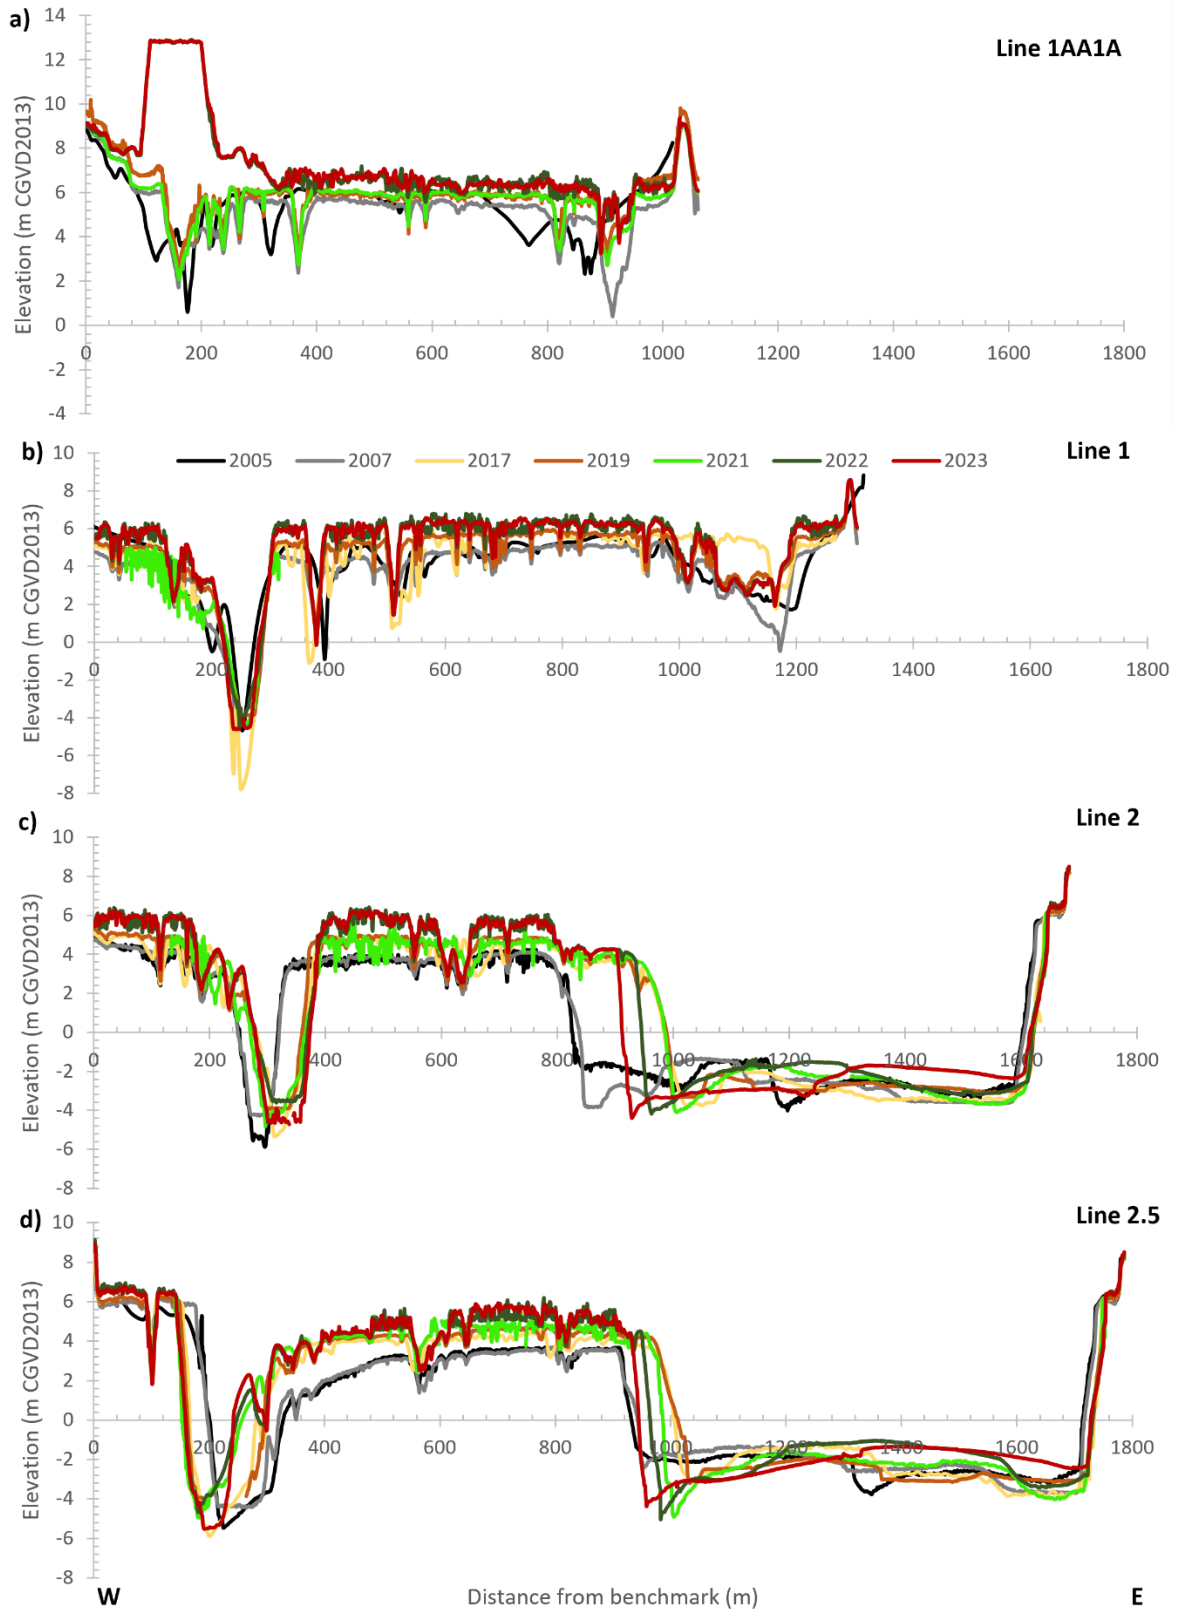
Figure 4.1: Cross-sectional profiles of the first four transect lines within the Avon River based on surveys done prior to construction, 2005, 2007, and 2017, and during increased human activity, 2019, 2021, 2022, and 2023.

Line 1AA1A is the closest transect line to the causeway located within the Avon River (Figure 4.1a). It was not surveyed in 2017 but has been surveyed both before and after the construction of the twinned highway (Table 3.1). The newly constructed highway can be seen crosscutting the transect line where the deepest channel was before 2022. After the newly twinned highway was established and this western channel was filled, the deepest point in the channel within the cross-section was the eastern channel, in the same location as the position of the thalweg in 2007 (Figure 4.1a). Transect Line 1AA1A is located primarily across the Windsor Marsh, so elevation changes that are derived from RPAS data are highly influenced by changes in vegetation height, rather than erosion and deposition of sediments as seen with transect lines that cross mostly riverbed (Figure 3.3). These changes in vegetation height can be seen through the middle of the cross-section as elevation is highly variable over short distances within a single survey period and changes slightly from year to year (Figure 4.1a).

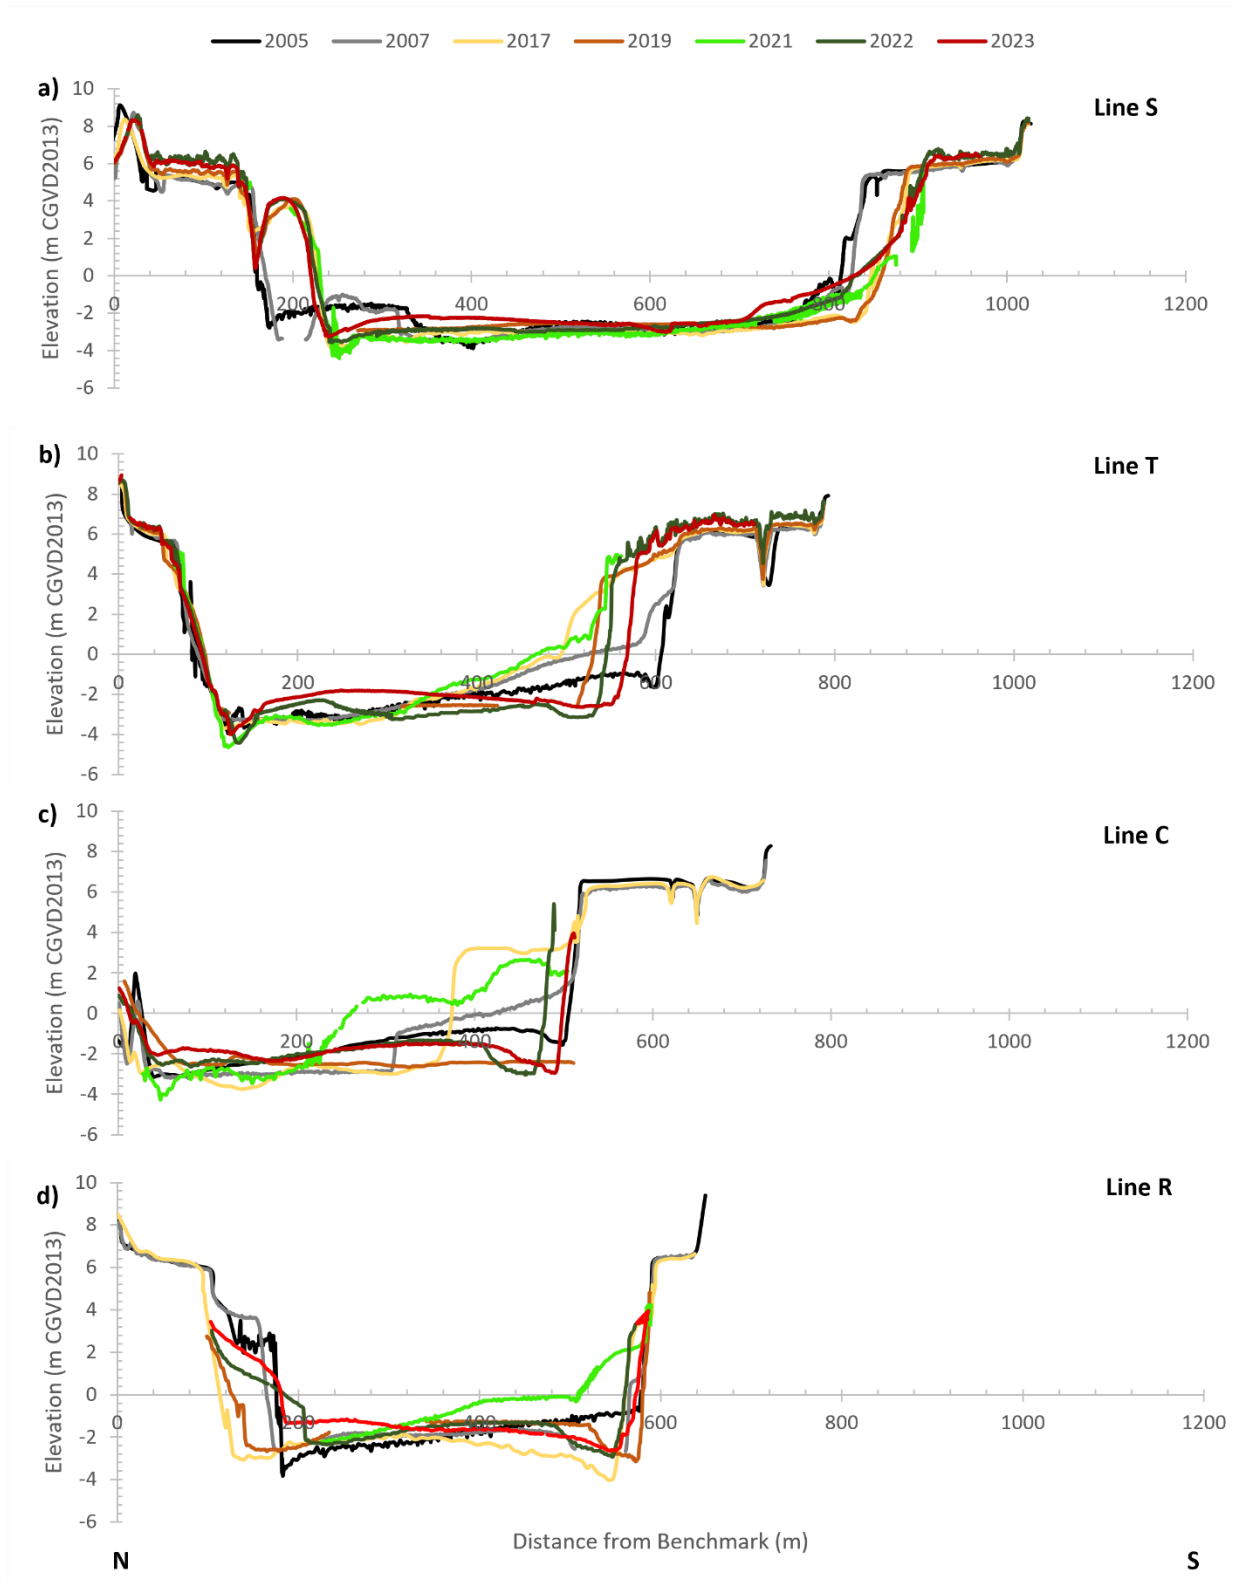
Figure 4.3: Cross-sectional profiles of transect lines within the St. Croix River based on surveys conducted prior to construction in 2005, 2007, and 2017, and during construction in 2019, 2021, 2022, and 2023.

The north bank fluctuates between periods of erosion and deposition with erosion between 2007 and 2017 followed by deposition between 2019 and 2022. Since the 2021 survey started 200m in from the stake, it is unclear from the cross-sectional profiles if the north bank was stable between 2019 and 2021, or if there was erosion or deposition. On the southern bank, changes remained relatively stable with slight elevation fluctuations from year to year. In 2021 however, there was a substantial increase in elevations which corresponds to the increase in elevation and mid channel bar development that was observed in Line C in 2021.

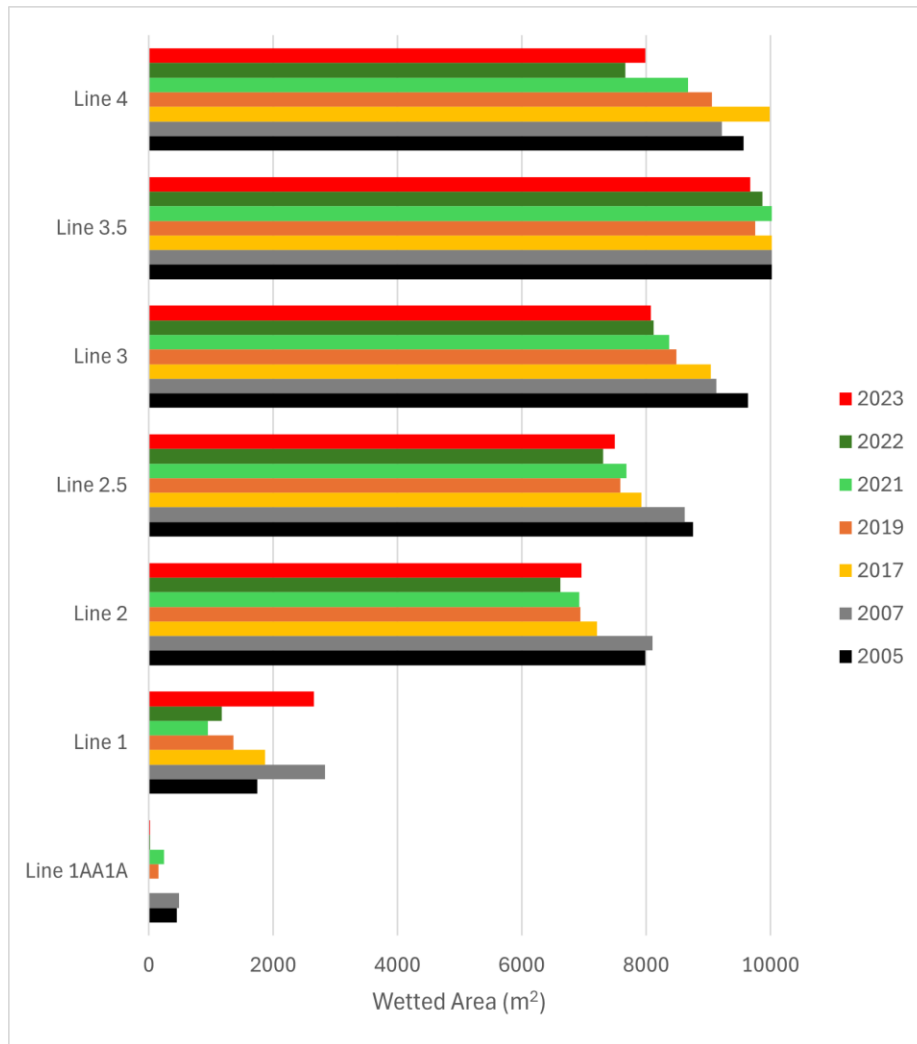
Figure 4.4: Wetted area of the Avon River, lines closest to the causeway are at the bottom of the figure while lines furthest away are at the top.

The wetted area of the Avon River generally shows a decreasing trend from 2005 to 2023 (Figure 4.4). Lines that are furthest away from the causeway are fairly consistent in this trend while lines close to the causeway are much more variable. While a decreasing trend is visible, it is important to note that in 2023, the wetted area of many transect lines increases compared to 2022. Lines 1AA1A and 1 are closest to the most variable and intersect both the Windsor Marsh and the main sluice gate channel. Because a substantial portion of both transect lines is on the Windsor Marsh, the wetted area is much lower than other transect lines which mostly cover riverbed. Line 1AA1A also intersects the twinned section of Highway 101, so when construction of the highway occurred in 2022, there was a decrease in wetted perimeter (Figure 3.3). Line 1 displays a decrease in a decrease in wetted perimeter until the lowest wetted area is reached in 2021 and was followed by an increase in wetted area. Since the primary area of interest across Line 1 is the tide gate channel, it is possible that the change in wetted area can be attributed to a change in this area.

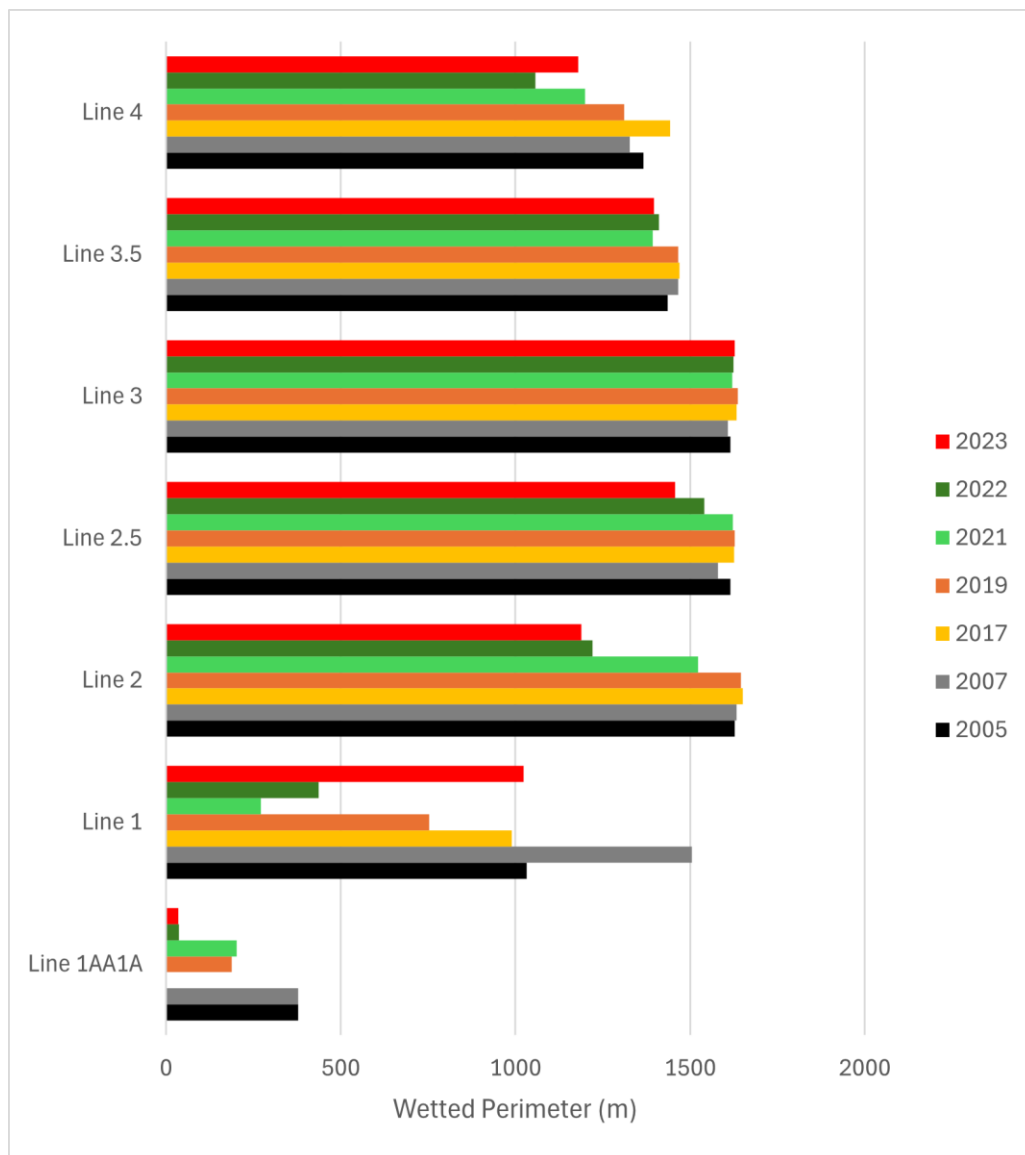
Figure 4.5: Wetted Perimeter of the Avon River, lines closest to the causeway are at the bottom of the figure while lines furthest away are at the top.

The wetted perimeter values mirror the trend of the wetted area values with many transect lines displaying a decreasing trend (Figure 4.5). Once again, transect lines further from the causeway display more stability while lines close to the causeway are highly variable. The wetted perimeter values for Line 1AA1A are impacted by construction in 2022 when wetted perimeter notably decreased. Line 1 shows high variability but it matches with trends seen in the wetted area data. Lines 2.5, 3, and 3.5 exhibit the most uniform wetted perimeter across surveys, they also either intersect or are very near the Newport Bar. It is

possible that this stability comes from the bar experiencing similar amounts of erosion and accretion as well as minimal development of intertidal bars. With the exception the two lines closest to the causeway, all transect lines reach their peak wetted perimeter values in either 2017 or 2019. This maximum is before or very early into the period of notable human influence on the system and is followed by a decrease. It is also interesting to note that while wetted area seemed to be on the rise in 2023 for many transects, there are only three transect lines which show an increase in wetted perimeter between 2022 and 2023.

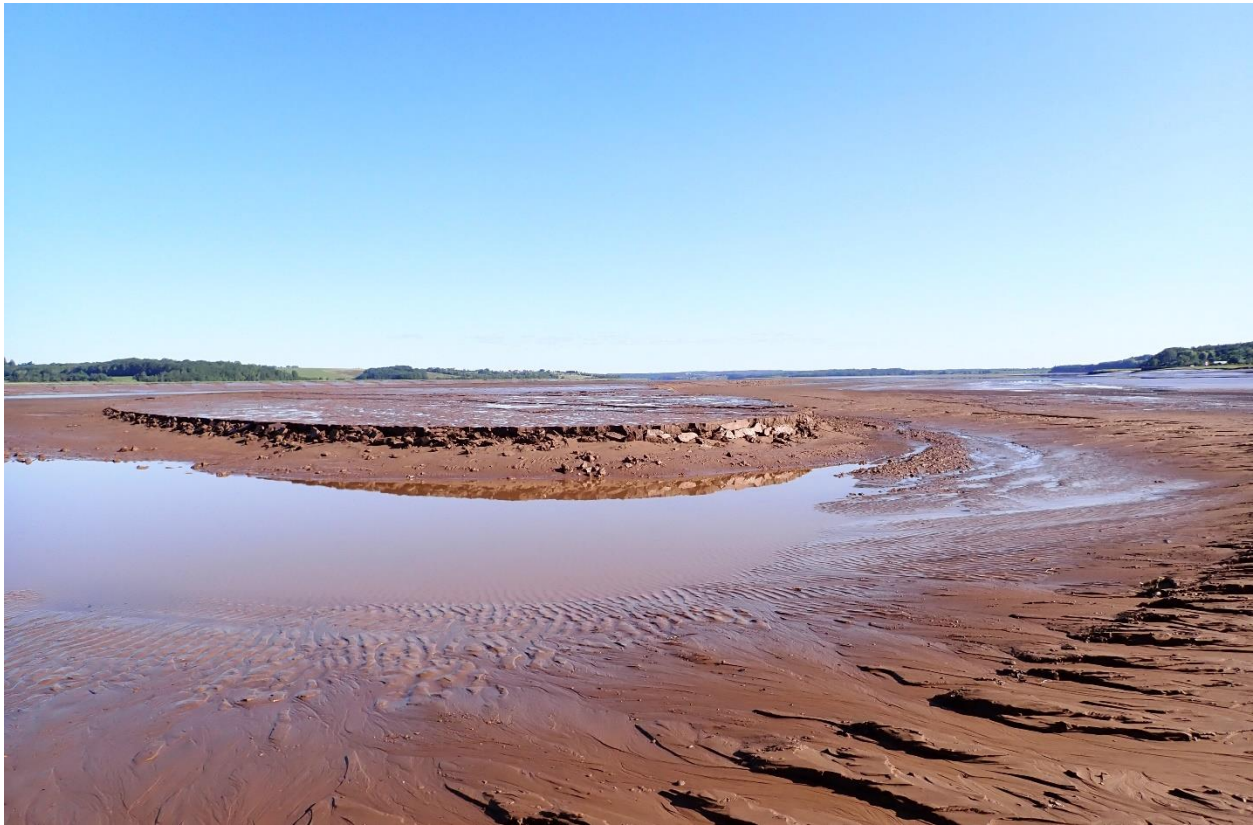
Figure 4.15: Muddy midchannel bar at low tide developing within Zone 6 on August 3<sup>rd</sup>, 2023.

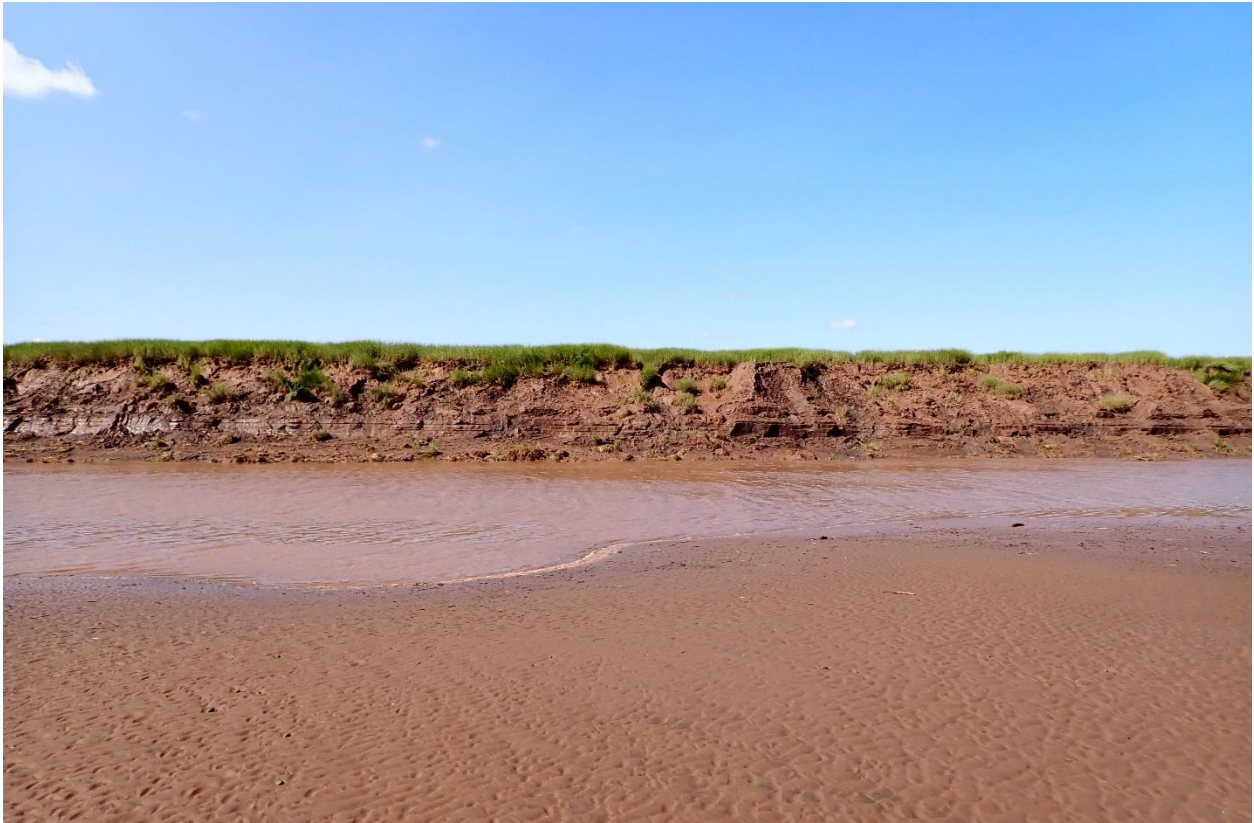
*Figure 4.19: Erosion along the eastern edge of the Newport Bar at low tide with blocks of vegetation being eroded on August 4<sup>th</sup>, 2023.*

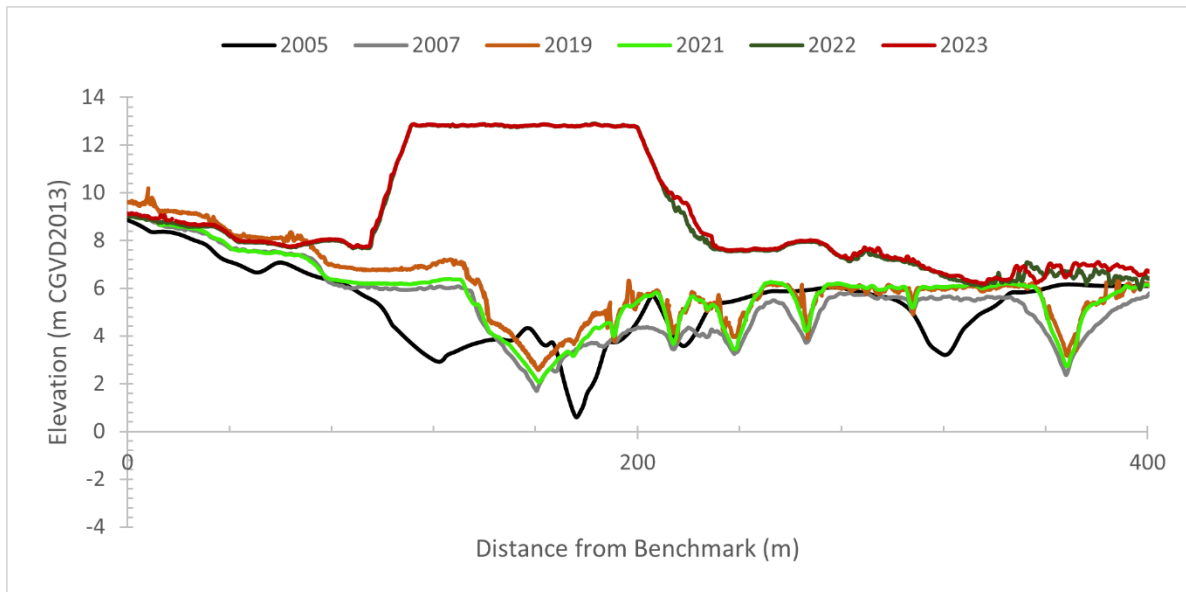
Figure 4.30: Influence of channel infilling from the construction of the twinned highway in 2022 on the cross-sectional profile of Transect Line 1AA1A.

Human activities in the area began in 2019 when the first phase of construction on the twinned portion of highway began. Originally, it was estimated that the project could be completed by 2022, however disagreement on what should be done with the aboiteau has delayed the project. Initial planning and the start of construction was done between 2019 and 2022. In 2021, there was partial infilling as evidenced by Figure 4.18 along the southern edge of the orthophoto. While it appears as though the newly constructed road cuts through transect Line 1AA1A, there is no infilling as observed in 2022 (Figure 4.30). We believe that aggregates were placed down and allowed to settle during this period before paving the newly twinned section of the highway. In 2022, the channel was completely infilled, and the twinned highway structure was completed, with the exception of the portion that crosses the tide gate. Since 2022, not much has been done in the area, however the next phase of construction will encompass alterations to the aboiteau structure.

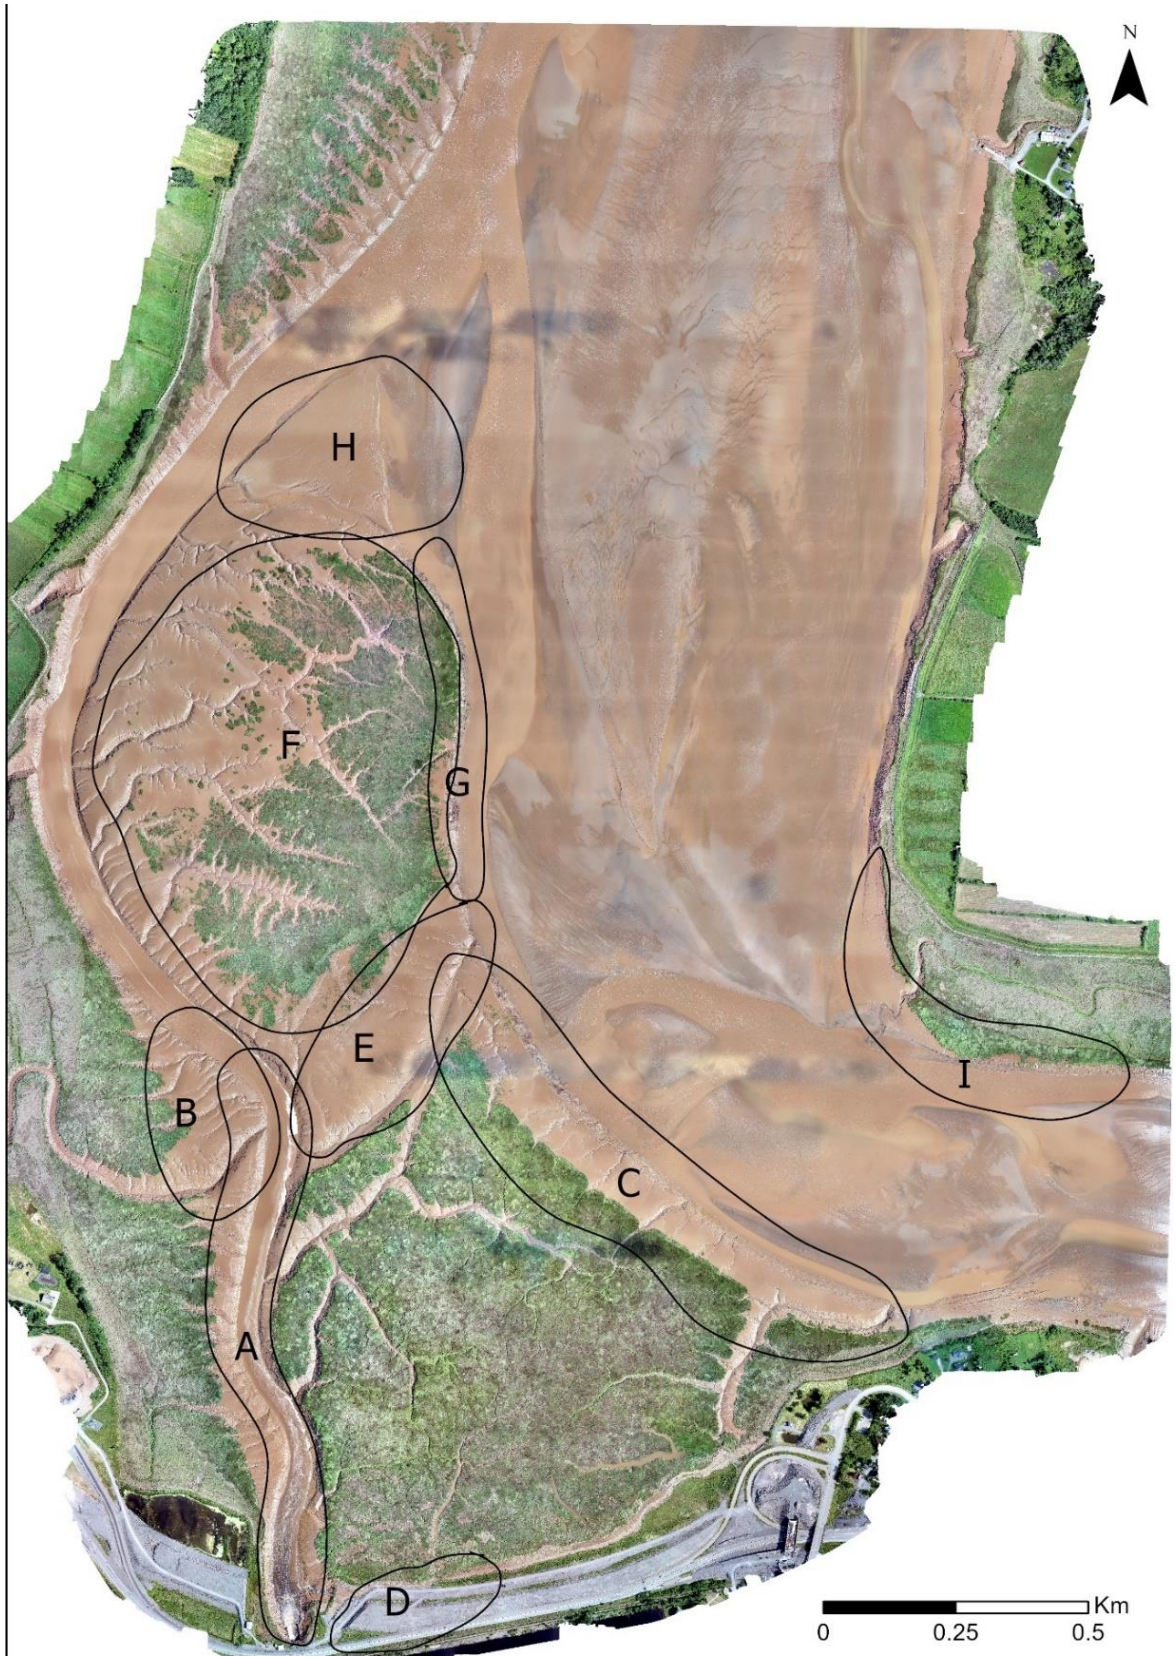
Figure 4.31: Notable changes throughout the Avon River Estuary between 2005 and 2023.

The Windsor Marsh exhibits changes primarily along the northeast bank (area C in Figure 4.31). This area has seen substantial erosion between 2019 and 2023 which has resulted in a shift of the position of the channel thalweg within the St. Croix. The erosion of the bank has had minimal impact on vegetated area and overall, vegetation was found to be expanding in this area with notable increase in vegetation on the northern tip of the Windsor Marsh. The other difference in this area was a decrease in channel wetted area, wetted perimeter, and width in 2022 when the highway was twinned (area D in Figure 4.31).

Finally, the northern bank of the opening of the St. Croix has seen a gain of sediments followed by erosion between 2022 and 2023 (area I in Figure 4.31). While this area does not count for a substantial portion of the study area, it is interesting to note that this is one of the only areas where there has been a loss of vegetation. A summary of the most notable results can be found in Table 4.4.
