**CITADEL HIGH SCHOOL STEAM LINE INSTALLATION,
HALIFAX:**

**ARCHAEOLOGICAL RESOURCE IMPACT ASSESSMENT
FINAL REPORT**

Heritage Research Permits A2006NS79, A2007NS04

Submitted by:
Davis Archaeological Consultants Limited
6519 Oak Street
Halifax, Nova Scotia
B3L 1H6

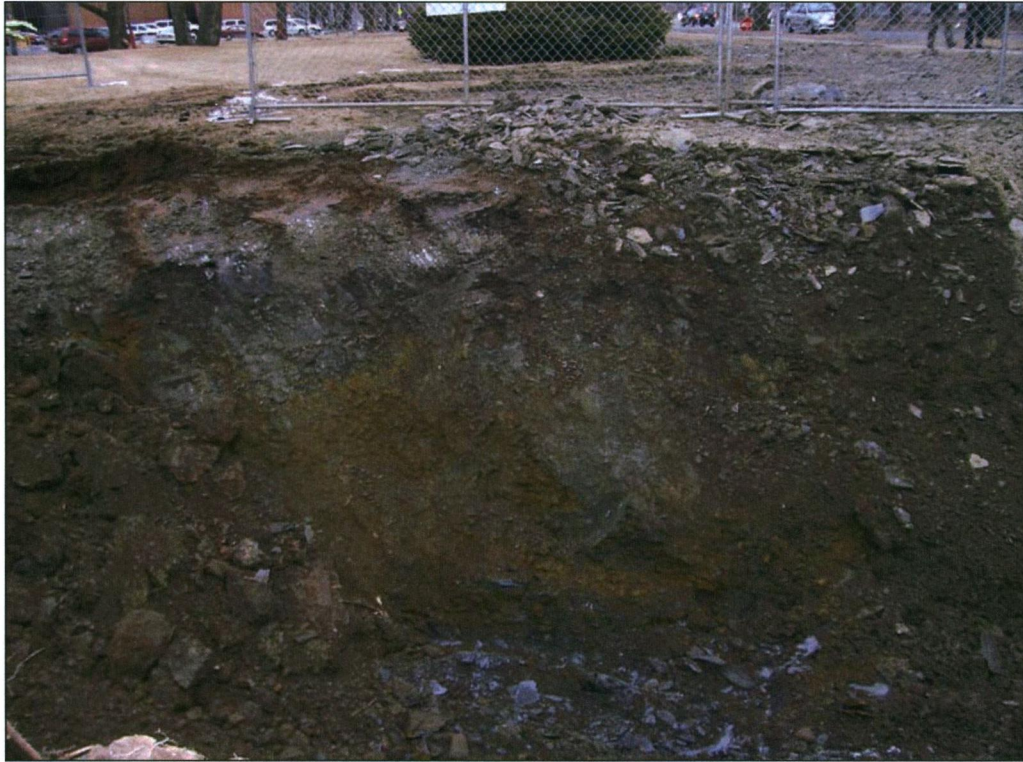
Plate 1: Disturbance on the west side of Bell Road in the area of the catch basin installation.

On the west side of Bell Road, excavation for the installation of a catch basin (MH3, Figure 2.0-1) revealed that this area had previously been extensively disturbed to the full depth of excavation (Plate 1). The soil stratigraphy throughout the main trench had been previously disturbed. The easternmost half of the trench was comprised of broken up asphalt directly beneath the sod. Beneath the asphalt were patches of gravel fill and/or medium brown and grey disturbed soil and ash with late nineteenth to late twentieth century debris including whiteware ceramics, vitrified earthenware ceramics, bottle glass, and metal strapping among other debris. Disturbed architectural debris including granite curb, cut rectangular stone, brick, concrete, and cast iron pipes were present below this to the full depth of excavation (Plate 2).

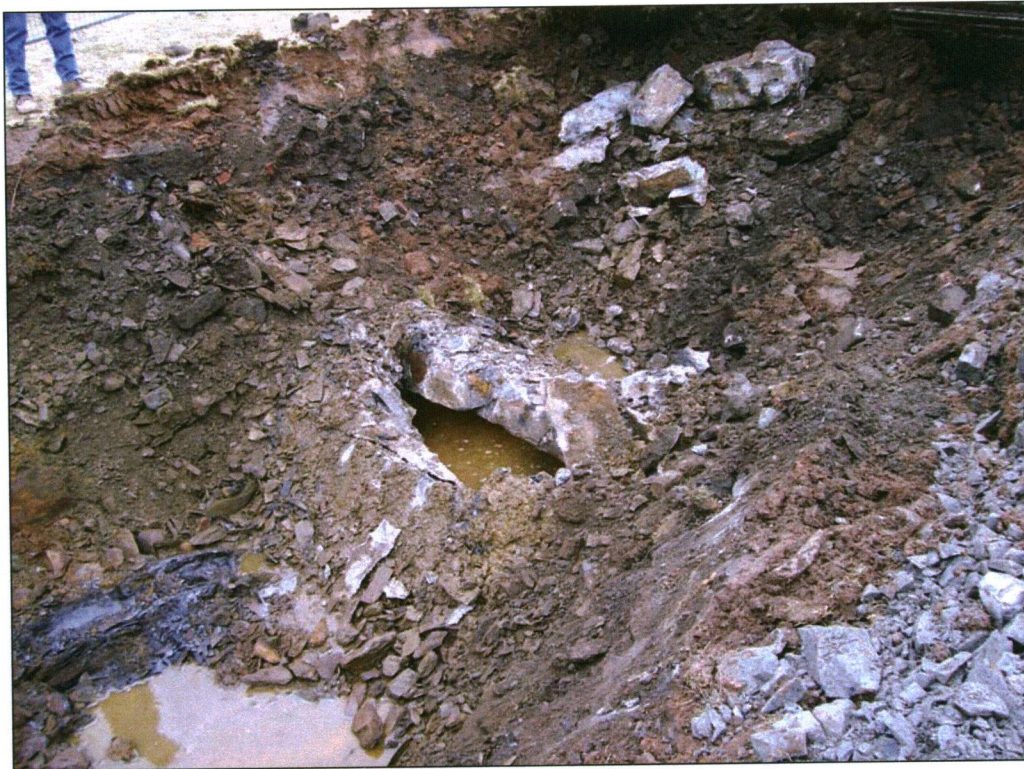
Plate 3: Top of the mortared stone culvert upon initial discovery. Backhoe has broken through the top of the feature.

Approximately 22 metres southwest of MH2 a well-mortared stone culvert was encountered at approximately 1.55 metres below surface. The culvert measured 1.09 metres in diameter with a 0.30-metre-thick wall and was full of water (Plates 3 and 4). The bedrock had been excavated into for installation of the culvert. This culvert may be related to the diversion of Freshwater Brook in the nineteenth century. The culvert was recorded *in situ*. However, the portion of the culvert contained within the trench had to be removed for installation of the steam pipe.

No additional archaeological mitigation is recommended for the development area. However, it should be noted that *in situ* remnants of the stone culvert likely exist to the north and south of this trench. Therefore, it is recommended that an archaeological assessment be conducted should there be any further impact to the north end of the Nova Scotia Museum of Natural History property.

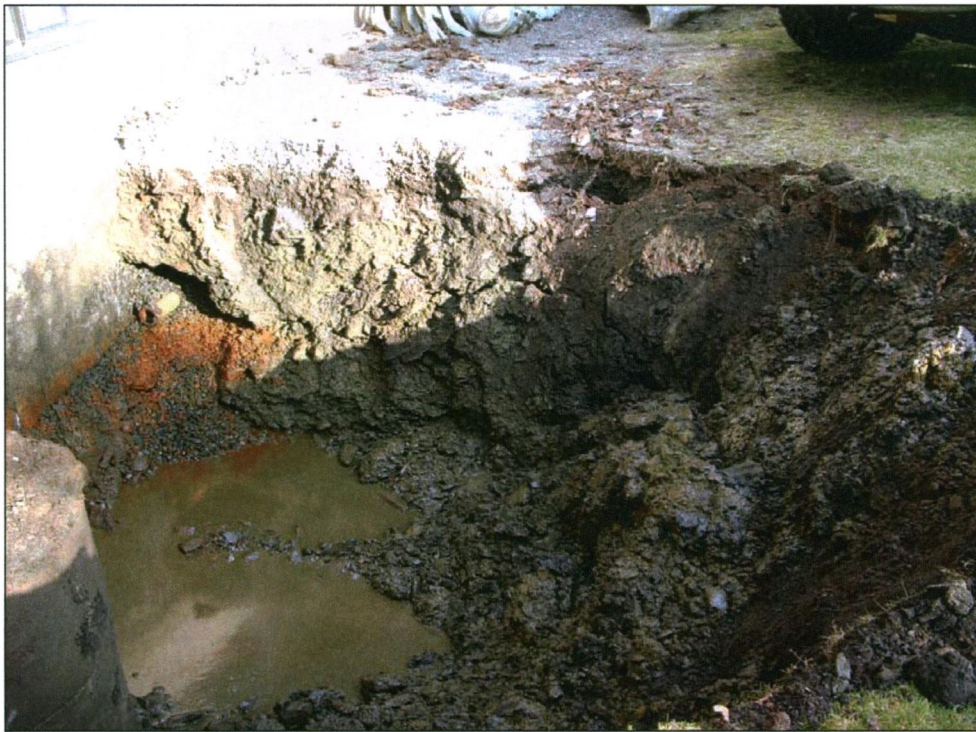
Plate 5: Disturbance adjacent to the museum building as a result of previous catch basin installation (catch basin can be seen in the left foreground).

installation of a catch basin was evident as well (Plate 5). Approximately 4 metres east of the museum building was a definitive layer of brick and building debris with artifacts dating to the mid to late nineteenth century. The strata was relatively undisturbed and it appeared that a building had been demolished here, possibly the same building shown on the 1957 map in the general of the museum (Plate 6).

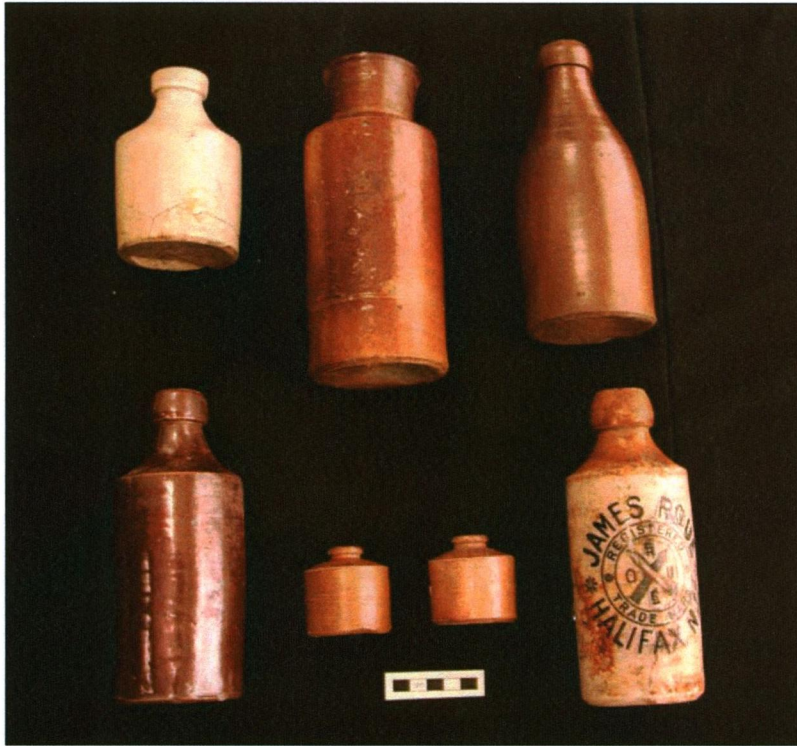
Clockwise from top left:

- BdCv-36:52**
- BdCv-36:65**
- BdCv-36:53**
- BdCv-36:56**
- BdCv-36:63**
- BdCv-36:49**
- BdCv-36:54**

Plate 7: Late nineteenth century stoneware bottles collected during excavation.

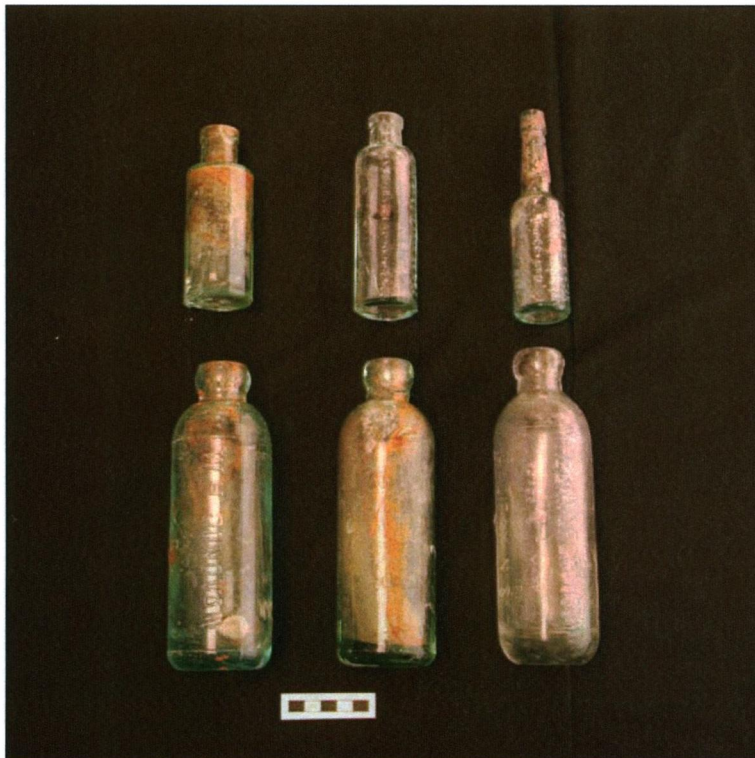
Clockwise from top left:

- BdCv-36:48**
- BdCv-36:62**
- BdCv-36:47**
- BdCv-36:45**
- BdCv-36:44**
- BdCv-36:46**

Plate 8: Late nineteenth century bottles collected during excavation.

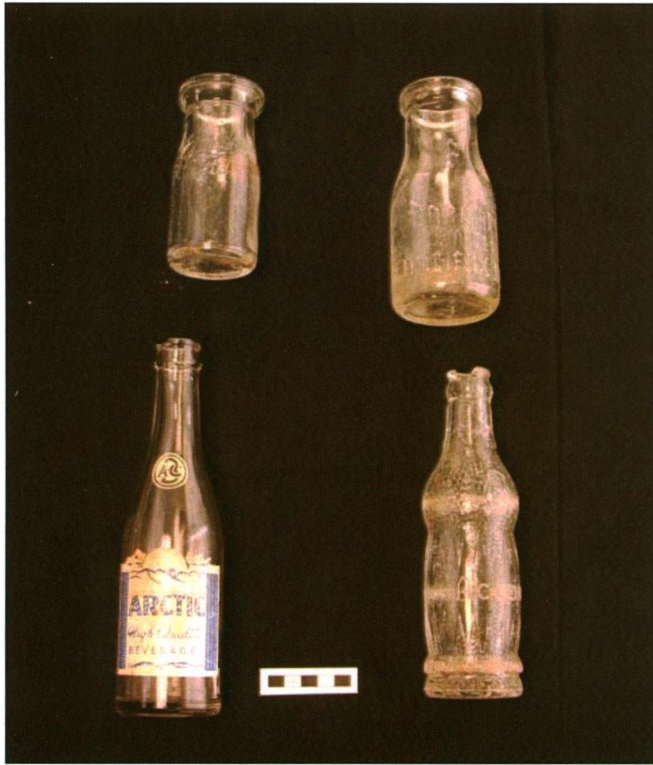
Clockwise from top left:
BdCv-36:60
BdCv-36:61
BdCv-36:58
BdCv-36:59

Plate 9: Early to mid twentieth century bottles collected during excavation.

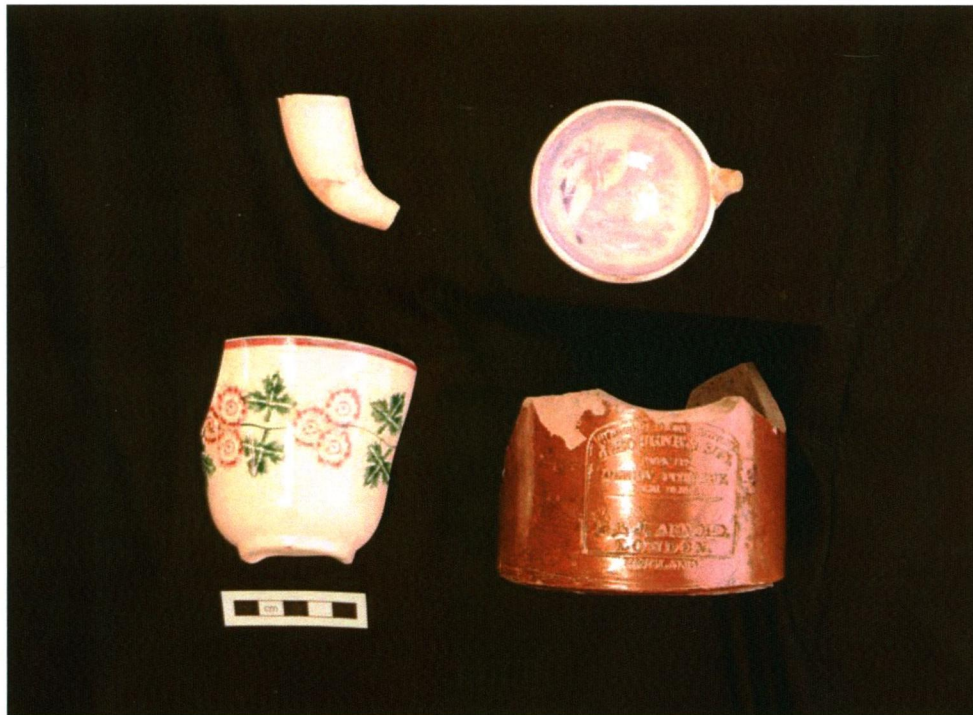
Plate 10: Clockwise from top left: Clay tobacco pipe (BdCv-36:51), purple transfer printed pearlware ladle (BdCv-36:64), salt-glazed stoneware crock (BdCv-36:57), stamped pearlware tea cup (BdCv-36:50).
