**SALTER'S GATE:
ARCHAEOLOGICAL RESOURCE IMPACT ASSESSMENT
FINAL REPORT**

Heritage Research Permit A2005NS10

**Heritage Research Permit A2005NS10
Category C**

Davis Archaeological Consultants Limited

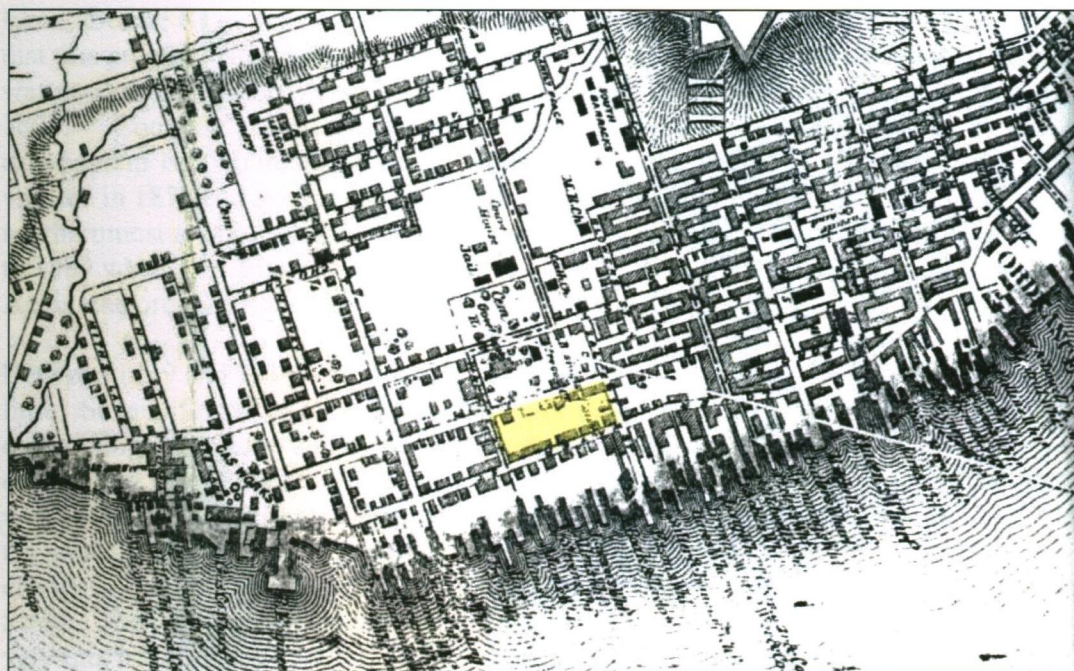
Figure 3.0-7: Ambrose F. Church's map of Halifax, 1865.¹⁵ City block containing the study area is highlighted in yellow.

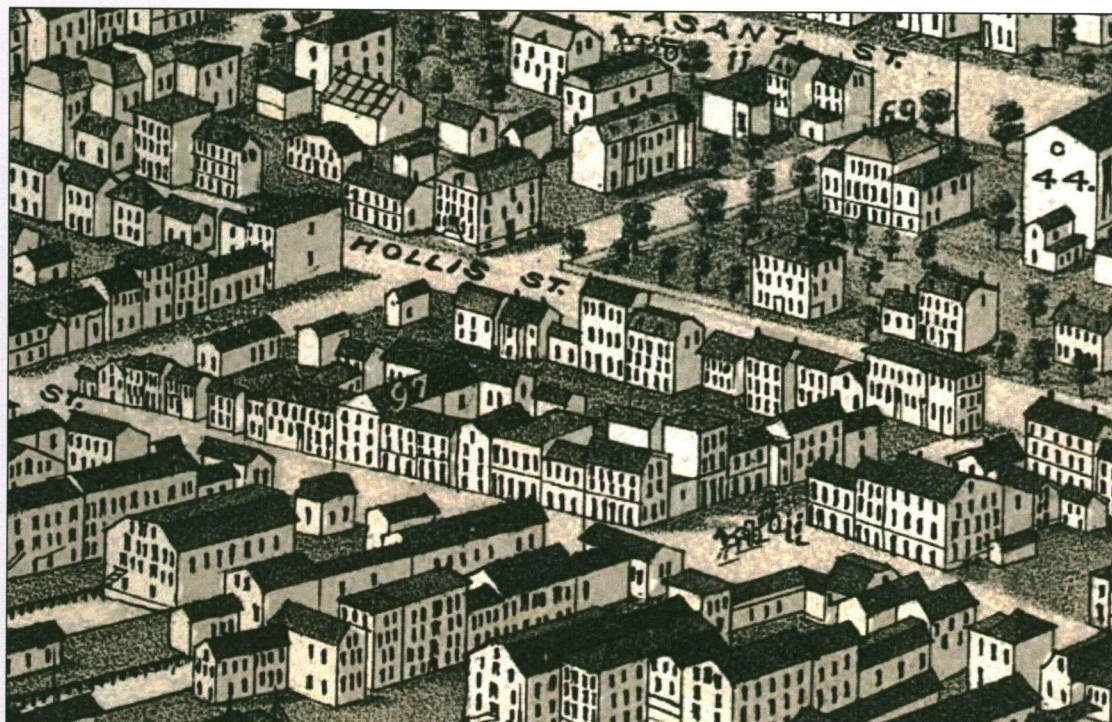
Figure 3.0-12: Panoramic view of city block (Bishops Row, Hollis, Salter, and Lower Water Streets) (centre) in 1879.²²

An 1879 panoramic view of the city by A. Ruger shows a similar picture as the Land Use Atlas but does not show the same concentration of outbuildings inside the city block (Figure 3.0-12). As this is an artist's rendition of the city, however, and is not produced to scale, it is not deemed entirely accurate.

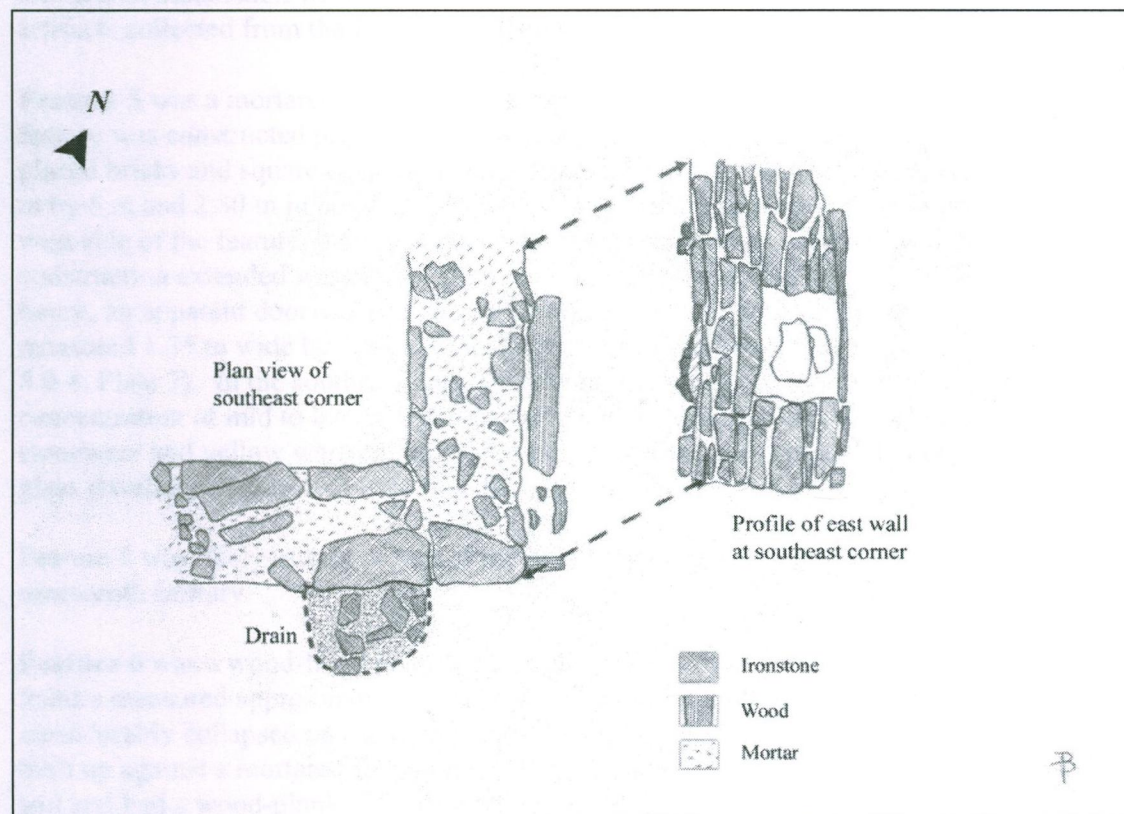
Figure 5.0-3: Southeast corner of feature 2 showing plan view and profile. Scale 1:20.

Features 2, 3, and 4 were a series of mortared ironstone foundations for row houses along Hollis Street. **Feature 2** was located 1.20 m west of feature 1 and measured 14.30 m in width (north-south) by 11.50 m in length (east-west). The foundation measured 0.90 m high on average. On the east wall of the house approximately 0.50 m north of the southeast corner was an opening in the base of the wall measuring 0.60 m wide by 0.44 m high. On the exterior of the wall was a wood-lined drain that ran parallel to the wall and wrapped around the southeast corner. On the south of the house, approximately 0.50 m west of the southeast corner was a stone-lined drain that extended from the base of the foundation to a depth of 0.57 m (Figure 5.0-3). The south wall of the house was truncated by a previous soil test pit at 1.92 m west of the southeast corner. An iron drain pipe extended from the east wall of the house approximately 6 m north of the southeast

corner and likely connected to the coarse earthenware pipe on the north side of feature 1. Approximately 7.00 m north of the southeast corner of the feature, previous disturbance from an unknown source resulted in a break in the east wall of the foundation.

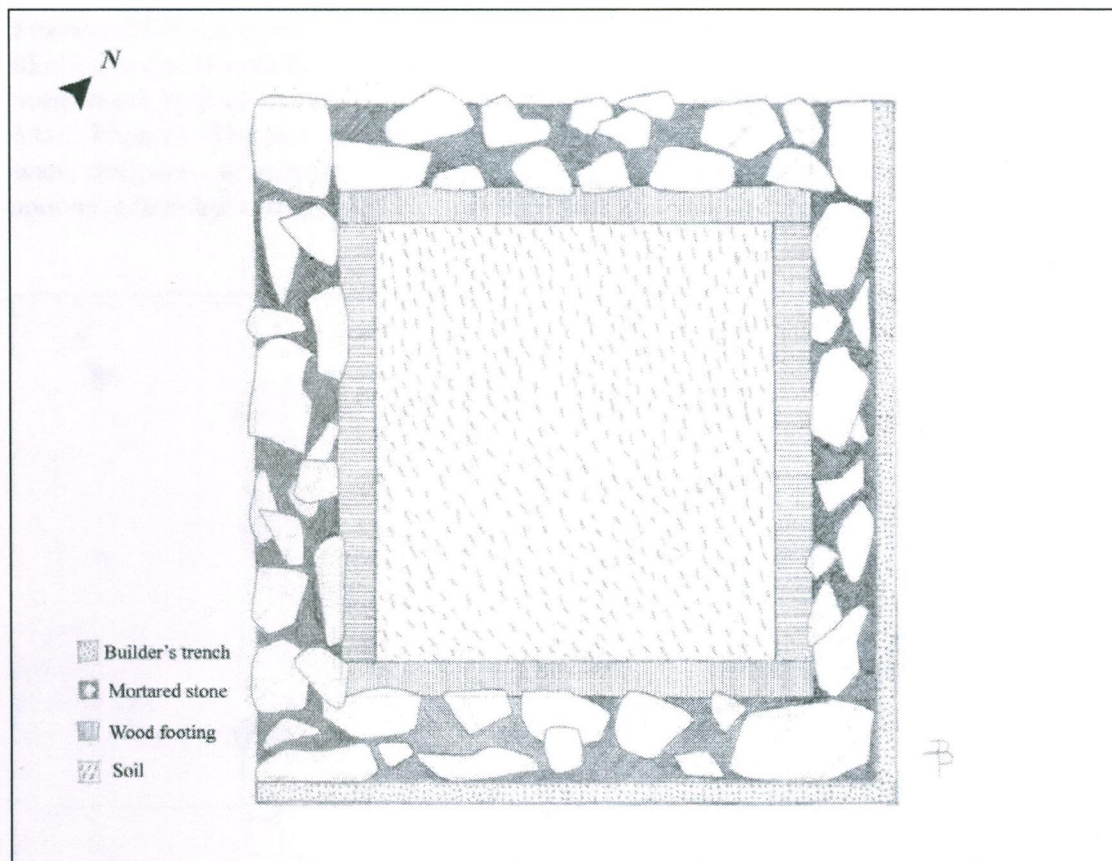
Figure 5.0-5: Plan view of feature 6. Scale 1:10.

Feature 6 was a wood-lined privy located near the southeast corner of feature 1. The feature measured approximately 1.75 m north-south by 2.00 m east-west and was considerably collapsed on the west and north walls. The north wall of the feature was built up against a mortared fieldstone wall of unknown origin. The privy was built on soil and had a wood-planked footing along the interior walls. The average height of the privy walls was 0.90 m (Figure 5.0-5, Plate 8).

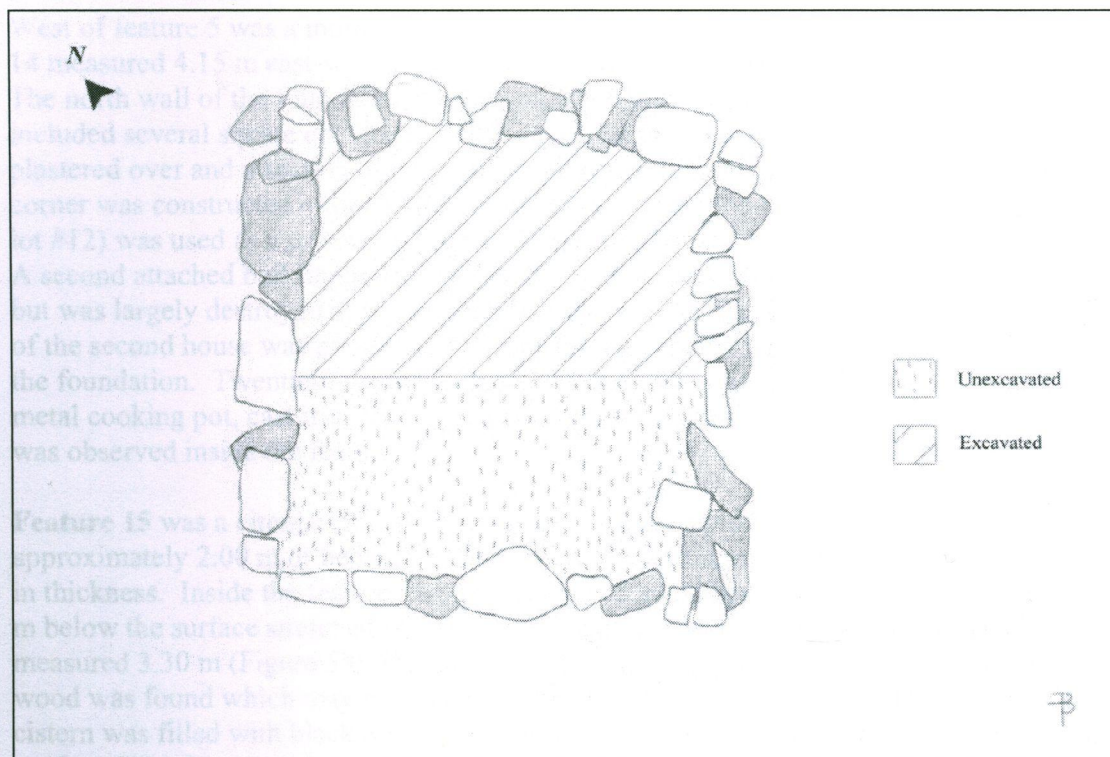
Figure 5.0-6: Plan view of feature 10. Scale 1:20.

Feature 10 was a wood-lined privy approximately 1.50 m west of feature 9 and was likely associated with the same Salter Street residence. The feature measured 2.30 m north-south by 2.20 m east-west and had a mortared stone footing at the surface (Figure 5.0-6, Plate 9). The privy contained mid- to late-19th-century artifacts including yellow ware, ironstone, whiteware, annular and shell edged pearlware, glass buttons, copper spoons, a bakelite syringe, and black bottle glass and was in-filled with ash.

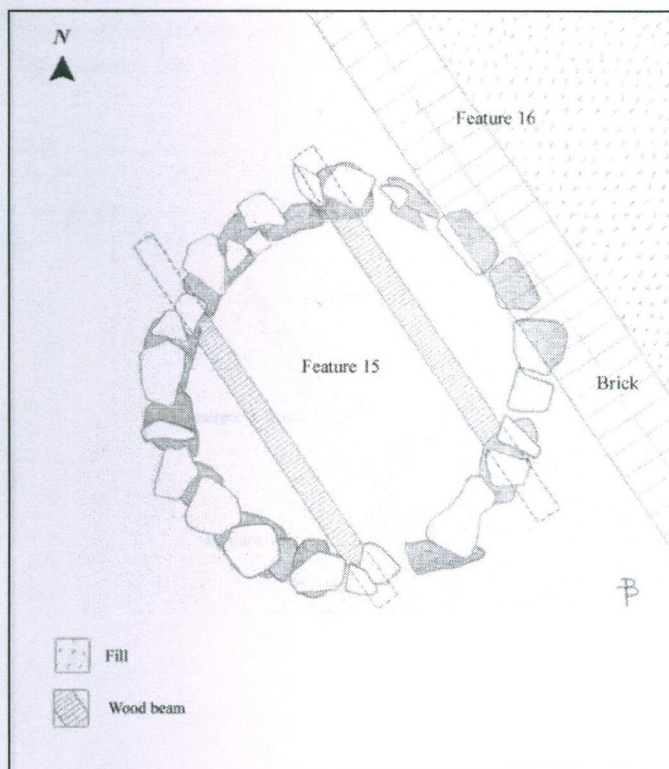
Figure 5.0-7: Plan view of feature 15 showing west wall of feature 16. Scale 1:25.

Feature 15 was a circular dry stone-lined cistern excavated and constructed into approximately 2.00 m of bedrock. The wall of the feature measured, on average, 0.35 m in thickness. Inside the feature, two parallel wooden support beams approximately 1.60 m below the surface stretched across and beyond the diameter of the cistern, which measured 3.30 m (Figure 5.0-7, Plate 12). On top of the beams, a substantial amount of wood was found which may have been related to a floor at this level. The interior of the cistern was filled with black organic soil and wood fragments along with late 19th-century artifacts. On the east side of feature 15, the top of the feature was overlain by the west wall of **feature 16** – a mortared fieldstone foundation with a course of bricks on top of the west half of the feature. The south end of the foundation ran under the asphalt at the north end of lot A-2. The exposed portion of the foundation measured 9.75 m east-west by 4.75 m north-south and 0.75 m in height.

No such features are indicated on late nineteenth century maps or images of the city block, suggesting that the feature predates and was dismantled before this time. The east side of the feature appears to have impacted by the adjacent feature (feature 16), also suggesting that the cistern predates it.

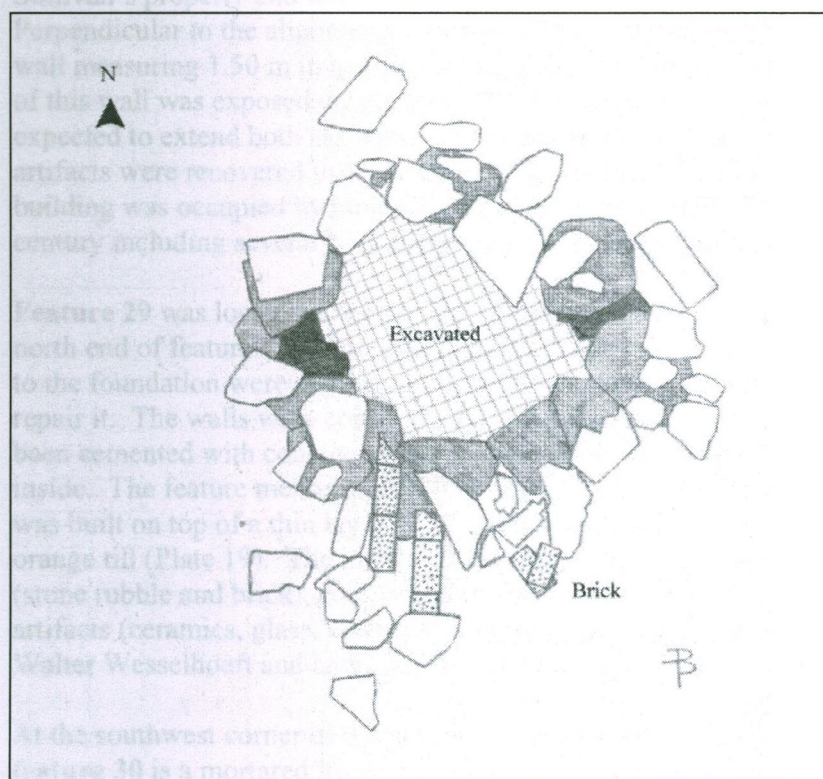
Figure 5.0-10: Plan view of feature 24. Scale 1:20.

Clay pipes, ironstone ceramics, coarse earthenware and stoneware, glass buttons, machine-made bottle glass, leather shoes, and a wooden barrel base were recovered from Feature 24.

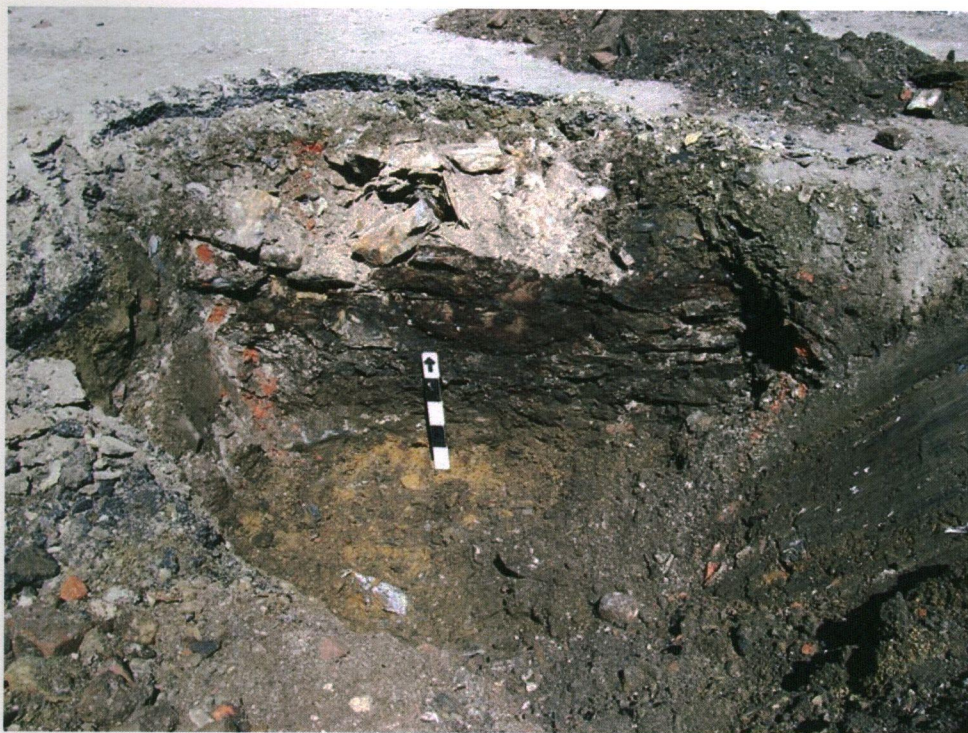
PLATE 1: North wall of Feature 2, unearthed during soils testing by Maritime Testing Limited.

Prior to the excavation for construction, geotechnical testing was conducted throughout the development area in 2000 by Maritime Testing Limited. The results of these tests are summarized in DAC's previous report and are discussed in detail in Maritime Testing Limited's report.²⁶ In May 2005, Maritime Testing Limited conducted further testing to determine soil chemistry and potential contamination. A total of four test pits were excavated by backhoe to the depth of natural till. Two features were encountered in the upper lot during this testing (Features 2 and 3) (Plates 1 and 2).

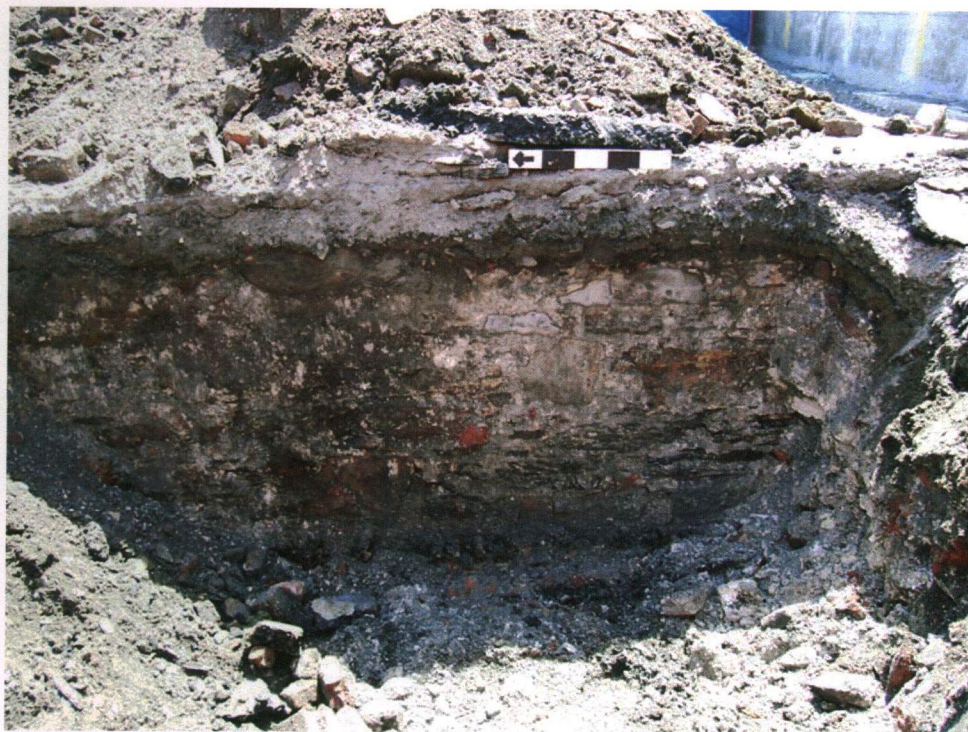
PLATE 2: North wall of Feature 3, unearthed during soils testing by Maritime Testing Limited.

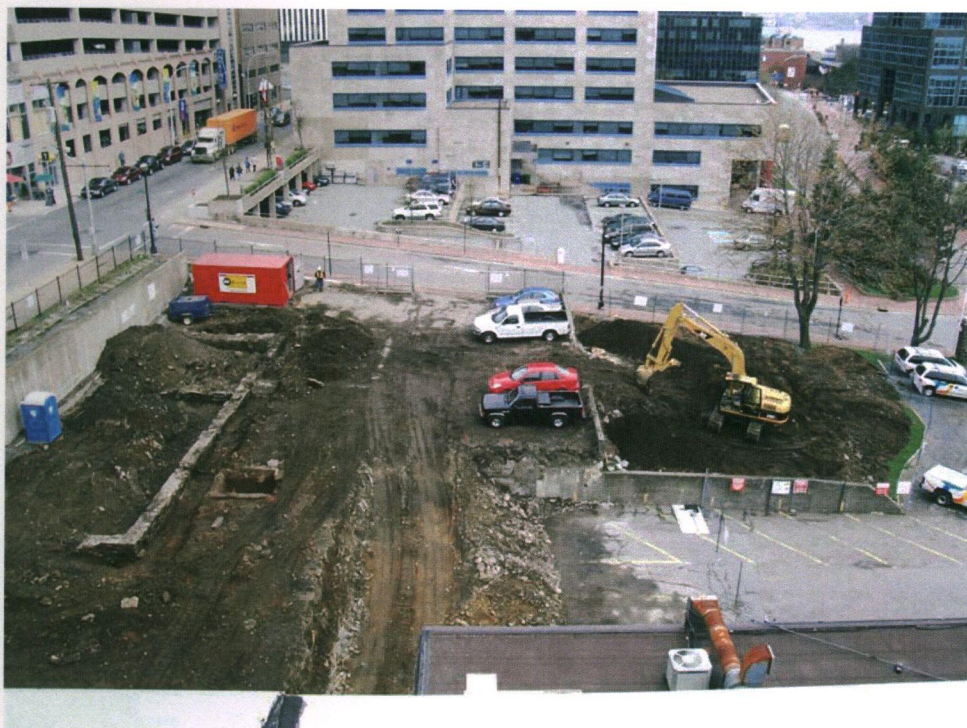
PLATE 3: Mechanical stripping of the west side of the study area showing the tops of archaeological features along Hollis Street.

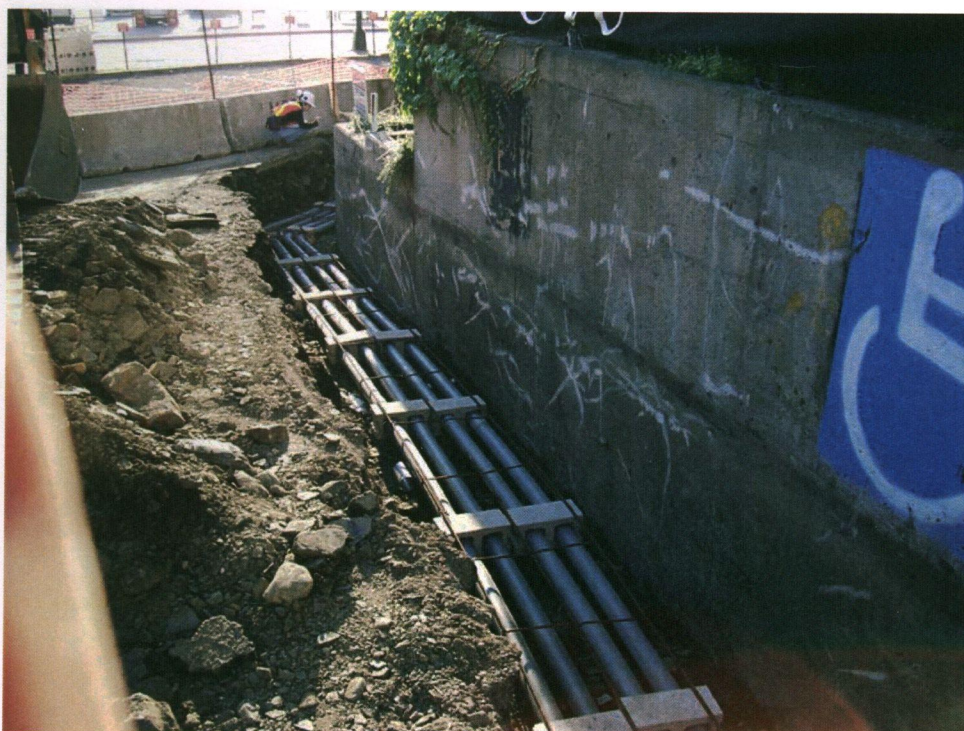
PLATE 4: Excavation of the conduit trench on the north side of the Brewery building.

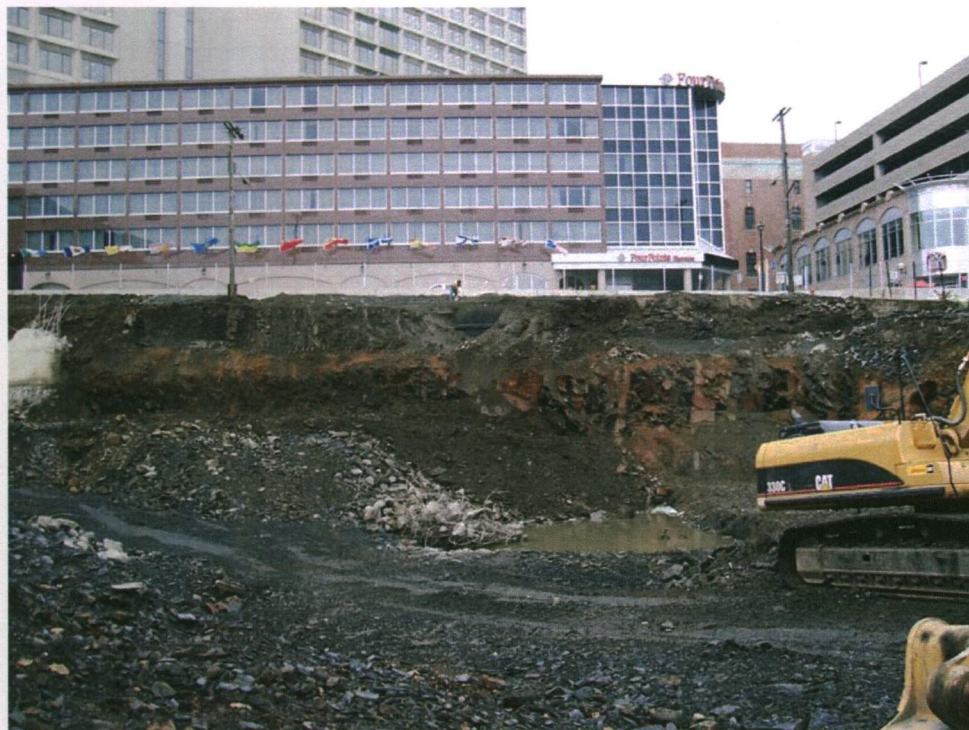
PLATE 5: West side of the study area along Hollis Street after removal of the concrete retaining wall.

An approximate 1.50 metre-wide area under the Hollis Street sidewalk was also excavated during the removal and replacement of a concrete retaining wall running parallel to the sidewalk. A similar size area beneath the Lower Water Street sidewalk was also excavated. The parking area adjacent to the northeast corner of the Keith's Brewery Building was left undisturbed.

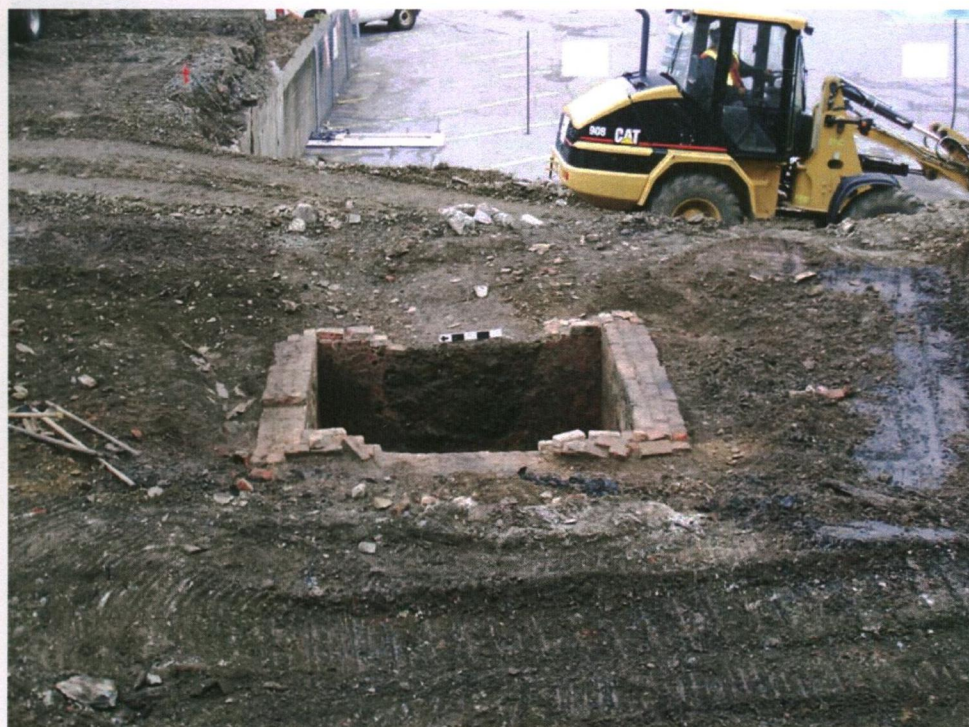
PLATE 6: Feature 1 showing previous disturbance to the east wall of the structure, looking east.

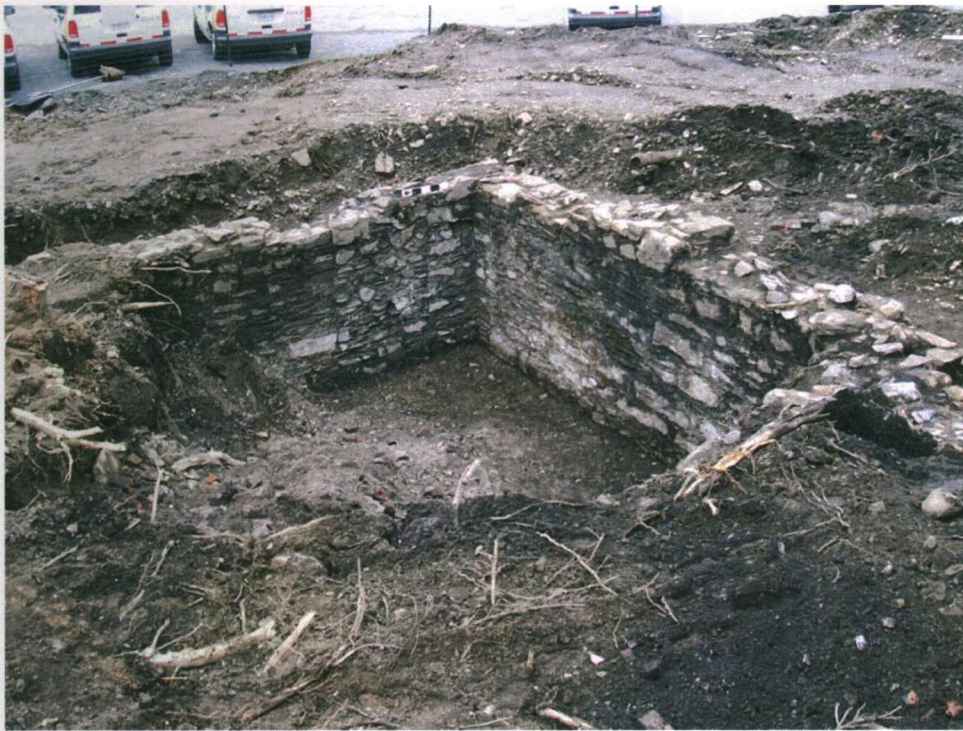
PLATE 7: Feature 5 after excavation. Southeast corner of the feature is in the centre of the photo. Walled-up opening can be seen adjacent to it, on the left.

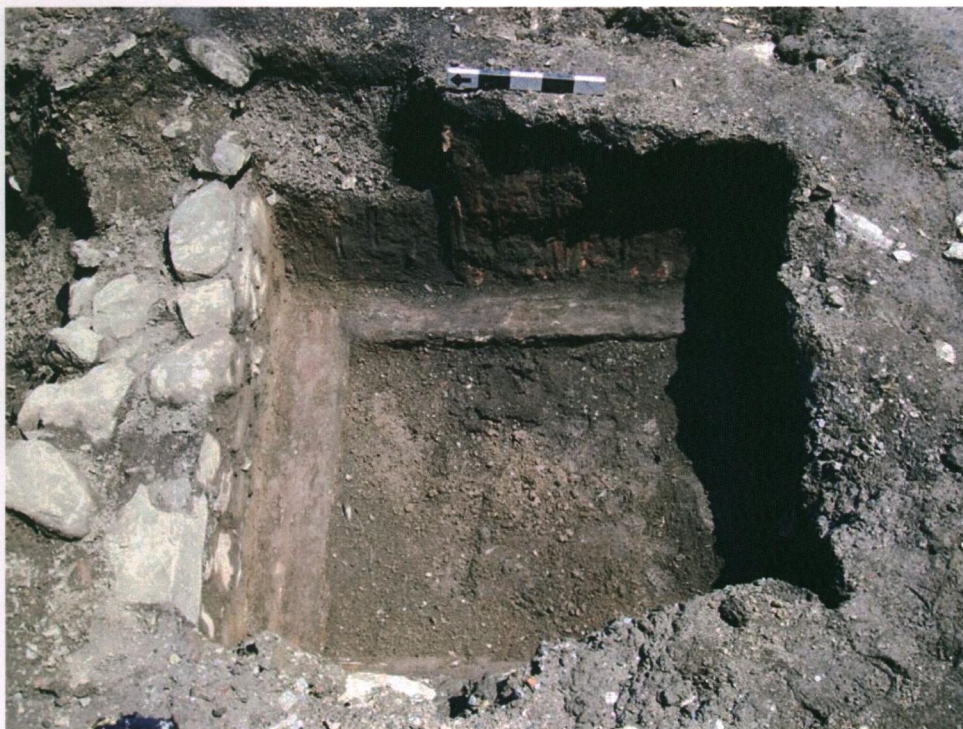
PLATE 8: Feature 6 from above, after excavation. The feature is wood-lined on all sides except the north (left), which is stone-lined.

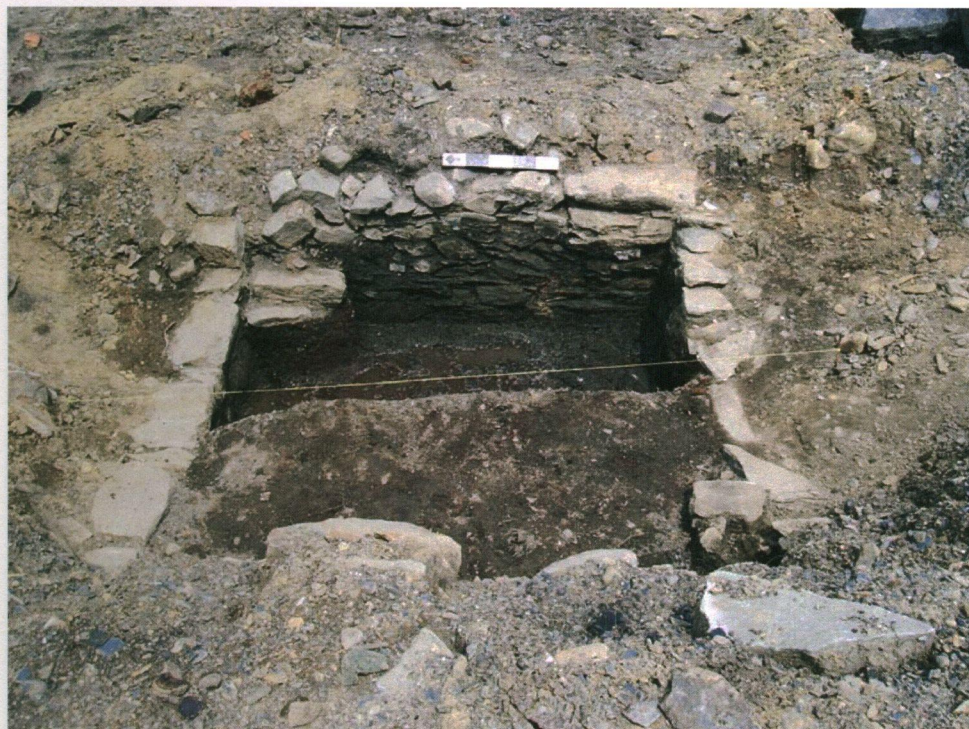
PLATE 9: Feature 10 after excavation of the east half of the feature, looking east.

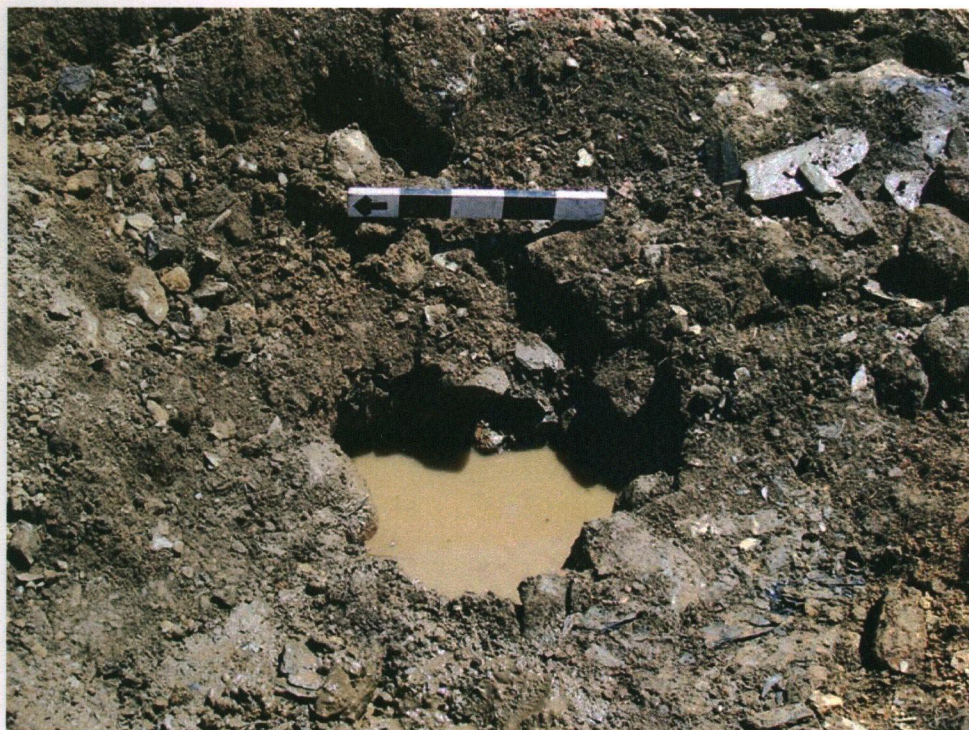
PLATE 10: Top of feature 11, looking south.

Feature 11 was a circular stone-lined well likely associated with the row houses on Hollis Street. The feature measured approximately 0.60 m in diameter and was dug to bedrock. Most of the well was likely obliterated in an early levelling episode, likely when the block was cleared and excavated for the construction of the parking lot, as it measured only 0.22 m in depth (Plate 10). No artifacts were recovered from the feature.

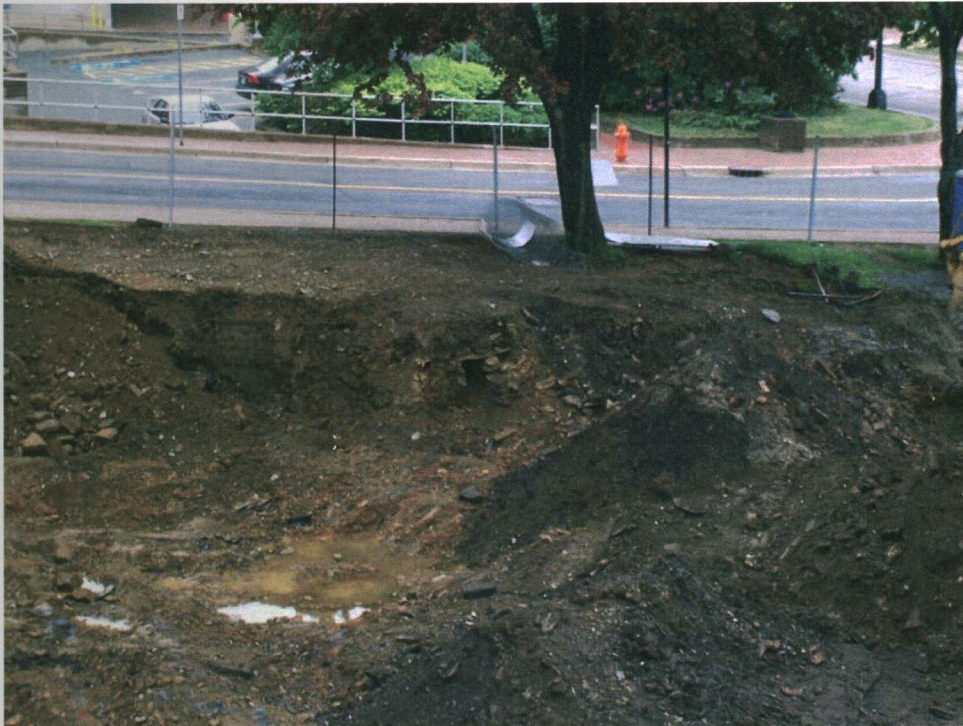
PLATE 11: North end of the study area showing a stone-lined drain running perpendicular to Salter Street in the background.

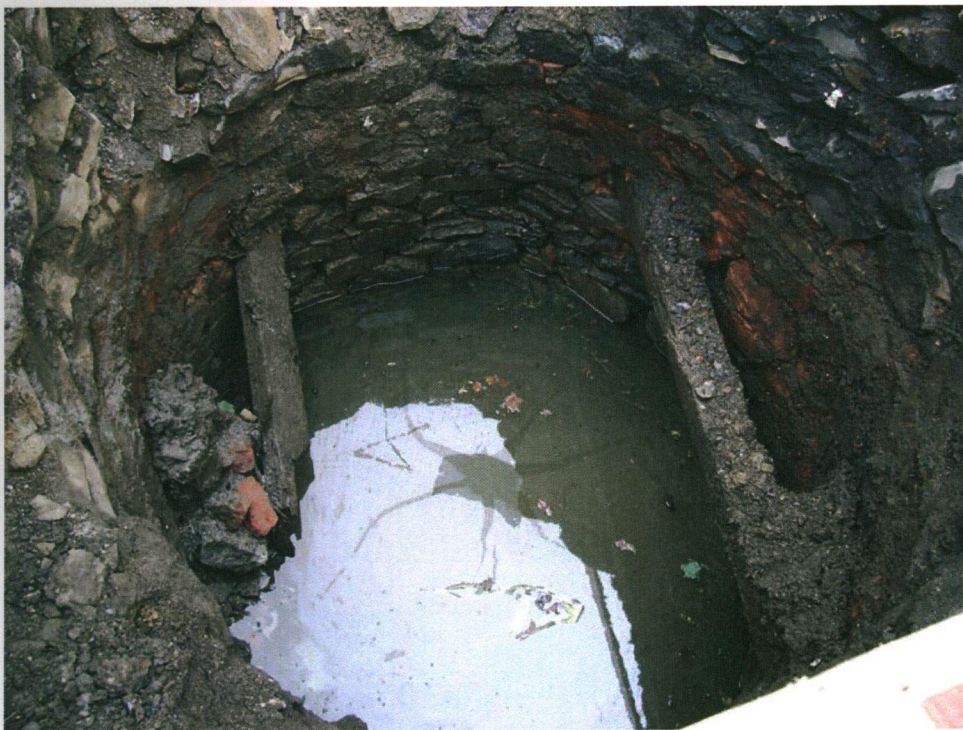
PLATE 12: Feature 15 from above showing the north-south aligned wood support beams in the interior.

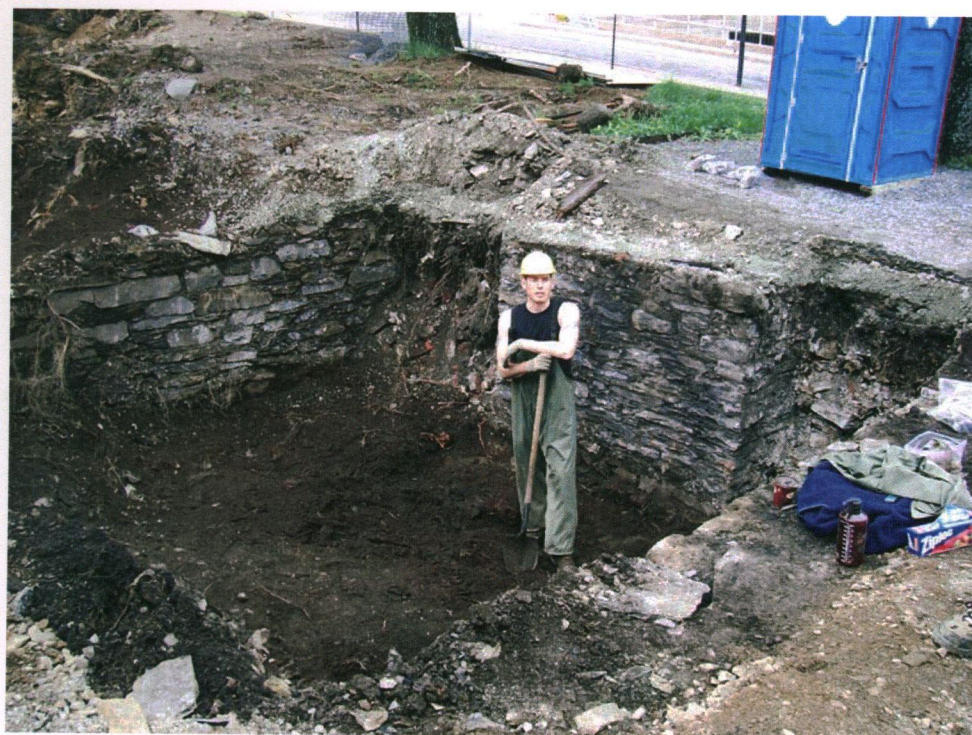
PLATE 14: Feature 20 during excavation, looking northwest.

Feature 20 was a mortared ironstone domestic structure facing on Salter Street. The feature measures 6.80 m east-west by more than 5.80 m north-south and extends beneath the treed area adjacent to Salter Street. The feature was approximately 1.40 m high and had a wood floor. At the north end of the exposed portion of the feature, a square or rectangular mortared ironstone feature – possibly a chimney base – extends northward under the treed area as well (Plate 14). Artifacts recovered from inside the feature dated to the mid to late 19th century and included coarse earthenwares and stonewares, glass ink

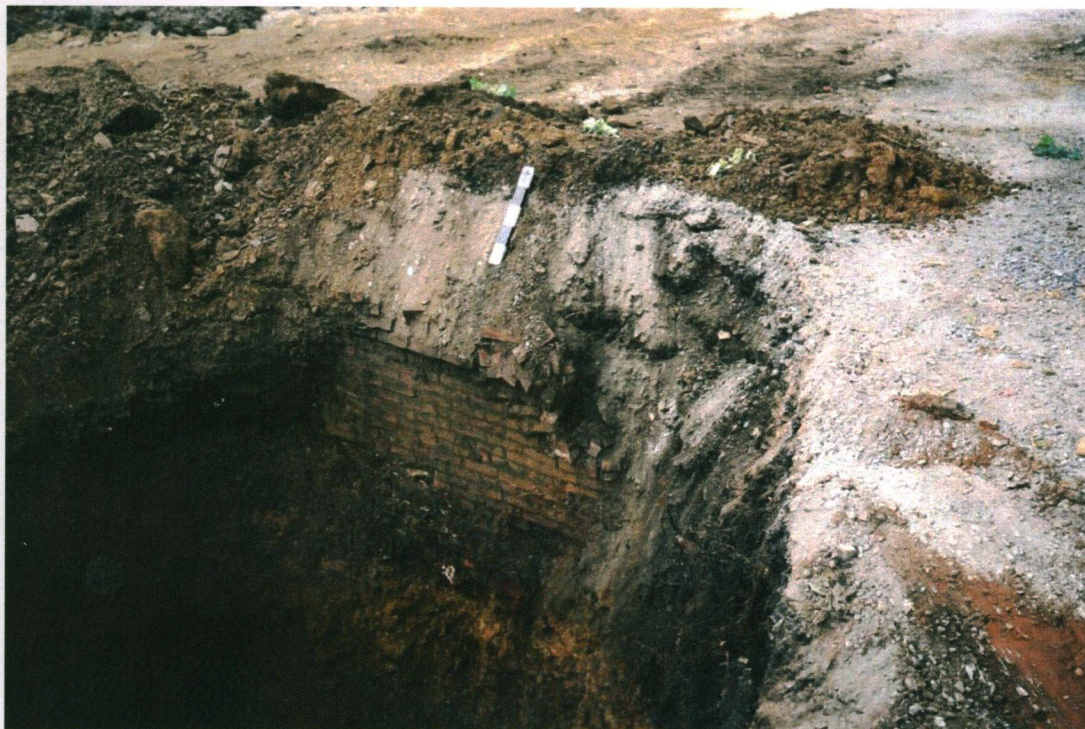
PLATE 15: Feature 22, looking northeast.

Feature 22 was a remnant mortared ironstone foundation east of feature 20. The feature was heavily impacted at some point as only a southeast corner was discernable upon discovery (Plate 15). A sample of late 19th-century artifacts was collected near the east wall of the feature. Fire Insurance Plans indicate that a semi-attached dwelling, probably boarding rooms, was located here. City directories show that the building was home to several different residents throughout the last half of the nineteenth century.

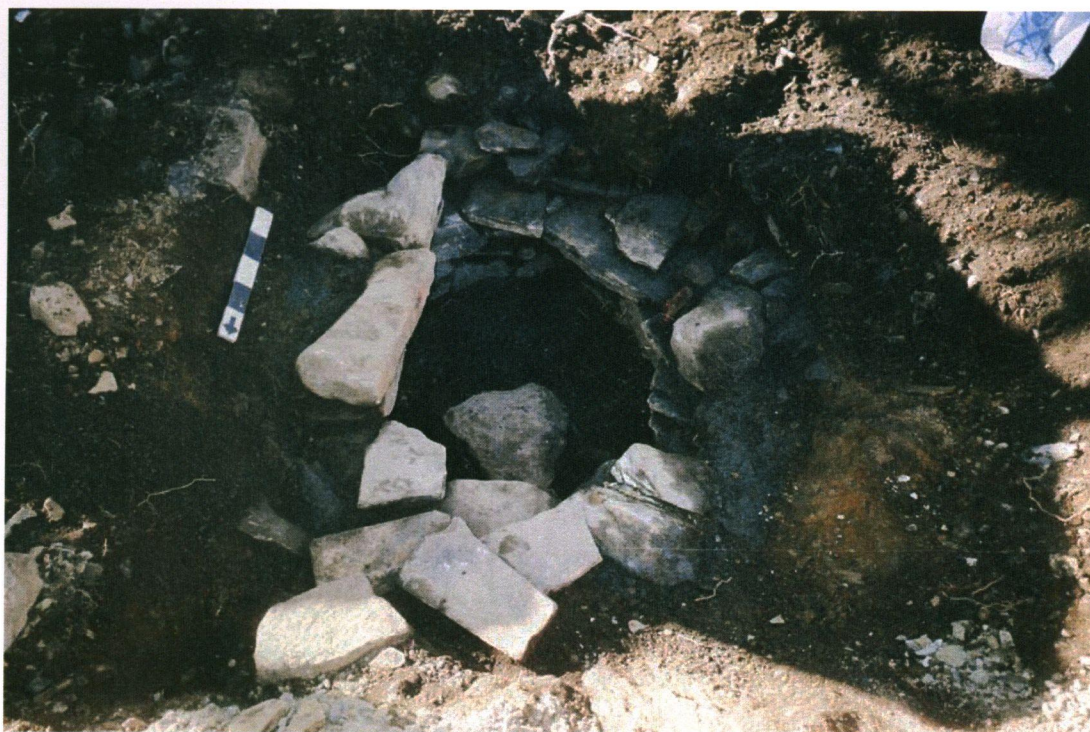
PLATE 16: Feature 24 after excavation, looking south.

Feature 24 was a dry stone-lined circular feature located at the southeast end of the development area. The feature measured 1.95 m in diameter and 2.00 m in depth although the black organic loam inside the feature extended to bedrock at a depth of 3.50 m. On the southeast side of the feature, two parallel linear arrangements of mortared brick capped by flat stones appeared to form a drain 0.30 m wide to direct water into the circular feature (Figure 5.0-10, Plate 16). This feature was located during trenching for removal of the electrical conduit to the west, as were features 25 through 28.

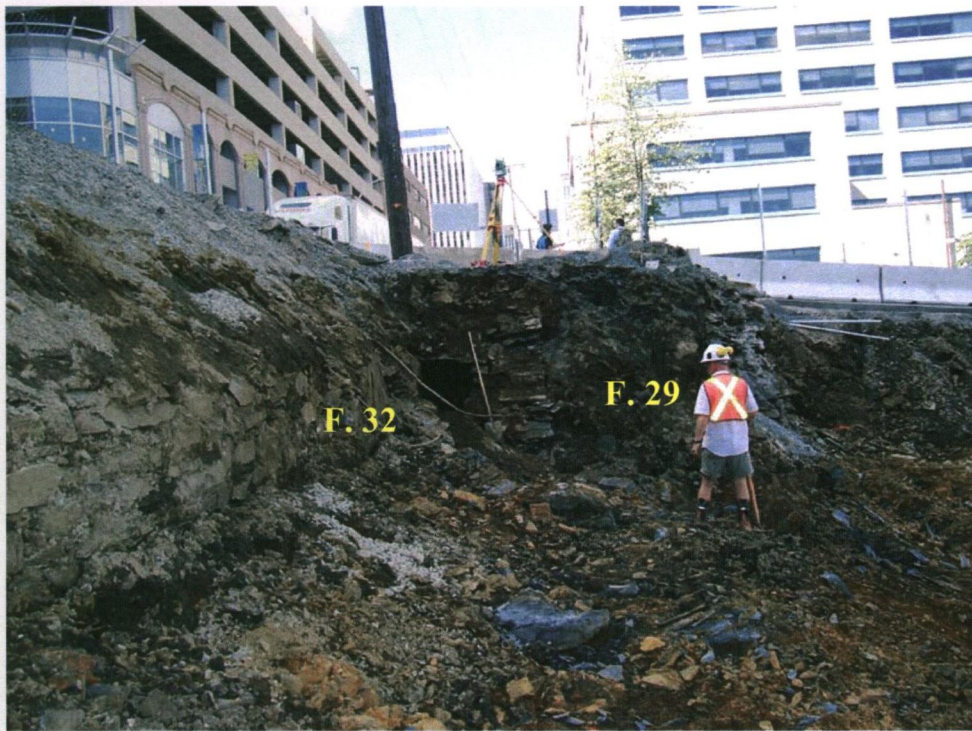
PLATE 19: Features 29 and 32 behind concrete retaining wall and fill on Hollis Street, looking north.

Feature 29 was located at the northwest corner of the development area attached to the north end of feature 4 and comprised a fourth row house along Hollis Street. Alterations to the foundation were made in the late 19th or early 20th century in order to stabilize or repair it. The walls were constructed of mortared ironstone, although the east wall had been cemented with concrete at the top and lined with a single course of mortared brick inside. The feature measured 15.20 m north-south by 11.50 m east-west. The foundation was built on top of a thin layer (0.15 m thick) of black greasy organic soil over the natural orange till (Plate 19). The interior of the foundation was in-filled with structural debris (stone rubble and brick), coal, ash, and soil fill along with late 19th- to early 20th-century artifacts (ceramics, glass, electrical components, etc.). This building was the office of Dr. Walter Wesselhoeft and later Dr. Herbert H. Read.

Feature 32 was a stone-lined drain located at the northwest corner of the development area which had been built up against bedrock on the west side and ran along the Hollis Street façade of feature 29. The drain measured 0.70 m wide by 0.70 m high (Plate 19). No artifacts were recovered from this feature.

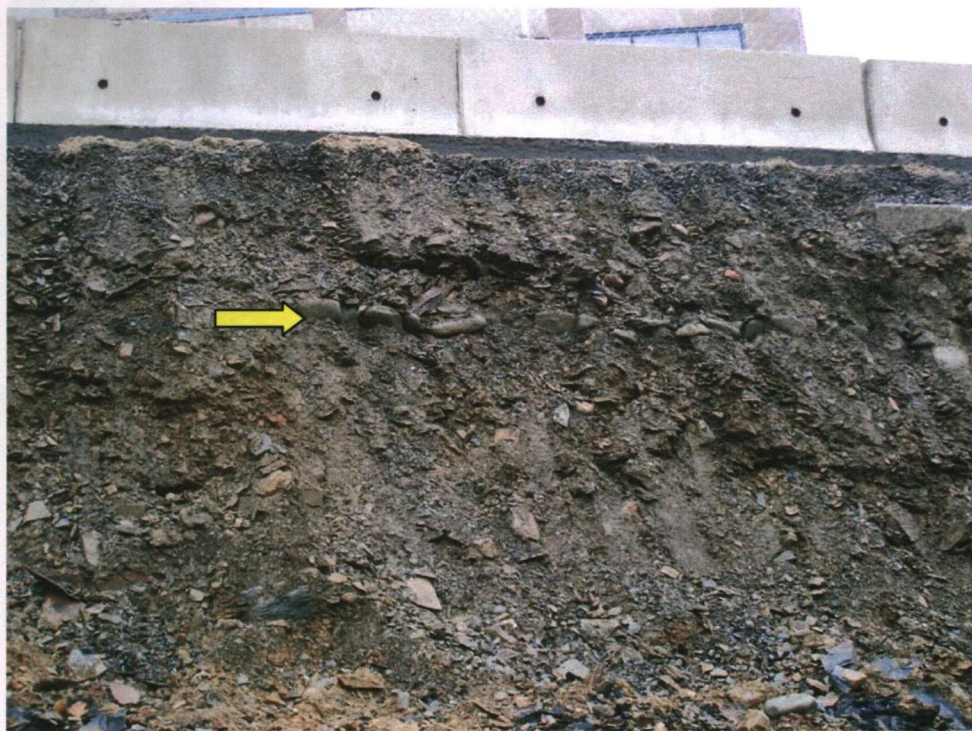
PLATE 20: Feature 33 below Salter Street in the background. One of the granite lintel stones can be seen at the right.

Feature 33, the original cobblestone surface of Salter Street, was discovered during removal and excavation of the sidewalk. The roadway was located 1.38 m below the present Salter Street level and was paved with a single course of cobblestones approximately 0.30 m in diameter. The original roadway sloped toward Lower Water Street at a slightly greater angle than the current street surface – approximately a 20° difference. The soil matrix above the cobblestone surface was fill and two side-by-side cut granite lintel stones were discovered approximately 0.40 m below the current street level, possibly associated with a building façade (Plate 20). No artifacts were recovered from this feature.

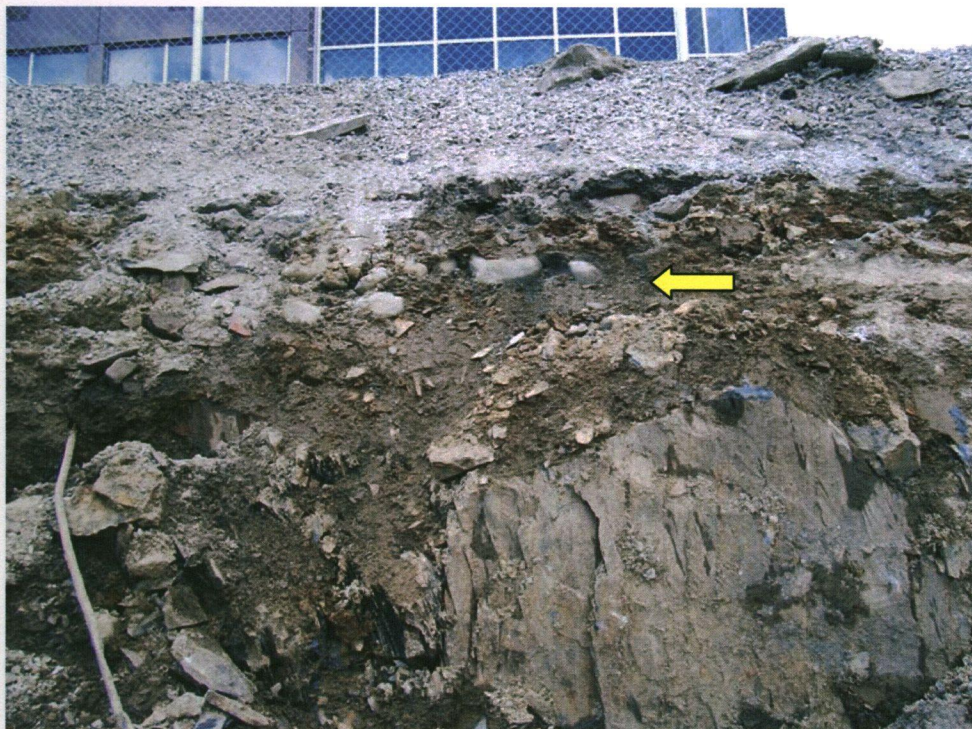
PLATE 21: Feature 34 below Hollis Street in the background.

Similarly, the original cobblestone surface of Hollis Street was designated **feature 34** and was located approximately 1.50 m below the present street level. The fill above the cobblestone level was comprised of red brick and gravel with a layer of natural clay between the brick and cobblestones. The fill above the brick was primarily gravel deposited during construction of the original concrete retaining wall. The roadway was located 0.75 m above feature 32 (Plate 21). Again, no artifacts were recovered in association with this feature.
