**Understanding the Effects of Managed Realignment Schemes on Salt Marsh Recovery by
Assessing the Spatiotemporal Patterns of Vegetation Colonization in the
Bay of Fundy, Canada**

A Thesis Submitted to
Saint Mary's University, Halifax, Nova Scotia
In Partial Fulfillment of the Requirements for the
Degree of Bachelor of Science (Honours) in Environmental Science.

April 2023,
Halifax, Nova Scotia

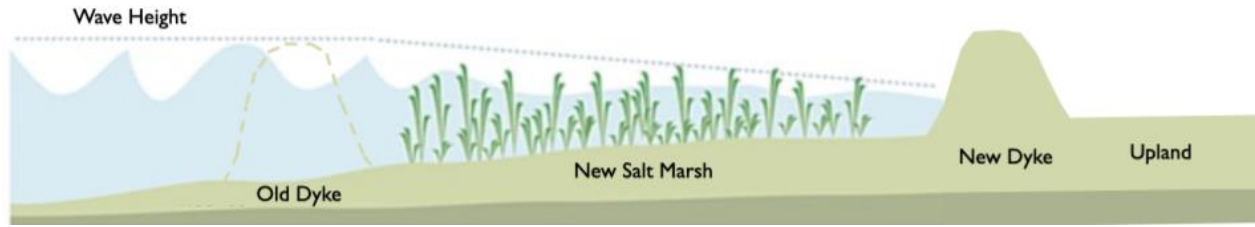
Figure 1.2. Managed realignment schematic showing reduced wave height due to established foreshore marsh. Reproduced with permission from Samantha Lewis.

Increasing the amount of tidal wetland habitat creates new intertidal habitat from formerly flood-defended areas of coastal land. This provides sustainable flood defences and establishes boundaries for coastal development (Bennett et al., 2020). If designed properly, MR projects can be a viable nature-based adaptation method to limit current and future risks associated with climate change.

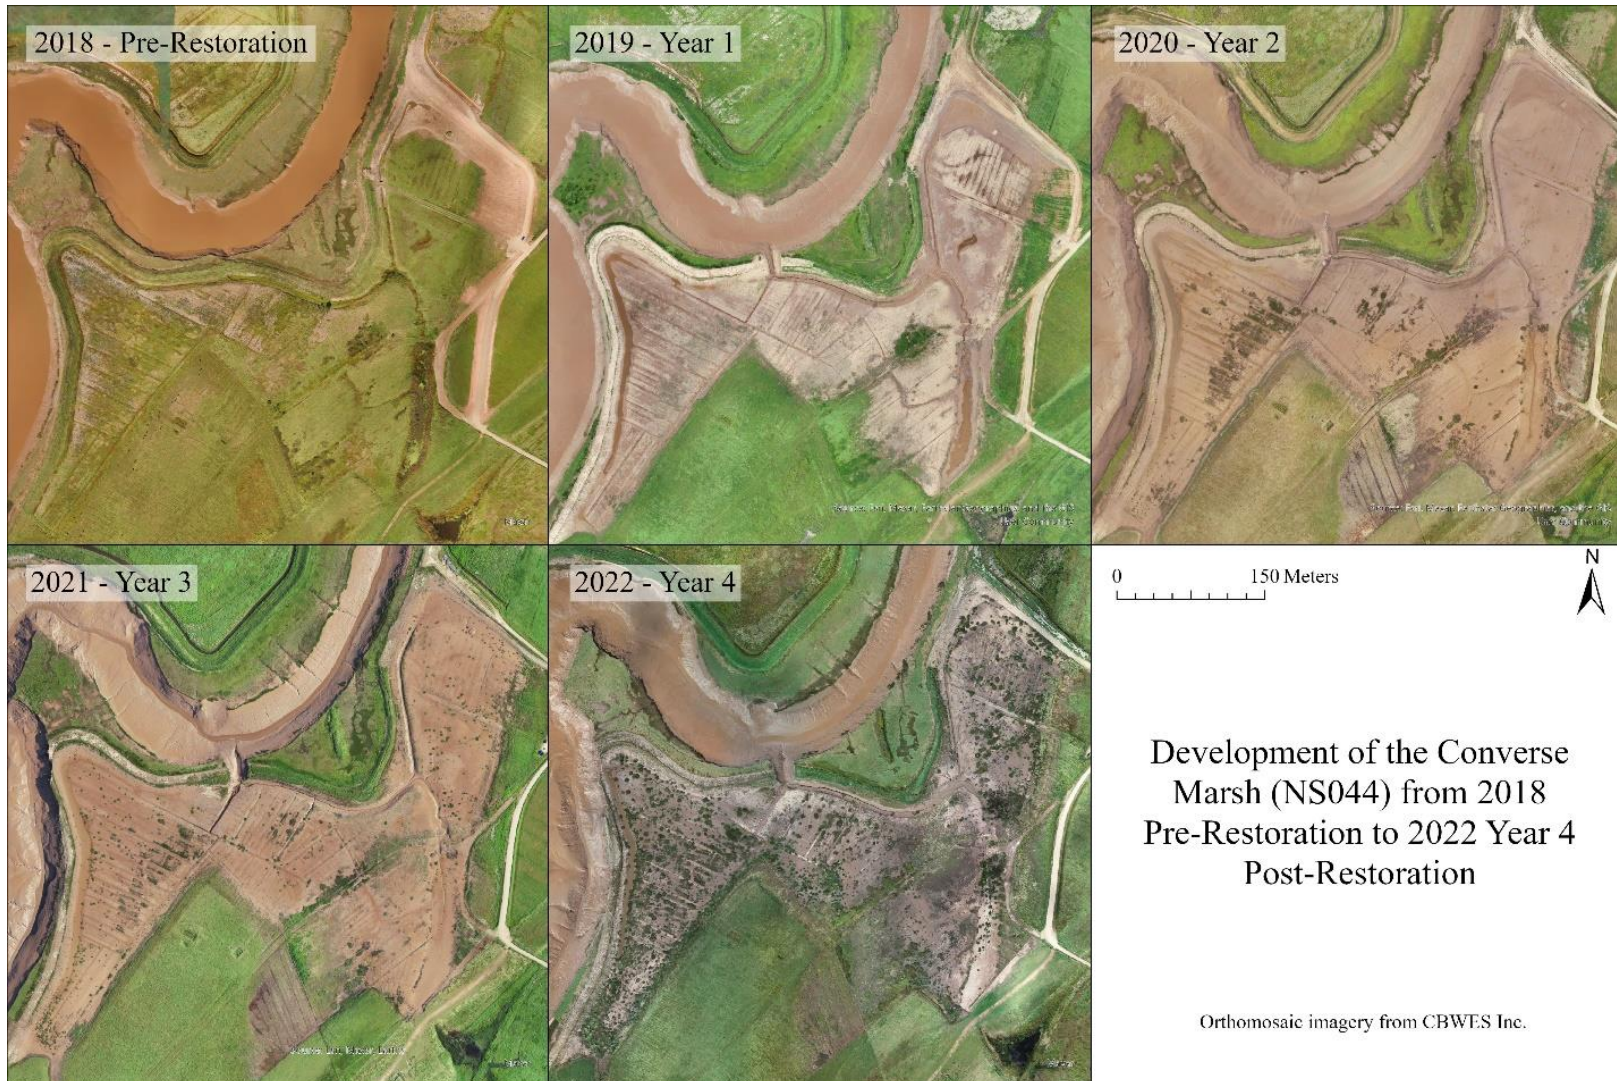
Figure 2.4. Development of the Converse Marsh from 2018 pre-restoration to 2022-Year 4 post restoration.

Geospatial data regarding hydrology, sediments, and vegetation have been collected each year from 2017 baseline conditions up to 2021 under a 5-year monitoring framework. The total restored area of this site was 15.4 ha (Bowron et al., 2021). The site has been slower to respond to the restored hydrology compared to other projects in the Minas Basin due to the strong influence of its antecedent landscape history such as agricultural vegetation, resulting in less favourable conditions for halophytic vegetation colonization in the first-year post-restoration. According to Lewis (2022), areas with remnant agricultural ditches typically maintained their position over time as part of the channel network and the antecedent landscape history, though there were also channels that developed within relic natural features and embryonic channels that had developed without the influence of landscape history. Areas such as the borrow pit that were stripped of their landscape history through excavation were faster to establish channel networks due to their lower elevation, though the marsh platform experienced higher rates of sediment deposition (Lewis, 2022). This appeared to have created more suitable conditions for vegetation colonization on the marsh platform as consecutive years demonstrated incremental sediment accretion and establishment of halophytic vegetation including *S. alterniflora*, *S. pectinata*, brackish species, and other early colonizers such as *Suaeda maritima* (Figure 2.4).

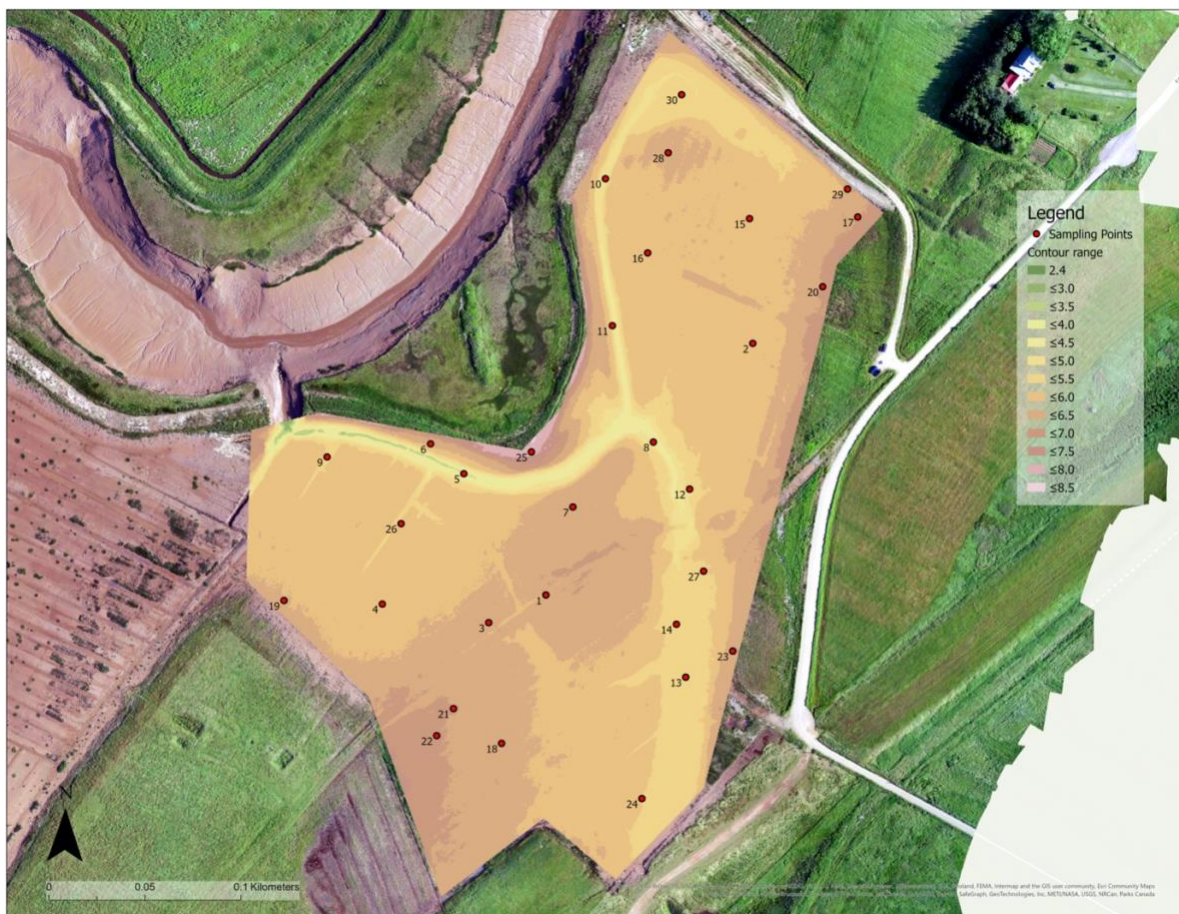
Figure 3.2. Sampling stations (n=30) placed within 13 different elevation bins at the Converse restoration site. Background imagery collected July 25, 2021 with a DJI Phantom 4 RTK RPAS.

Initial sampling stations were planned using a stratified sampling method in ArcGIS Pro. This was achieved by clipping the 2021 digital elevation model (DEM) to the extent of the study area and running the contour tool at 0.5 m intervals to create contour polygons. The result was 13 bins of elevation categories to represent the elevation gradient at the Converse marsh (*Figure 3.2*). The contour polygon was then input into the random points tool which placed plots (n=30) based on different elevation categories. The points were also compared to the 2021 habitat classification to ensure that different vegetation cover, elevation, and inundation frequencies would be captured to achieve a representative dataset of the site.

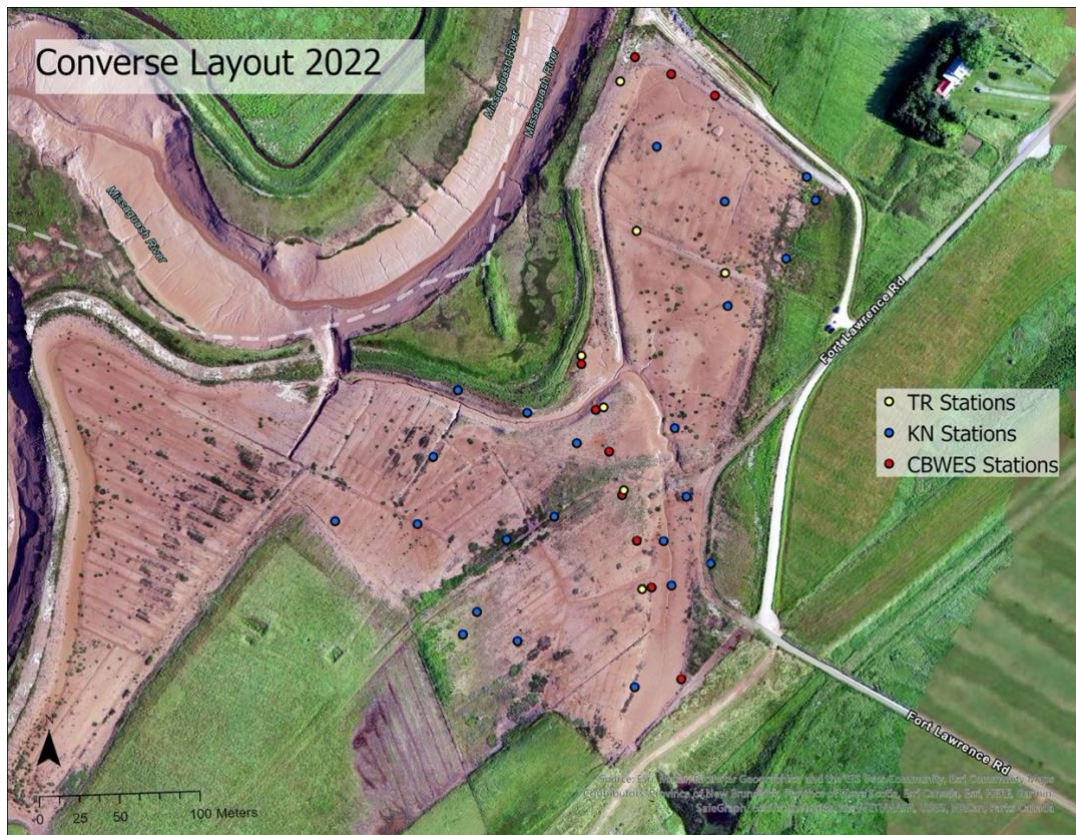
Figure 3.3. Final sampling station locations (n=40) for field data collection. Background imagery collected July 25, 2021, by CBWES with a DJI Phantom 4 RTK RPAS.

Points that were randomly generated in inaccessible areas such as deep channels were removed, resulting in 23 new sampling stations. Other plots were added including previously studied plots from the CBWES Inc. monitoring framework (n=10) and a previous Master's student (Rabinowitz, 2020) (n=7) that were within the study area. These plots were included to create a continuous dataset by monitoring vegetation within the plots that had been surveyed in previous years, allowing change to be monitored over time. The result was 40 sampling stations across the marsh surface to establish an appropriate sample size (*Figure 3.3*). The naming conventions for the CBWES plots kept their original names, Rabinowitz (2022) plots were named TR_(unique value), and the newly placed plots were named KN_(unique value). The easting and northing values were extracted from each station, exported as a .csv and transferred onto a Leica GS14 RTK GNSS unit in preparation for field data collection.

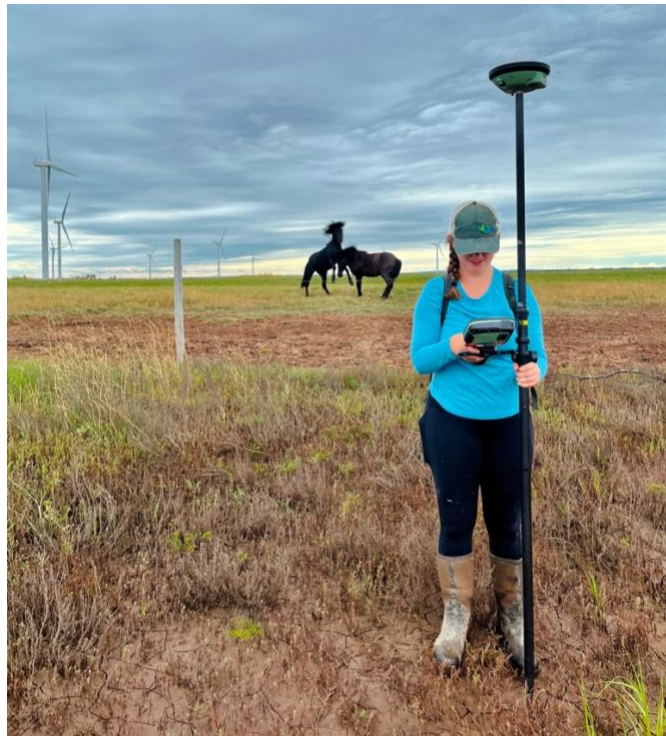
Figure 3.4. Measuring the location and elevation of survey stations using a Leica GS14 RTK GNSS unit on August 2, 2022. (Credit: TransCoastal Adaptations).

On August 2, 2022, the location and associated elevation of each vegetation survey station was staked out and measured with a Leica GS14 RTK GNSS unit (*Figure 3.4*). The points were marked using a survey flag and labelled for greater ease of recognizing each plot when returning to complete vegetation surveys.

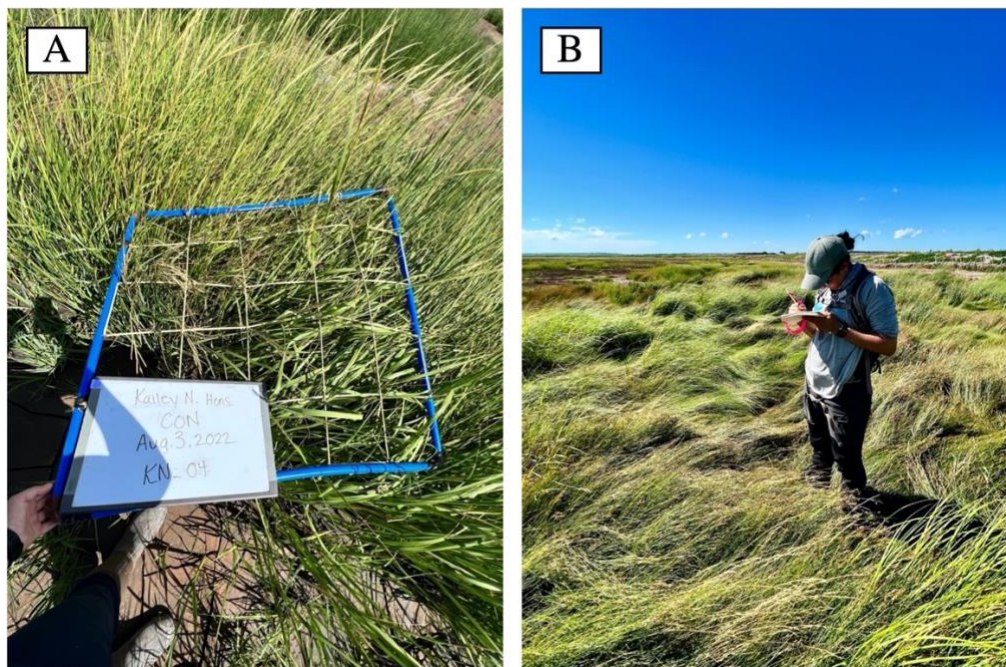
Figure 3.5. A) Quadrat placed over a vegetation plot; B) Documenting each species within a vegetation plot in the field notebook on August 3, 2022. (Credit: TransCoastal Adaptations)

vegetation from being trampled during the layout process. Once the quadrat was placed, each species that was observed within the quadrat was recorded, then a wooden dowel was held vertical to each sampling point until it reached the ground below. Each species that touched the rod was documented, and the process was repeated for each of the 25 intercept points at each station. A photo was taken at each station and a plant representing the dominant species within the plot was measured and recorded (*Figure 3.5*).

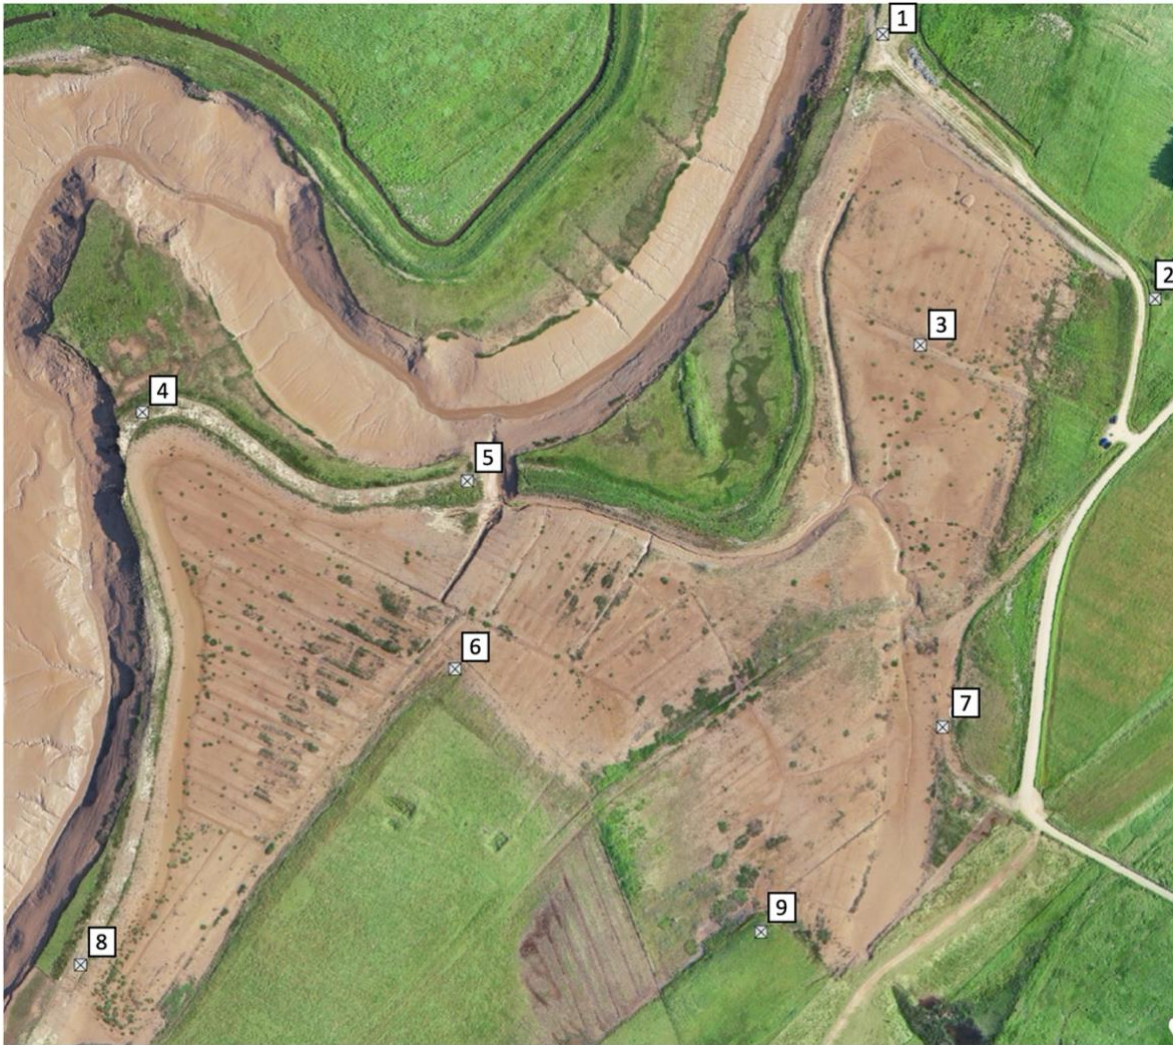
Figure 3.6. Approximate GCP deployment locations (n=9) at the Converse restoration site for the RPAS aerial survey. Background imagery collected July 25, 2021, with a DJI Phantom 4 RTK RPAS by CBWES Inc.

A total of 9 ground control points (GCPs) were deployed throughout the site prior to the survey. Each GCP location was measured using a Leica GS14 RTK GNSS unit (*Figure 3.6*). These targets and their surveyed positions were used to georeference the data products during photogrammetric processing. Validation points (n=100) were also collected across the marsh surface using the Leica unit in areas of bare mud surfaces.

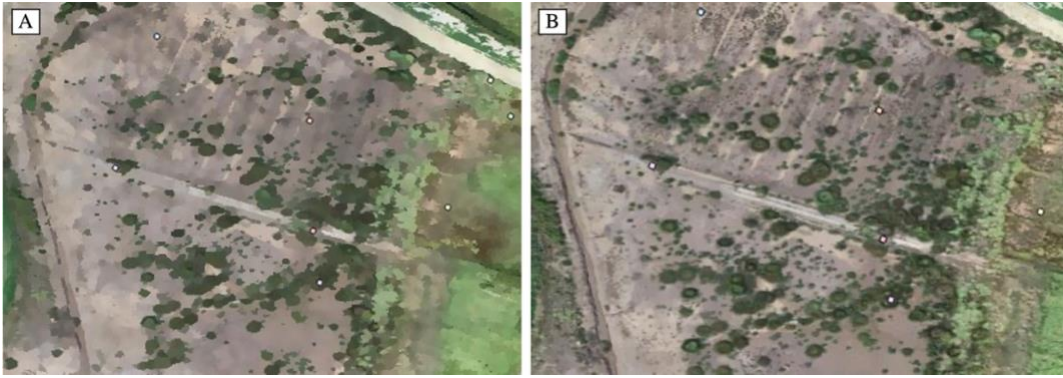
Figure 3.7. Screenshot of the result of changing the spectral detail in the image segmentation process: A) spectral detail = 15.00; B) spectral detail = 20.00.

The first step of the object-based classification was to run a segmentation on the 2022 orthomosaic imagery. The image segmentation process groups neighbouring pixels together based on similar spectral properties to inform the object-based classification, which then takes into account shape characteristics and neighbourhood relationships when assigning classes to the objects (Singh et al., 2021). The input parameters were manipulated until the desired level of detail was achieved. For example, increasing the spatial detail from 15 to 20 increased the visibility of smaller and more sparse patches of vegetation which were desired features in the output classification (*Figure 3.7*). The following parameters appeared to support the optimal segmented raster image: spectral detail = 19.00, spatial detail = 18.00, and minimum segment size in pixels = 2000.

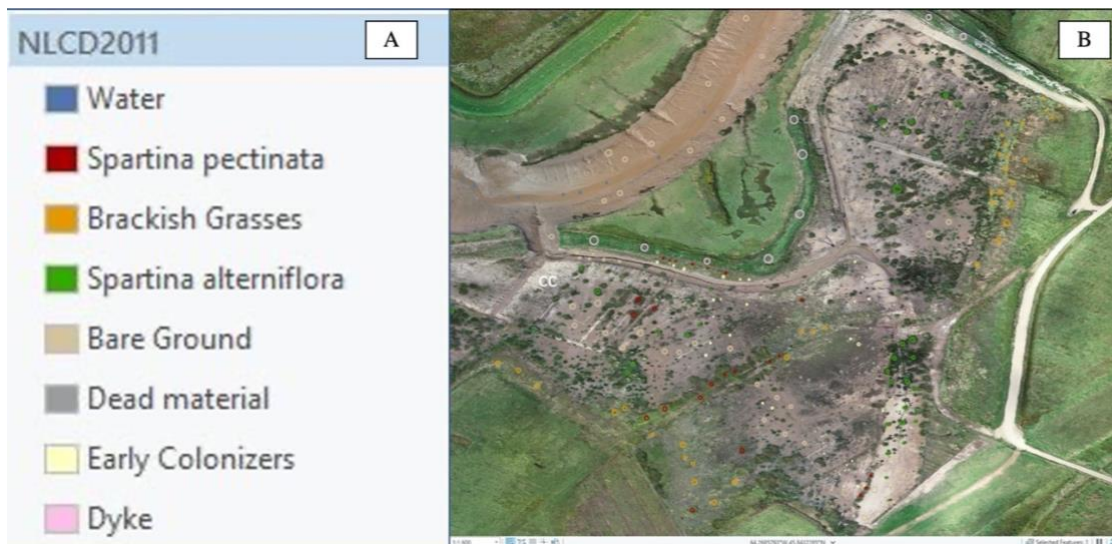
Figure 3.8. A) Classification schema selected for September 2022 imagery, B) Training samples generated from classification schema. Orthomosaic imagery was collected on September 6, 2022, by CBWES Inc.

Within ArcGIS Pro, the Classification Wizard tool offers a streamlined workflow to navigate the classification process. The 2022 orthomosaic imagery and segmentation were brought into the tool and the landcover classes were defined by the generic National Land Cover Database (NLCD) 2011 classification schema offered by ArcGIS Pro. In the Training Samples Manager within the Classification Wizard tool, the NLCD 2011 classification schema was altered to match the 2021 habitat map classes which are outlined in *Figure 3.8a*. Training samples were then generated for each class by drawing at least 20 polygons around known features of the desired class across the study area (*Figure 3.8b*).

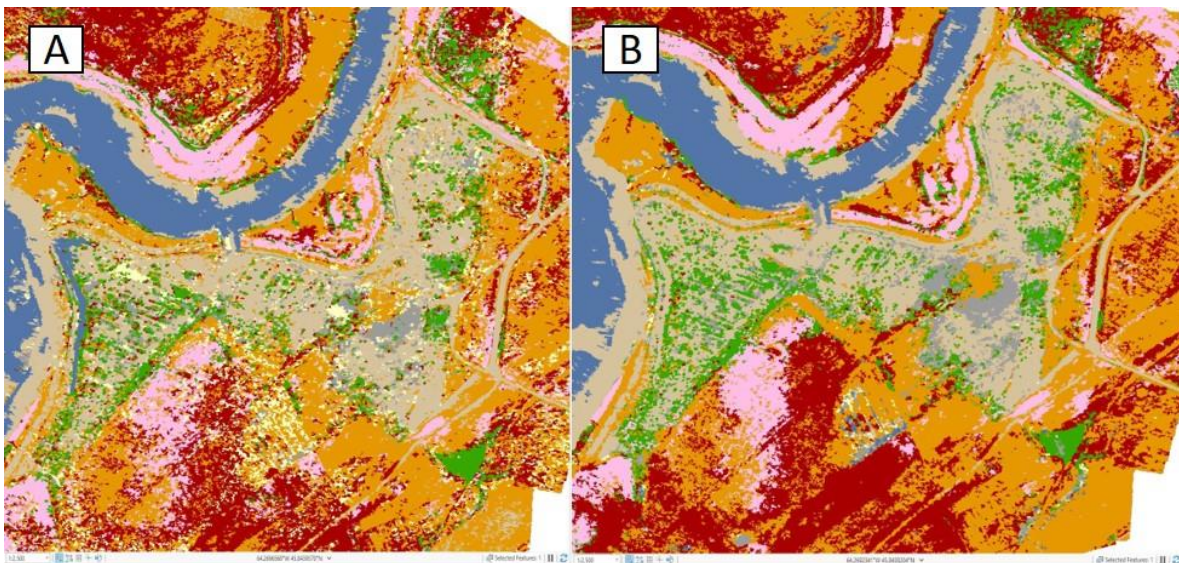
Figure 3.9. Comparison of different classifiers on the Converse imagery collected on September 6, 2022; A) Random Trees, B) Support Vector Machine.

The classifier page offers four different classification methods: ISO cluster, maximum likelihood, random trees, and support vector machine. The method used for this research was the support vector machine (SVM) as it is less susceptible to noise and an unbalanced number/size of training samples and widely used among researchers (ESRI, 2022). Random trees (RT) was investigated as an alternative method for the image classification process due to its popularity among other researchers (e.g. Akyol, 2020), though SVM appeared to provide more accurate results and displayed less noise in the data in the initial classification process (*Figure 3.9*).

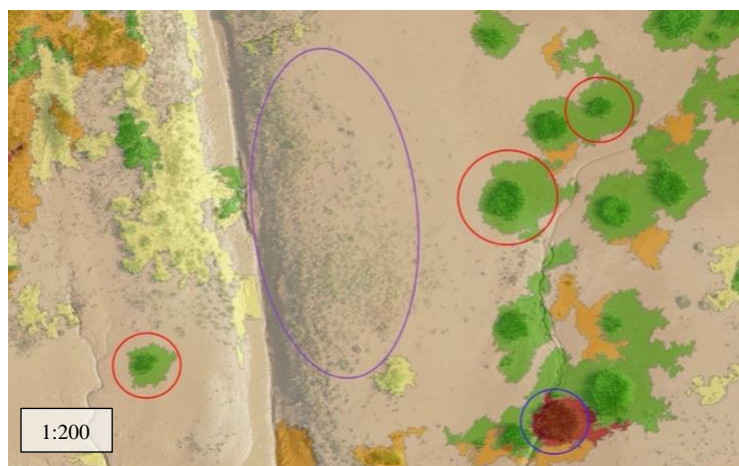
Figure 3.11. Examples of erroneous data within the classification, where red circles represent overclassified vegetation, blue circles represent misclassified vegetation, and the purple oval represents vegetation that was missed in the classification process.

Vegetation data was digitized and analyzed for the dominant plant species at each survey station. The stations (n=40) and their associated dominant vegetation species were imported into the ArcGIS Pro project as a point layer to serve as ground truthing points (Appendix A). The class name of the classified polygons intersecting the vegetation plots were assessed for accuracy between the SVM assigned class and the actual vegetation data and adjacent polygons were assessed based on their spectral and spatial similarity to the assigned plots. Due to the amount of vegetation missed as well as misclassified and overclassified polygons that were found, the dataset required extensive manual cleaning (Figure 3.11).

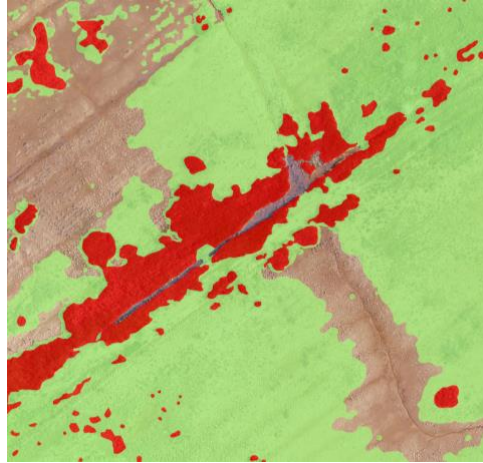
Figure 3.15. Example of the intersect output in ArcGIS Pro, with red polygons representing persistent vegetation into 2021 and green polygons representing new colonization in 2021.

New growth was determined from 2020-2022 using the extracted halophytes feature classes in the first step and the persistent halophytes feature classes. All halophytes from 2020 represented new colonization, therefore the extracted salt marsh species in the first step represented new growth. New colonization/expansion was determined in 2021 by inputting the 2021 halophyte feature class as well as the 2021 persistent halophytes feature class into the Erase tool. This essentially subtracted the persistent vegetation from the total halophytes in the study area, leaving only new colonization in the output layer. An area field was then added and populated using the Calculate Geometry tool. This process was repeated using the 2022 datasets to extract the new growth/colonization that occurred in 2022. These data were then mapped to assess where the persistent and new vegetation classes were occurring spatially and to visualize the general spatial patterns of vegetation colonization (*Figure 3.15*).

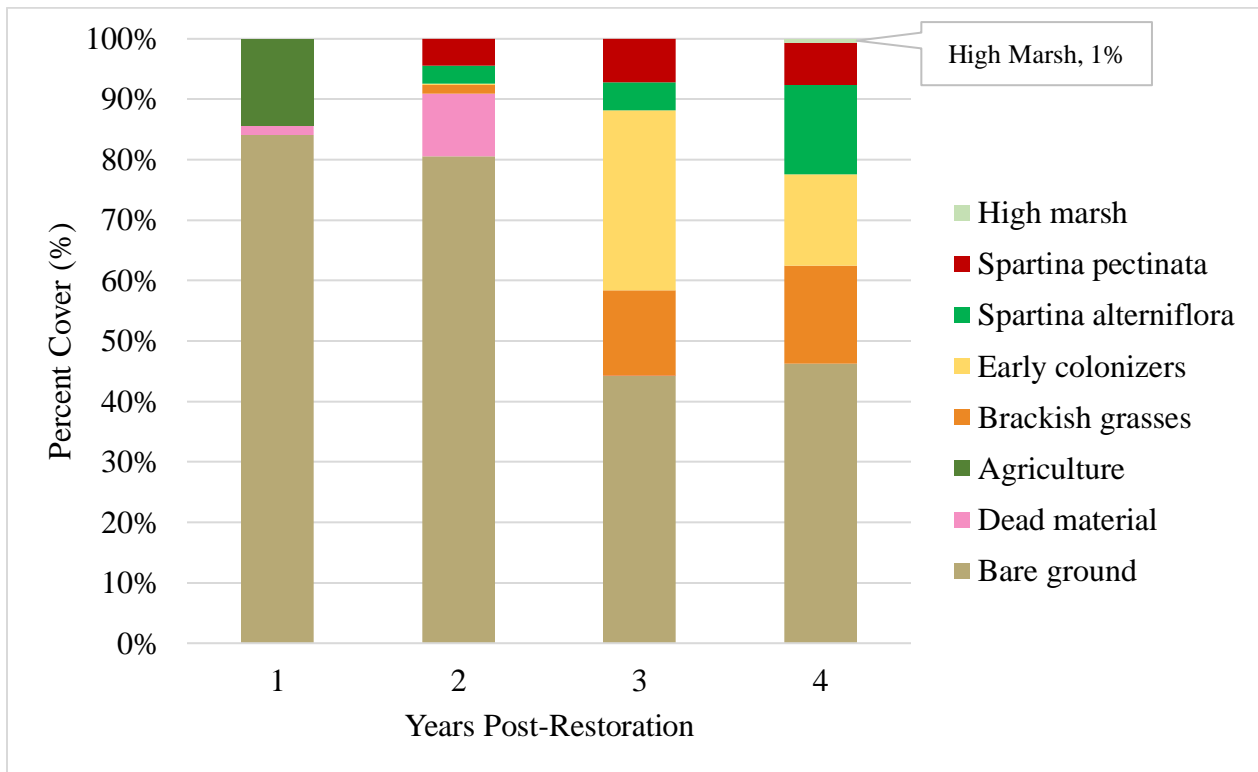
Figure 4.2. Stacked bar chart representing the percent cover of each class within the study area from year 1 post-restoration to year 4 post-restoration.

Generating habitat maps and class areas of the restoration site allows for ease of visual comparison of community structure year to year. In 2019 (Year 1 post-restoration), the Converse Marsh was dominantly characterized by bare ground (~85%), with remnants of its agricultural identity persisting (~15%) (*Figure 4.1a, Figure 4.2*). In 2020 (Year 2 post-restoration), bare ground still remained dominant in the site (~81%), though the agricultural vegetation had largely been replaced by *Spartina pectinata* and dead material (*Figure 4.1b*). Notably, this year offered the initial colonization of halophytic species and communities including *Spartina pectinata* (4%), *Spartina alterniflora* (3%), early colonizers (*Suaeda sp.*, *Salicornia sp.*)(<1%), and brackish grasses (*Juncus gerardii*, *Elymus repens*) (1%), though 10% of the study site was still characterized by dead vegetation (*Figure 4.2*). Year 3 post-restoration (2021) offered an approximate 40% reduction in bare ground area. There appeared to be rapid colonization of halophyte species, notably *Spartina alterniflora* (5%) colonization in the center and northwestern section of the site and bare ground dominance shifted toward early colonizer dominance (30%) (*Figure 4.1c, Figure 4.2*). Year 4 post-restoration (2022) demonstrated a reduction of early colonizers (15%) and increase in the target species, *Spartina alterniflora* (15%) (*Figure 4.1d, Figure 4.2*). It is also notable that a more even distribution of halophytic species and communities presented themselves in Year 4 compared to Year 3, though bare ground increased slightly (~2%) between years (*Figure 4.2*).

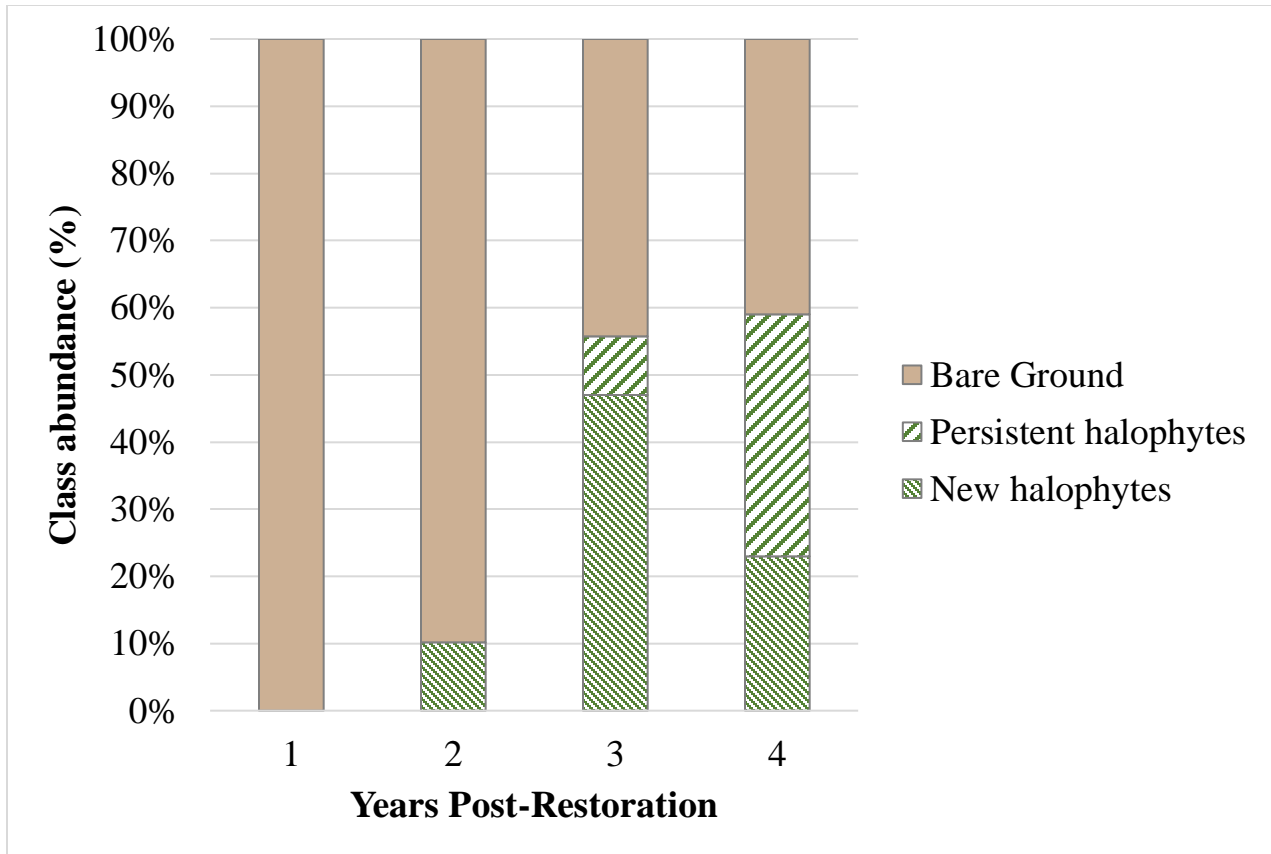
Figure 4.3. Stacked bar graph representing the abundance of bare ground, persistent halophytes, and new halophytes (new growth) from Year 1 post-restoration – Year 4 post-restoration.

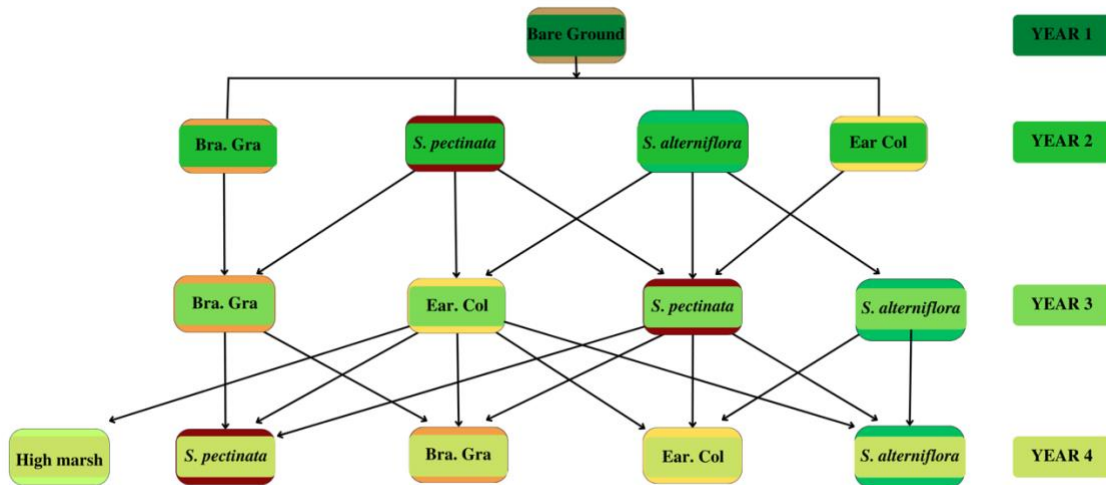
Figure 4.5. Schematic of the potential futures of each species from year 1 post-restoration to year 4 post-restoration derived from the output of the persistent vegetation analyses. Percentages of species transitioning from one to another <1%, were omitted.

By assessing the potential futures of each halophytic class, the limitations of the previous analyses were addressed by assessing if the persistent vegetation remains the same class the following year. In *Figure 4.5*, it is evident that polygons characterized by brackish grasses remained brackish grasses, though *S. alterniflora* and *S. pectinata* were replaced by several other classes in their respective spatial area from Year 2 to Year 3 post-restoration. Between Year 3 and Year 4, the areas characterized by a certain class either remained the same or were colonized or outcompeted by a different species/community (*Figure 4.5*).

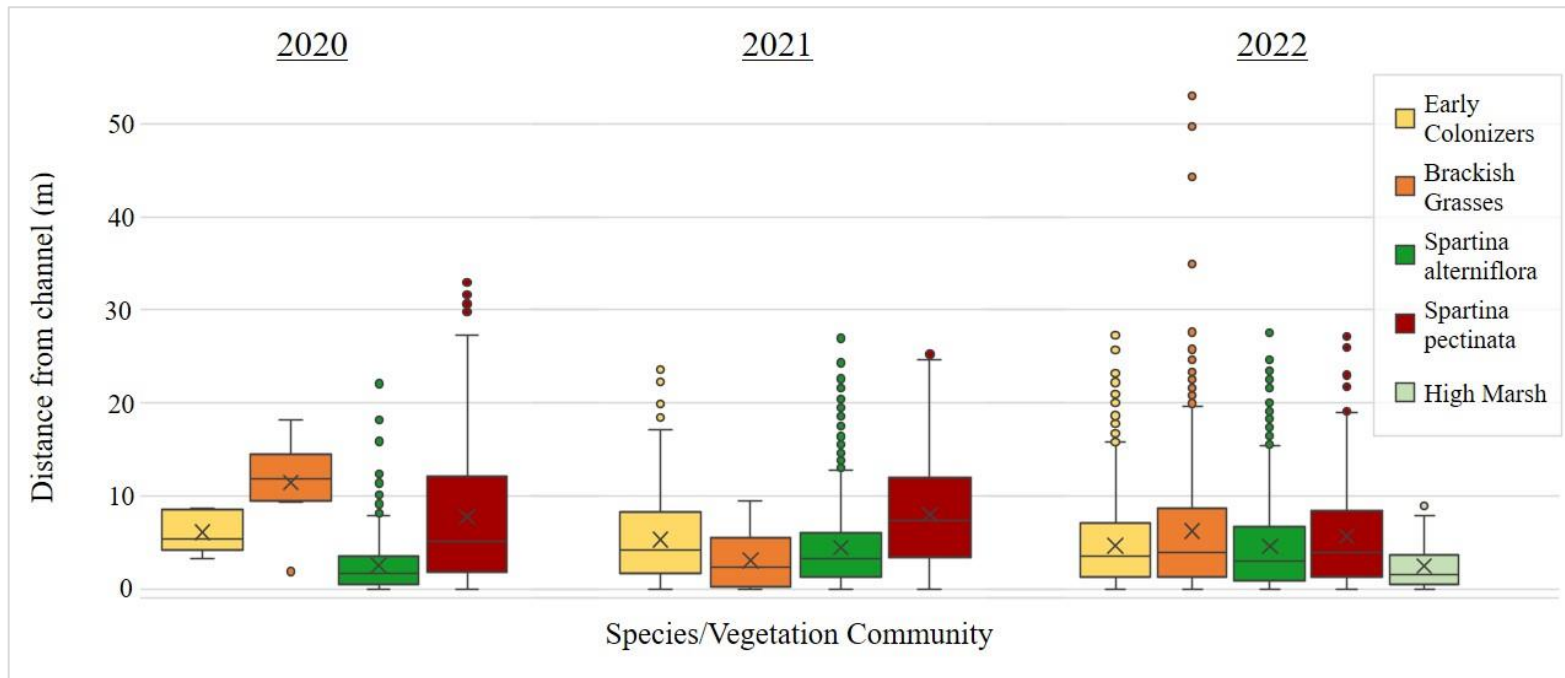
Figure 4.6. Box and whisker plot representing the distance (m) of each class relative to channel networks from 2020-2022

Due to the lack of consistent general patterns demonstrated in *Figure 4.6* and *Figure 4.7*, the correlation between vegetation colonization and channel networks is not strongly supported. Though it is evident that *S. alterniflora* is consistently proximal to channels (*Figure 4.6*) which is shown more prominently in the center and northern section of the study site, outlined by the circular patches with growth rings in *Figure 4.7C*.

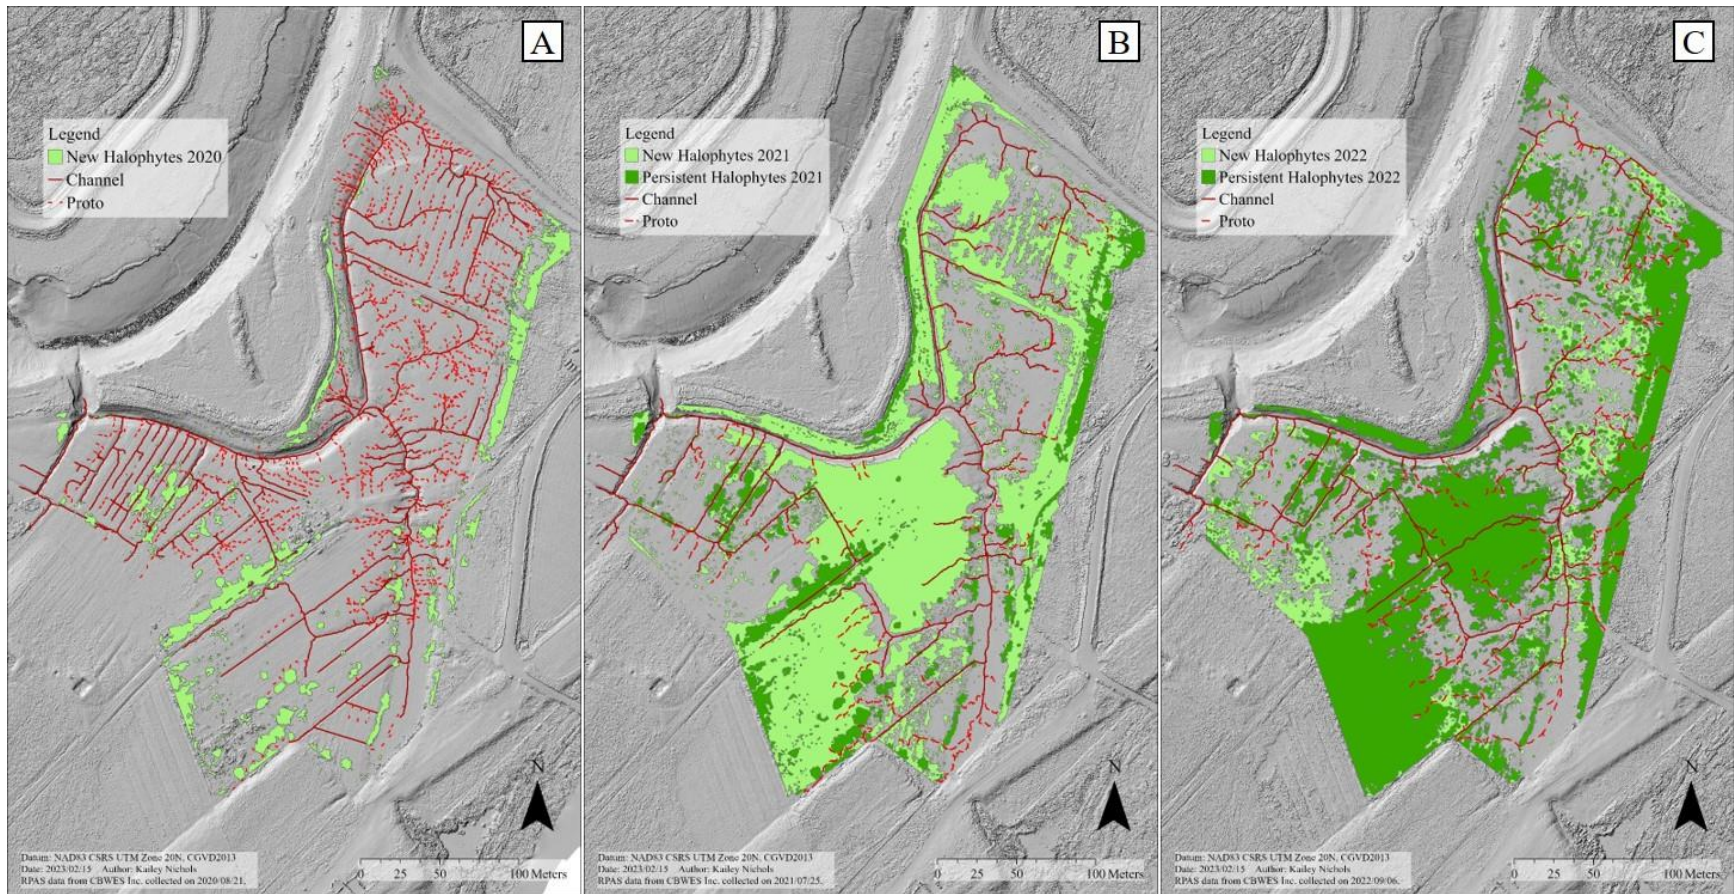
Figure 4.7. Relationship between channel networks and vegetation colonization in A) 2020; B) 2021; C) 2022. Light green represents new colonization, dark green represents persistent vegetation, solid red lines represent channels and dashed red lines represent protochannels.

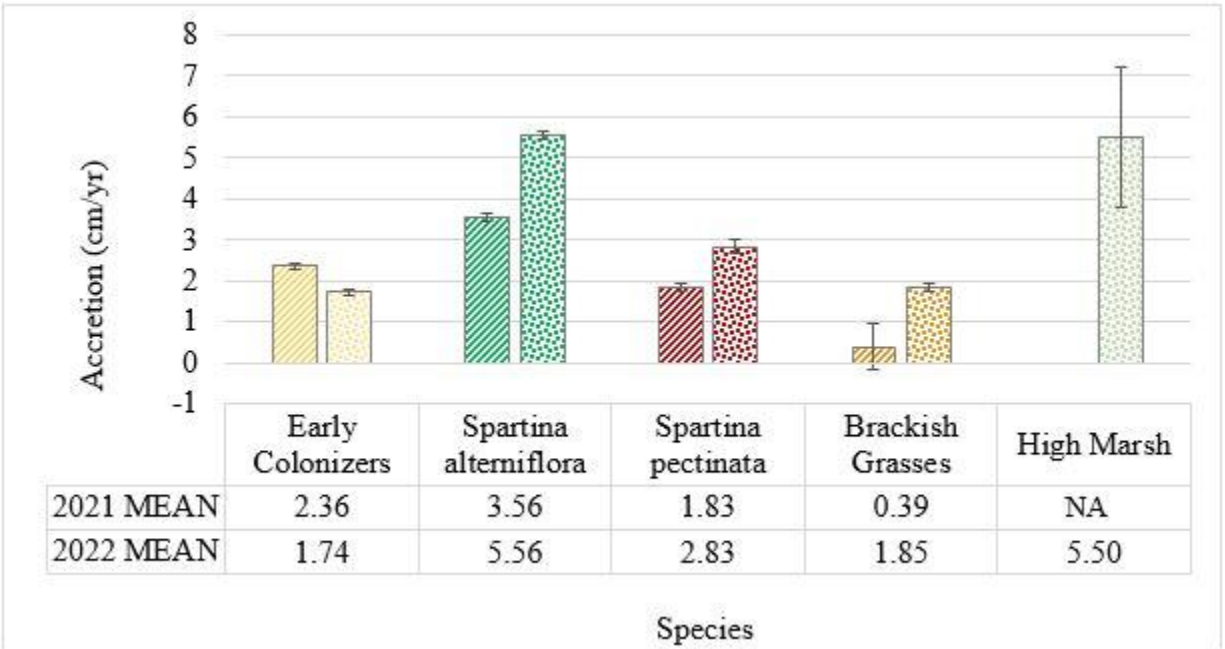
Figure 4.8. Average accretion rate extracted from the previous year's DoD for each halophyte/halophytic class representing new colonization in 2021 (hatched fill) and 2022 (dotted fill), with standard error bars.

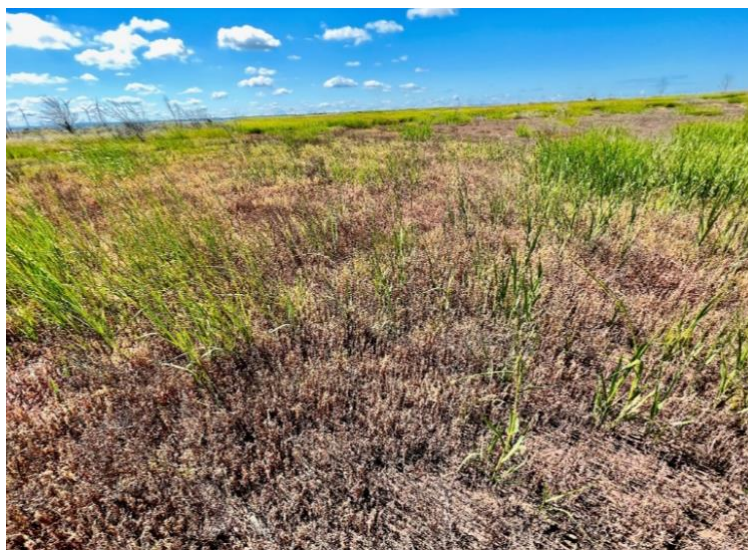
Figure 5.1. *Spartina alterniflora* colonizing among expansive patch of early colonizers (mostly *Suaeda sp.*) on August 2, 2022.

The expansive patches of annual halophytes represent primary salt marsh succession. Their presence promotes sediment accretion and facilitates the establishment of target perennial halophytes that characterize later successional stages (Mossman et al., 2012). This was demonstrated in Year 4 post-restoration as *S. alterniflora* represented a larger portion of the site and had begun to compete with *Suaeda sp.* in the low marsh zone (Figure 5.1). As a result, Year 4 post-restoration potentially represented a variation of the third stage of vegetative community succession outlined by Virgin et al. (2020). This was shown due to the mature consolidation of sediments and *S. alterniflora* had become more well established, though remained in equal abundance to the early colonists. It is also notable that high marsh had begun to encroach in the outer bounds of the site in Year 4, characteristic of the fourth phase of the vegetative community succession in managed realignment sites (Virgin et al., 2020). This shows that the Converse restoration site achieved each successional stage within a 4-year time frame and is on a positive trajectory towards complete restoration.

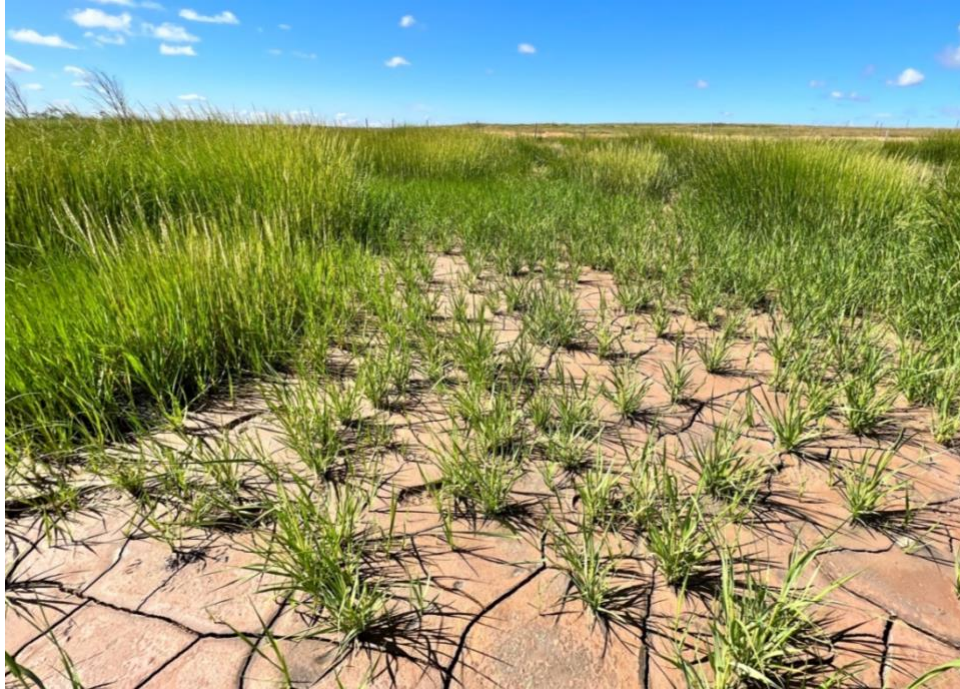
Figure 5.2. Mature patches of S. alterniflora beginning to merge via rhizome in August 2022.

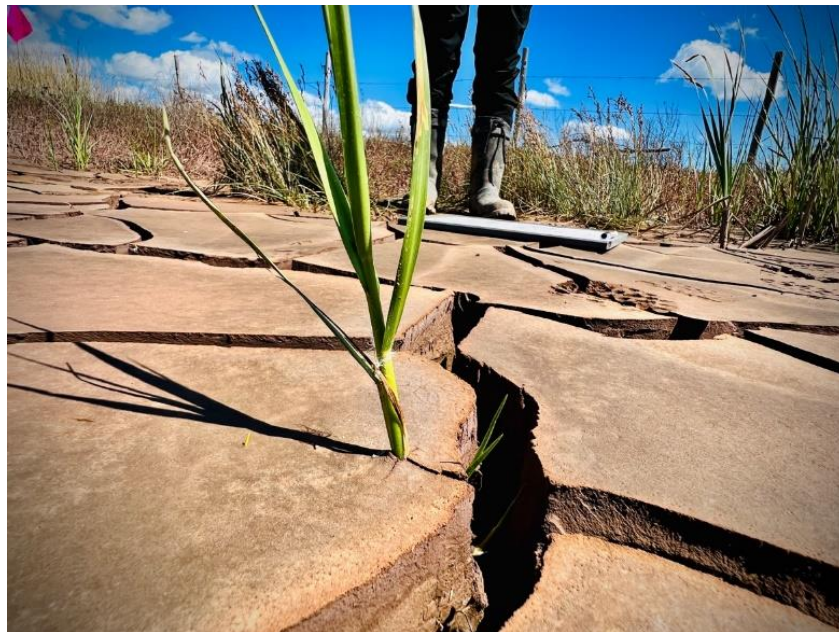
Figure 5.3. Colonization of S. alterniflora via seed trapping in cracked sediment.

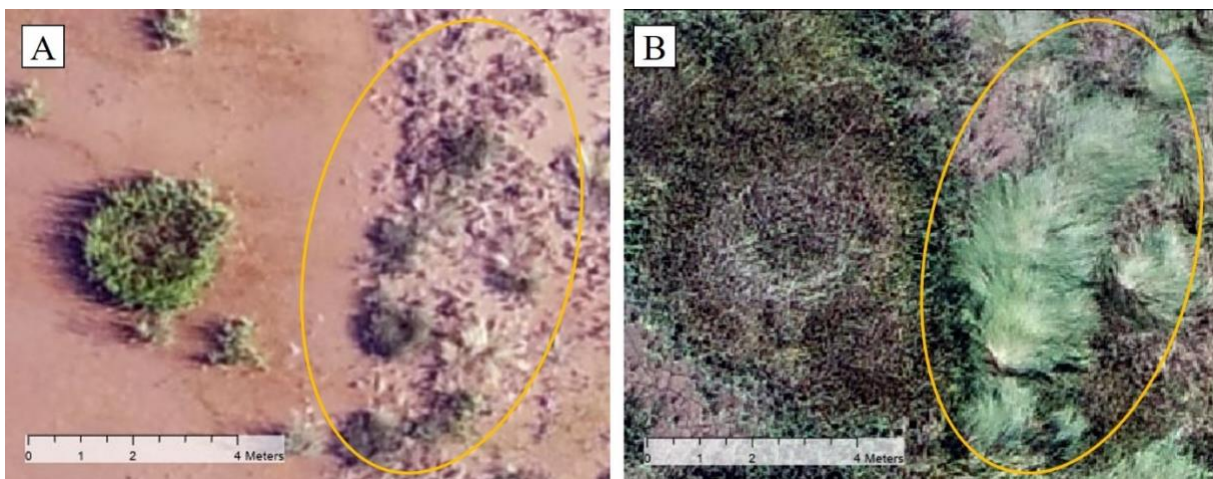
Figure 5.4. Mature patch of *S. patens*, greater than 4 m long that had not been there the year before: A) 2021, B) 2022.
