"An Integrative Approach to Prioritizing and Restoring Aquatic Habitat Connectivity in a National Park Setting: the Case of Kejimikujik"

A Thesis Submitted to

Saint Mary's University, Halifax, Nova Scotia

July, 2014, Halifax, Nova Scotia

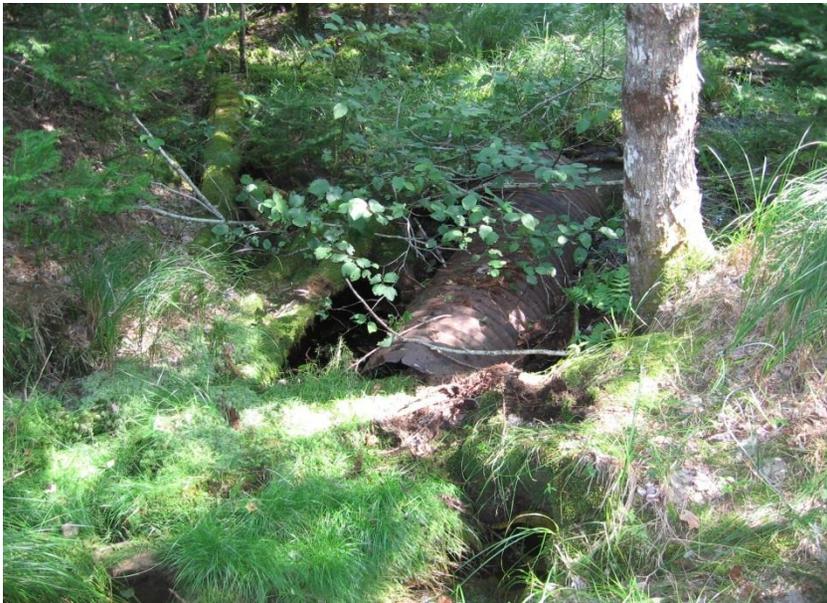
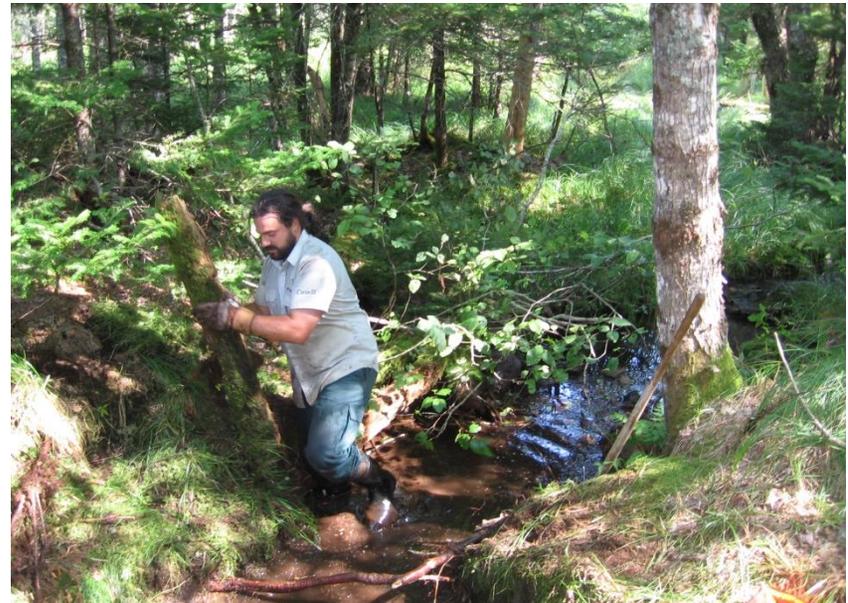
**Appendix E. CUL 176 Powerline  
UTM X 323106.96, UTM Y 4916136.65  
Pre Restoration Passability 0.5  
Post Restoration Passability 1  
Barrier type: Blockage**

Pre Restoration

Post restoration

31<sup>st</sup> 2010, CUL 176 Powerline (Appendix E) was restored (prior to the other sites ranked higher on the DCI list) as parks staff had the internal capacity to properly carry out the work (which in this case was simply clearing debris and the old culvert out of the stream). Likewise, on September 1<sup>st</sup> 2010, a fish ladder was installed in CUL 014 Rogers Brook (Appendix F) and on September 2<sup>nd</sup> 2010, CUL 055 Square Camp Brook (Appendix G) was replaced “in house” (meaning by park staff with park equipment) with a culvert having sufficient diameter to handle the flow. On September 9<sup>th</sup> and 10<sup>th</sup> 2010, contractors removed the full barrier and erected a bridge at CUL 099 Flowing Waters Trail (Appendix H). In the summer of 2011, while awaiting DFO approval for CUL 035 Big Dam Road and CUL 038 Canningfield Road, restoration at CUL 112 ben Lake trail (Appendix I) took place (which similar to CUL 176 simply required debris clearing). With the “go ahead” from DFO and the certified contractor finally available, on September 21<sup>st</sup> 2011, CUL 035 Big Dam Road (Appendix J) was replaced with a structure having appropriate diameter to handle the flow. A step by step restoration description for each site can be accessed by contacting Resource Conservation at Kejimikujik. Photos and maps of each of the 8 potential Restoration sites can be found in the Appendix.

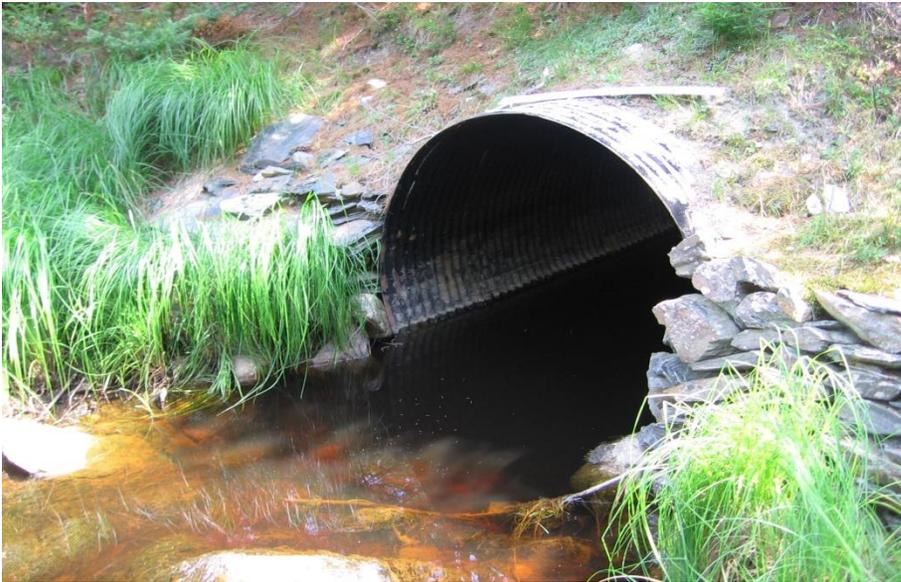
**Appendix F. CUL 014 Rogers Brook  
UTM X 323102.91, UTM Y 4919558.80  
Pre Restoration Passability 0.81  
Post Restoration Passability 1  
Barrier Type: Velocity**

Pre Restoration

Post Restoration diagram

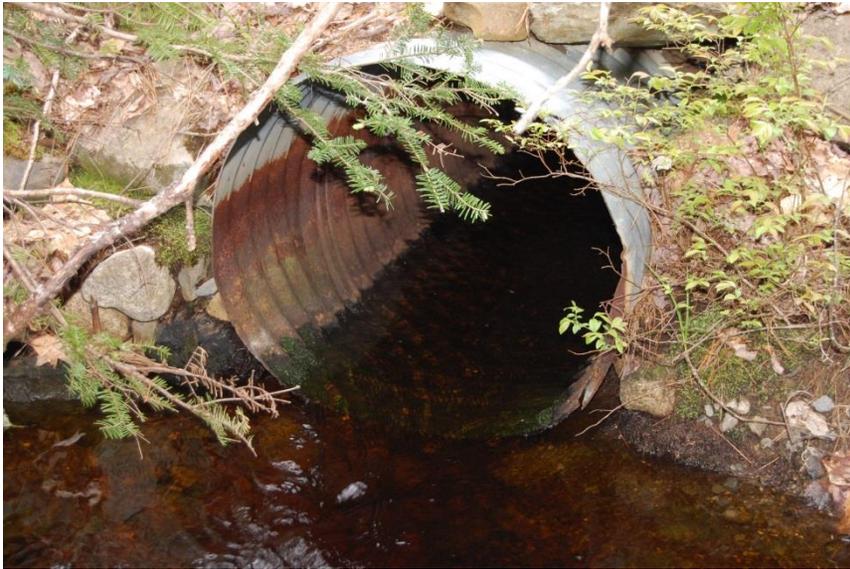
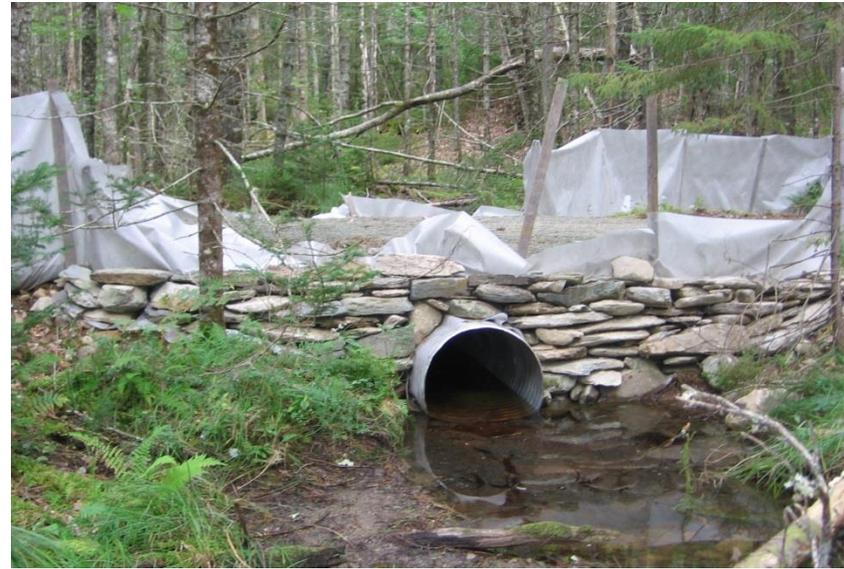
**Appendix G. CUL 055 Square Camp Brook**  
**UTM X 323742.97, UTM Y 4909601.78**  
**Pre-Restoration Passability 0.7**  
**Post Restoration Passability 1**  
**Barrier Type: Velocity**

Pre Restoration

Post Restoration

The first such restoration site was CUL 055 (Square Camp Brook), restored “in house” on September 2<sup>nd</sup> 2010. Interestingly, due to extremely dry weather during the time of work, there was no flowing water at the site and therefore water quality and suspended sediment data are missing for this period (as seen in Figures

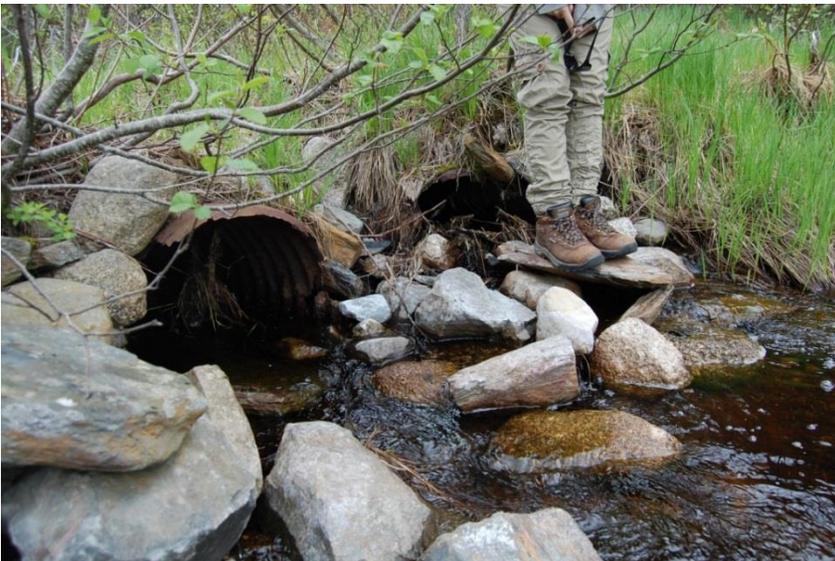
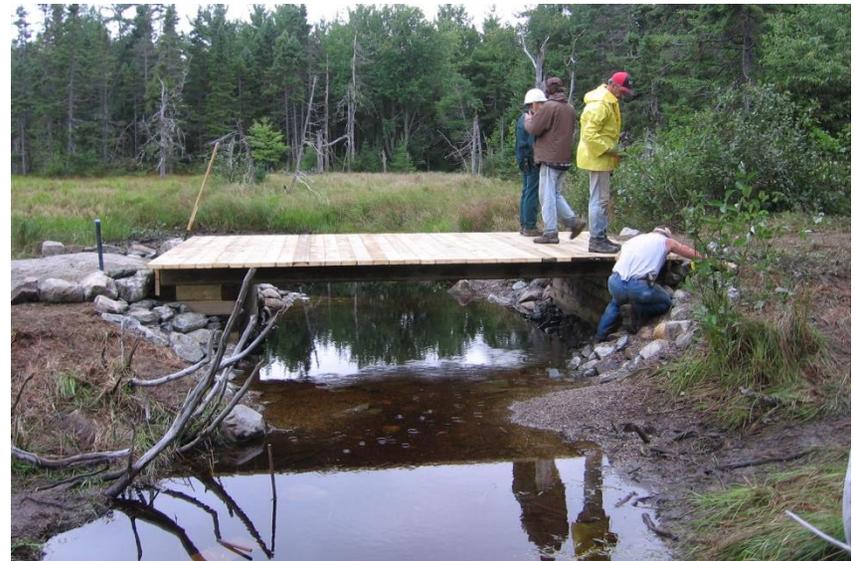
**Appendix H. CUL 099 Flowing Waters Trail**  
**UTM X 321311.74, UTM Y 4922057.64**  
**Pre Restoration Passibility 0**  
**Post Restoration Passibility 1**  
**Barrier Type: Collapsed Culvert**

Pre Restoration

Post Restoration

The second restoration site requiring heavy equipment was CUL 099 (Flowing Waters Trail), restored on September 9<sup>th</sup> and 10<sup>th</sup> 2010. The figures below regarding CUL 099 were derived from 35 samples collected between June 29<sup>th</sup> 2010 and October 15<sup>th</sup> 2010. 9 of these samples were collected during the in-stream work (values between the red lines in each figure).

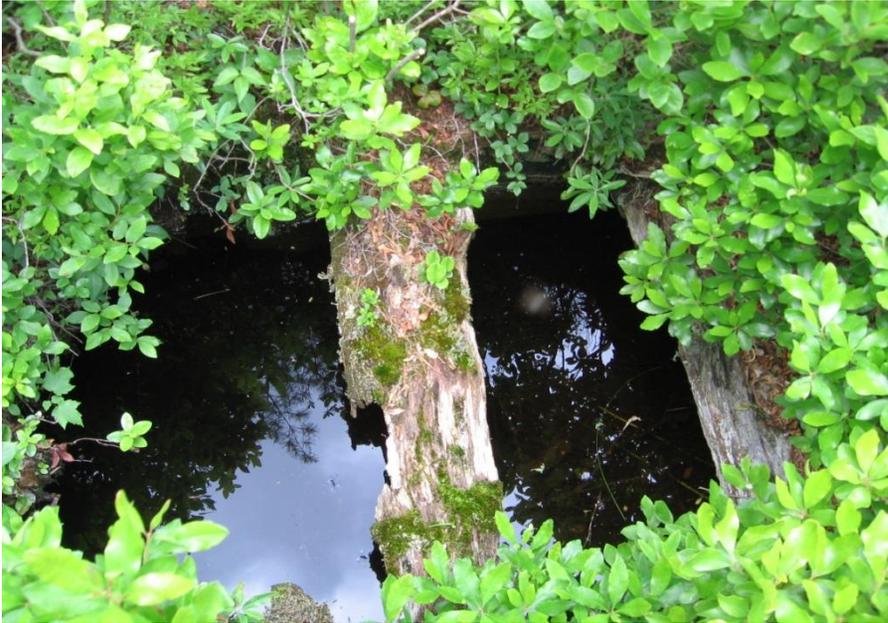
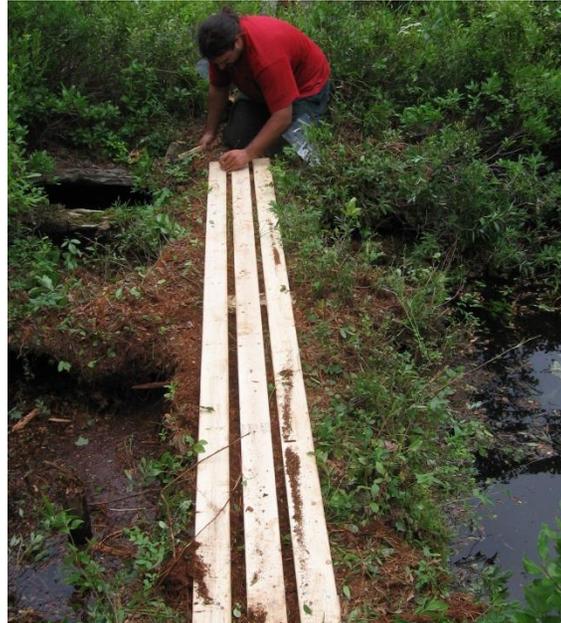
**Appendix I. CUL 112 Ben Lake Trail  
UTM X 313539.52, UTM Y4913207.77  
Pre Restoration Passability 0.5  
Post Restoration Passability 1  
Barrier Type: Debris**

Pre Restoration

Post Restoration

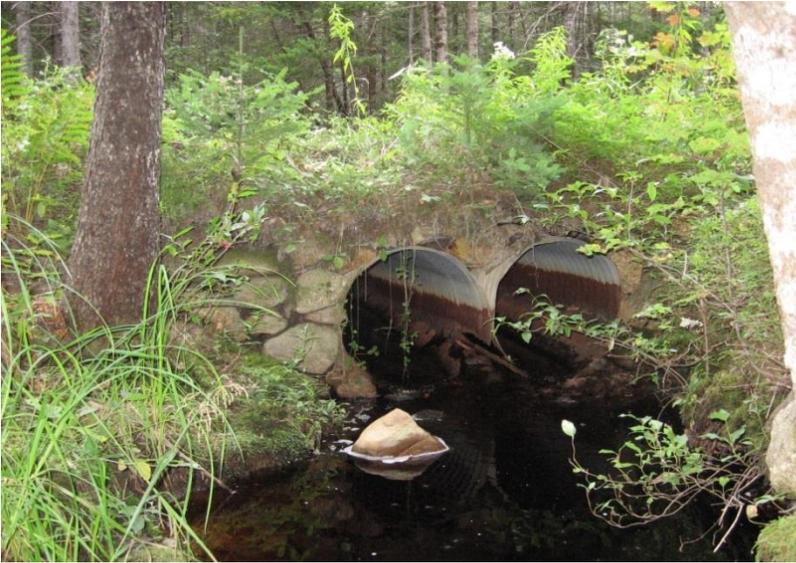
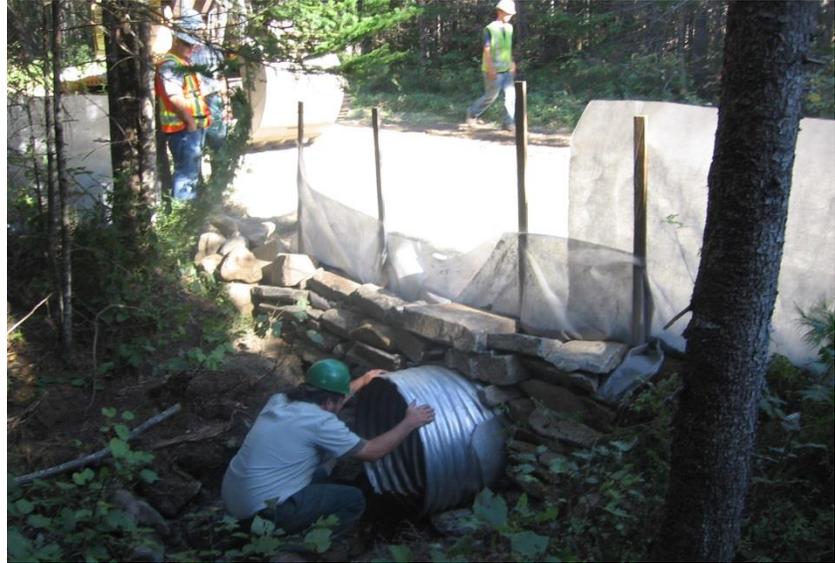
**Appendix J. CUL 035 Big Dam Road**  
**UTM X 320915.68, UTM Y 4922186.96**  
**Pre-Restoration Passability 0.86**  
**Post Restoration Passability 1.00**  
**Barrier Type: Velocity**

Pre Restoration

Post Restoration

The final restoration site requiring significant habitat alteration was CUL 035 (Big Dam Road), where restoration occurred on September 21<sup>st</sup> 2011. Because this structure was restored in 2011 (and therefore more pre monitoring data existed), the figures below were constructed using 51 readings, 9 of which were taken during restoration.

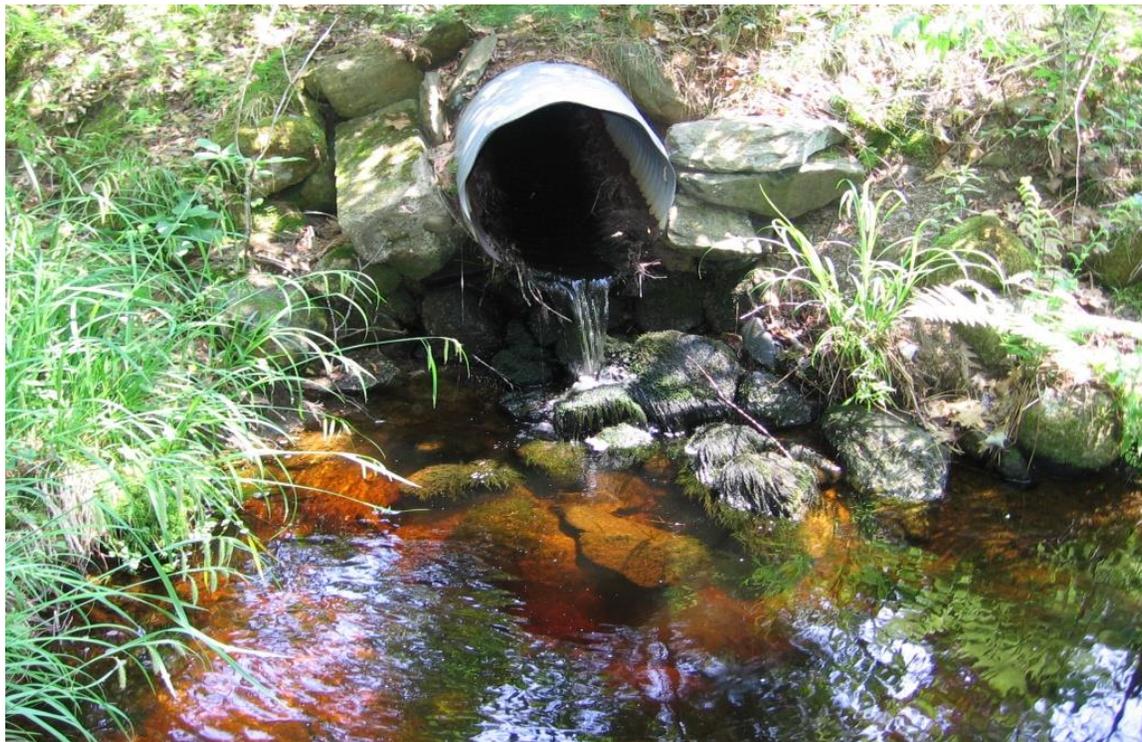
**Appendix K. CUL 038 Canningfield Road**  
**UTM X 324331.58, UTM Y4918822.22**  
**Pre Restoration Passability 0**  
**Post Restoration Passability N/A**  
**Barrier Type: Outlet Drop**

To date, and although the materials have been purchased to properly replace the existing culvert with a bridge, Kejimikujik has yet to hear back from DFO regarding approval or recommendations on the proposed habitat alteration at CUL 038 Canningfield Road (Appendix K). This is unfortunate as all three prioritization schemes
