**ASSESSING COASTAL VULNERABILITY TO SEA LEVEL RISE IN ST. LUCIA
AND THE RESILIENCY OF BEACHES**

by Frejhan Jn Baptiste

Honors Research Project: Environmental Science

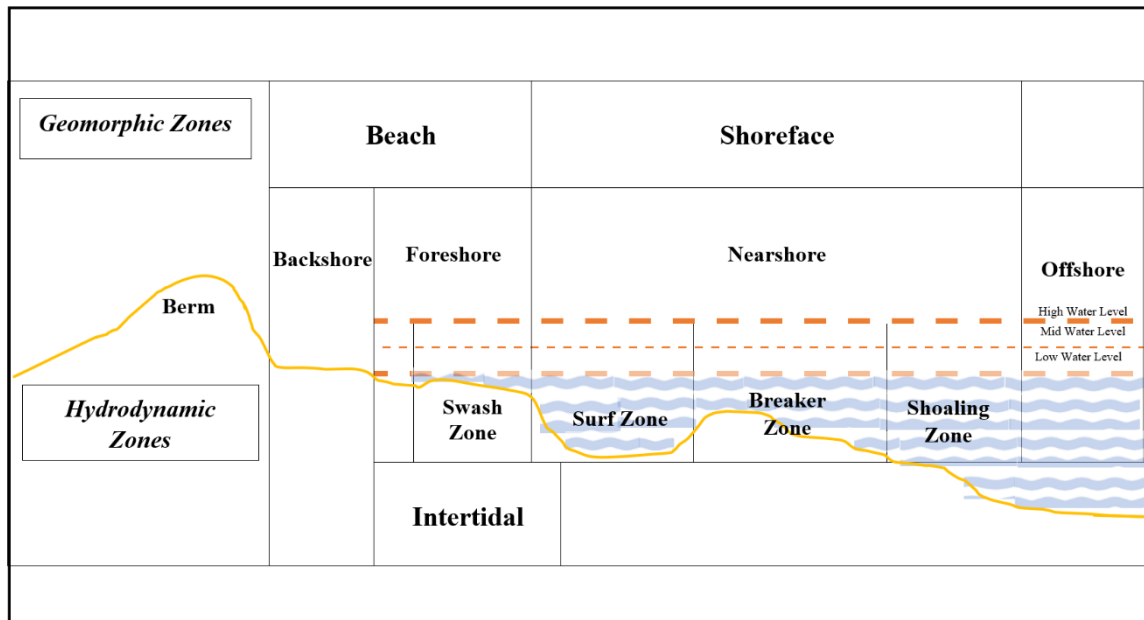
Figure 1.1 Cross sectional profile of coastal zones modified from Davidson-Arnott et al., (2019)

The coast or beach is divided into different zones based on where the waves break and where erosion and accretion occur. This allows us to identify the various locations of the foreshore, backshore and nearshore used for surveying (*Figure 1.1*).

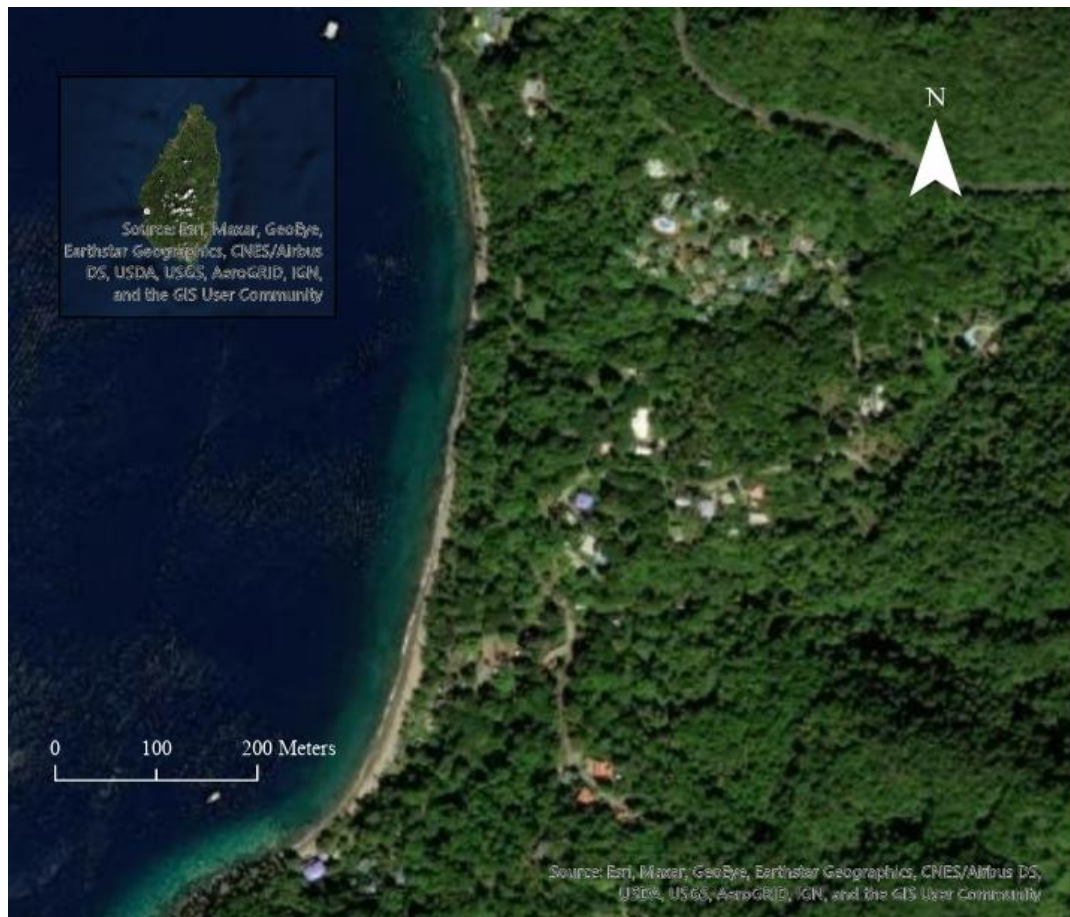
Figure 2.3 Map of Malgretoute Beach

Malgretoute Beach is a ~187m long beach with a combination of rocky and sandy shore located on the West coast of the island (*Figure 2.3*). The beach is bordered by coral reefs similar to Anse Chastanet Beach with a 20-39% coral cover as when assessed in 2015. It is commonly utilized for recreational activities such as yachting and other watersports (Kramer *et al.*, 2016).

Malgretoute Beach generally has more of an undeveloped foreshore and backshore. Comparing historic satellite imagery on Google Earth Pro, there is a clear decrease in the length of the sandy shore from ~530m in 2007 to 381m in 2020. Images also suggest a general decrease in anthropogenic structures in the backshore. It should be noted however, the location of these structures were not part of this assessment.

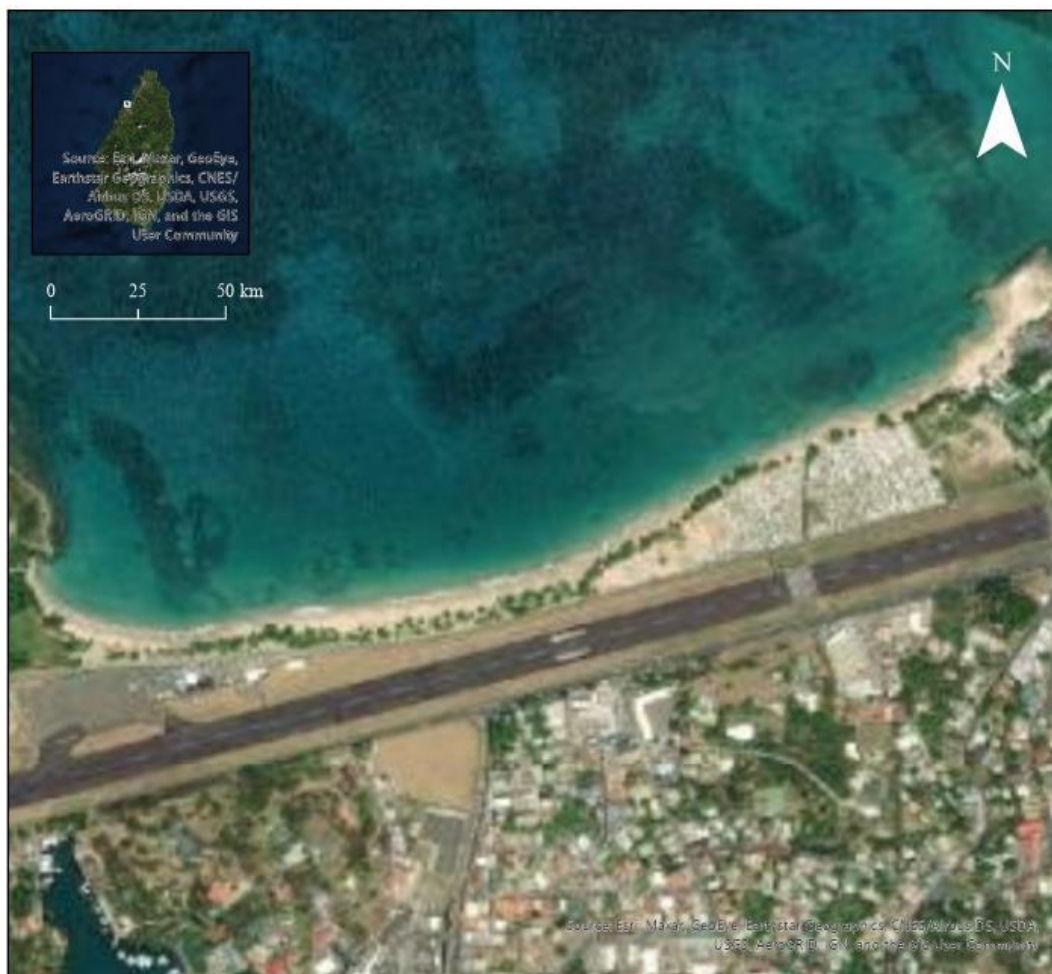
Figure 2.4 Map of Vigie Beach South

Vigie Beach, located in the North West of the island, has been divided into 2 separate beaches identified as Vigie South (~711m) and Vigie North (~1411m). The surrounding waters of Vigie South has estimated to have a coral cover of 10-20% as of 2015 (Kramer *et al.*, 2016). The surrounding backshore is composed of anthropogenic infrastructure including buildings, roadbeds and a cemetery which has been utilized since the First World War (Commonwealth War Graves Commission, 2020) as visible in *Figure 2.4*.

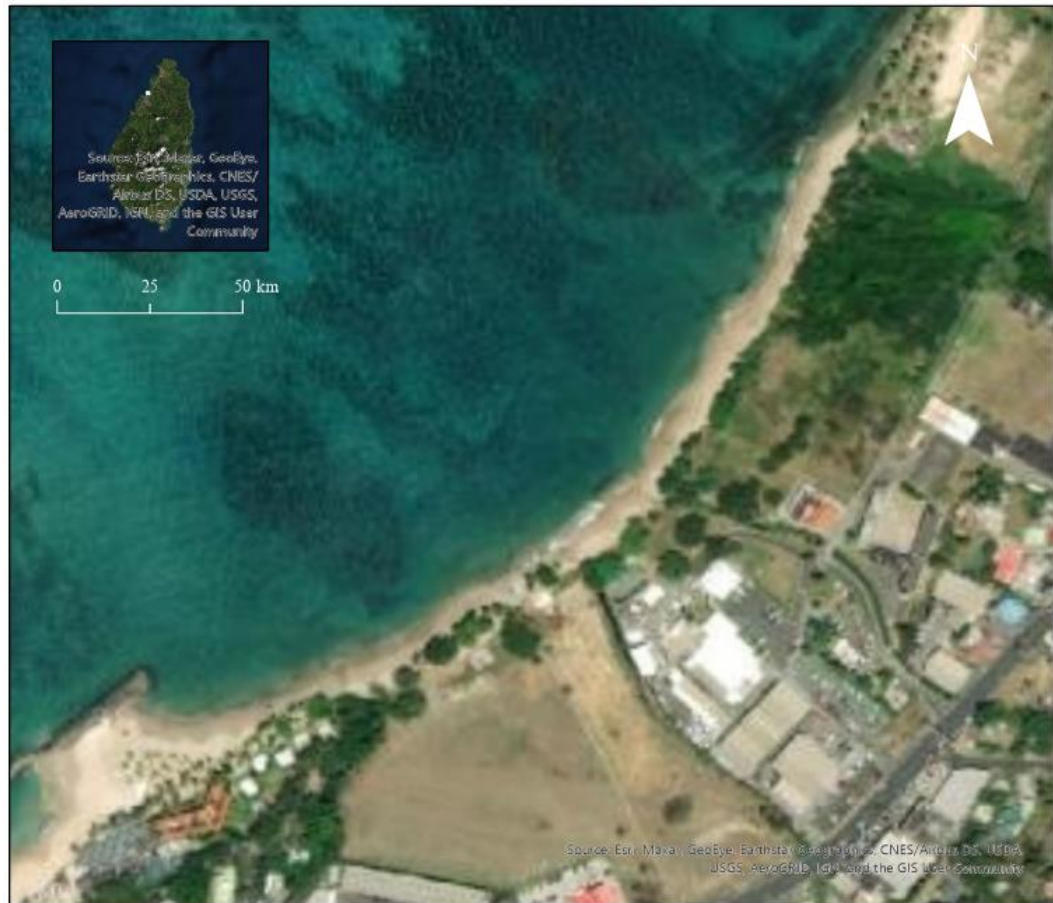
Figure 2.5 Map of Vigie Beach North

Vigie North was identified as the section of the beach beyond the man-made detached breakwater and groyne. This section of the beach consists of raised bedrock in the foreshore and natural dense vegetation in the backshore (*Figure 2.5*).

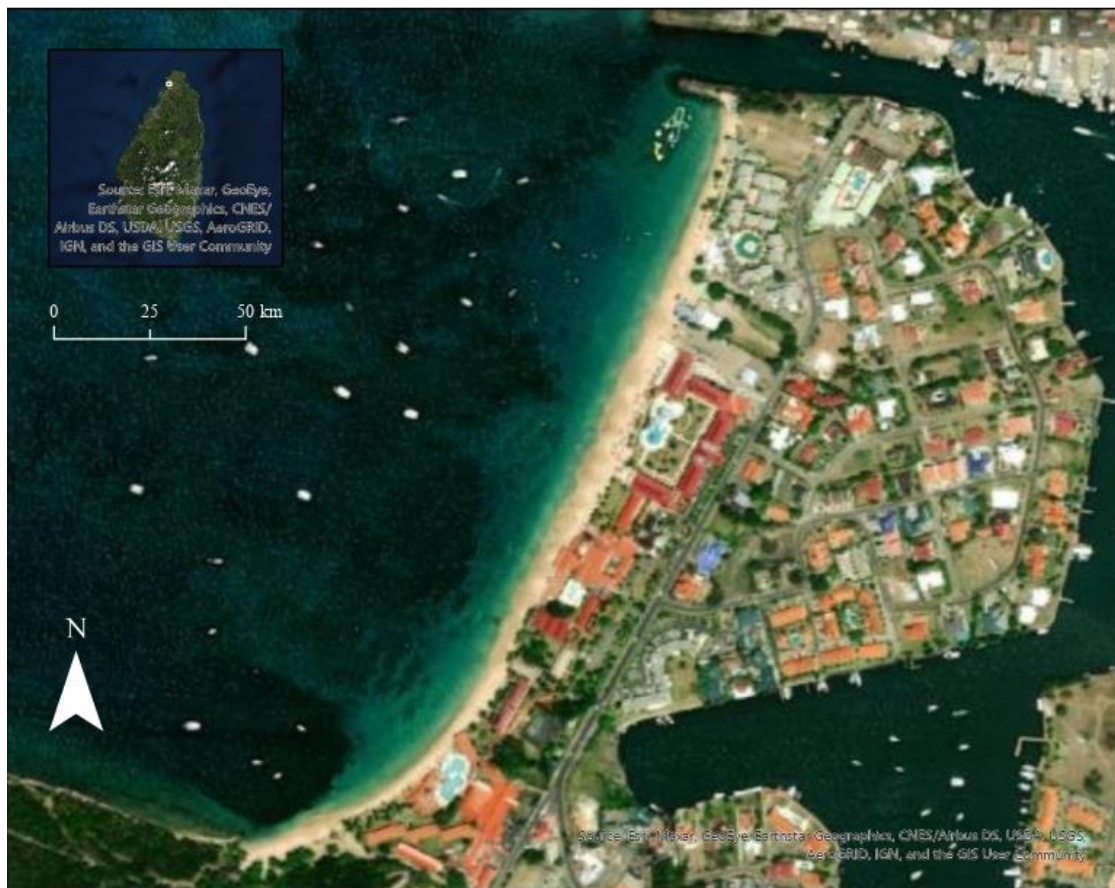
Figure 2.6 Map of Reduit Beach

Reduit Beach is 960m in length where 80% of the backshore of the beach consists of anthropogenic structures i.e. buildings or roadbeds. This coastal area is also near a marina in the Northern fishing community of Gros Islet. This beach is commonly used for recreational activities and watersports such as yachting jet skiing (*Figure 2.6*).

Redit beach for instance, has a heavily anthropogenized backshore as displayed in *Figure 2.6*. Coastal squeeze is particularly evident in the area near profile C. For continued use of these coastal resources, beach nourishment may be the best choice for this beach. The gryone to the north of the beach and the headland to the south, will ensure added sediment will remain. Observable sediment variation (from fine grained sand to mixed gravel sand)

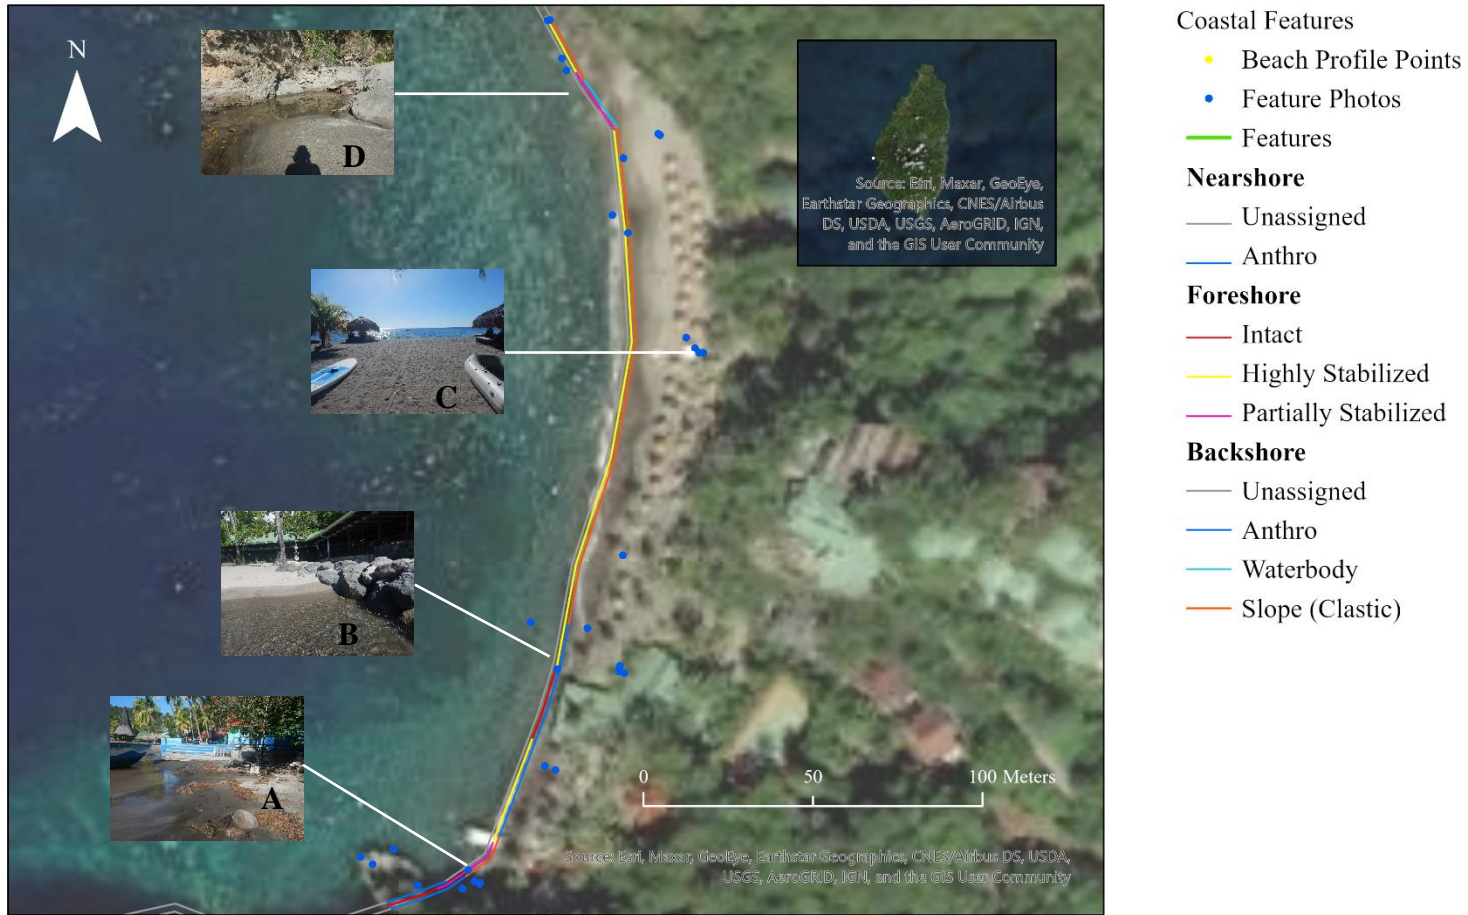
Figure 3.3 Anse Chastanet coastal characterization map and significant profile points

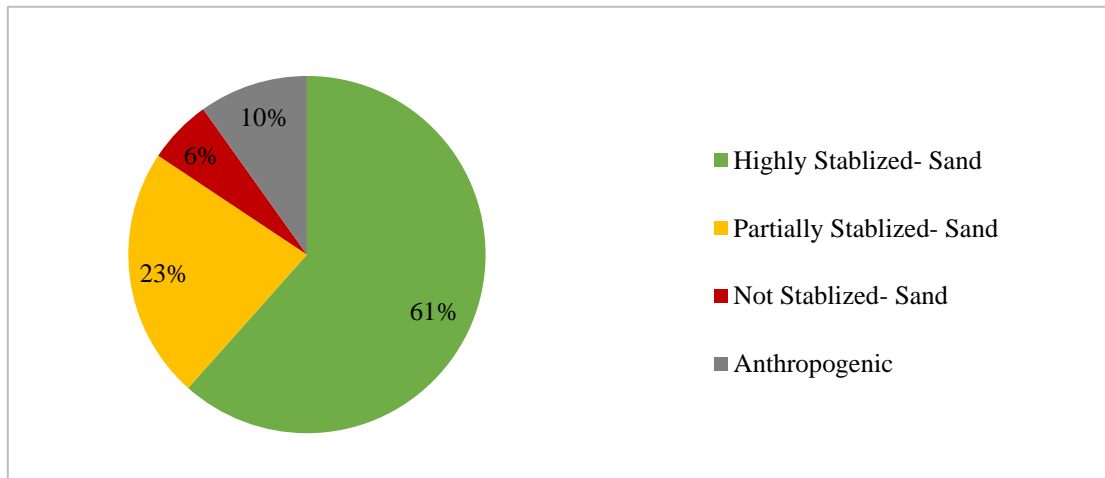
Figure 3.8 Foreshore coastal characterization of Vigie South

The Vigie South foreshore is composed of a clastic slope (90%), with one anthropogenic feature- an intact groyne, which encompasses 10% of the foreshore. Sixty two percent (62%) of the coastline was considered highly stabilized, with 1% of this characterized as a cobble slope as opposed to a sandy slope. Similar to the Pigeon Island Causeway, this section of the beach was present at the end of a cliff head. The non stabilized (6%) and partially stabilized (22%) portion of the foreshore was located at the same point of the

profile as the cemetery, and exposed gabion baskets, as well as the cobble backshore. There are distinct natural features within the nearshore. However, there is a groyne in the intertidal zone separating Vigie North and South as well as a detached breakwater part of the Vigie South nearshore zone (Figure 3.9 photo D).

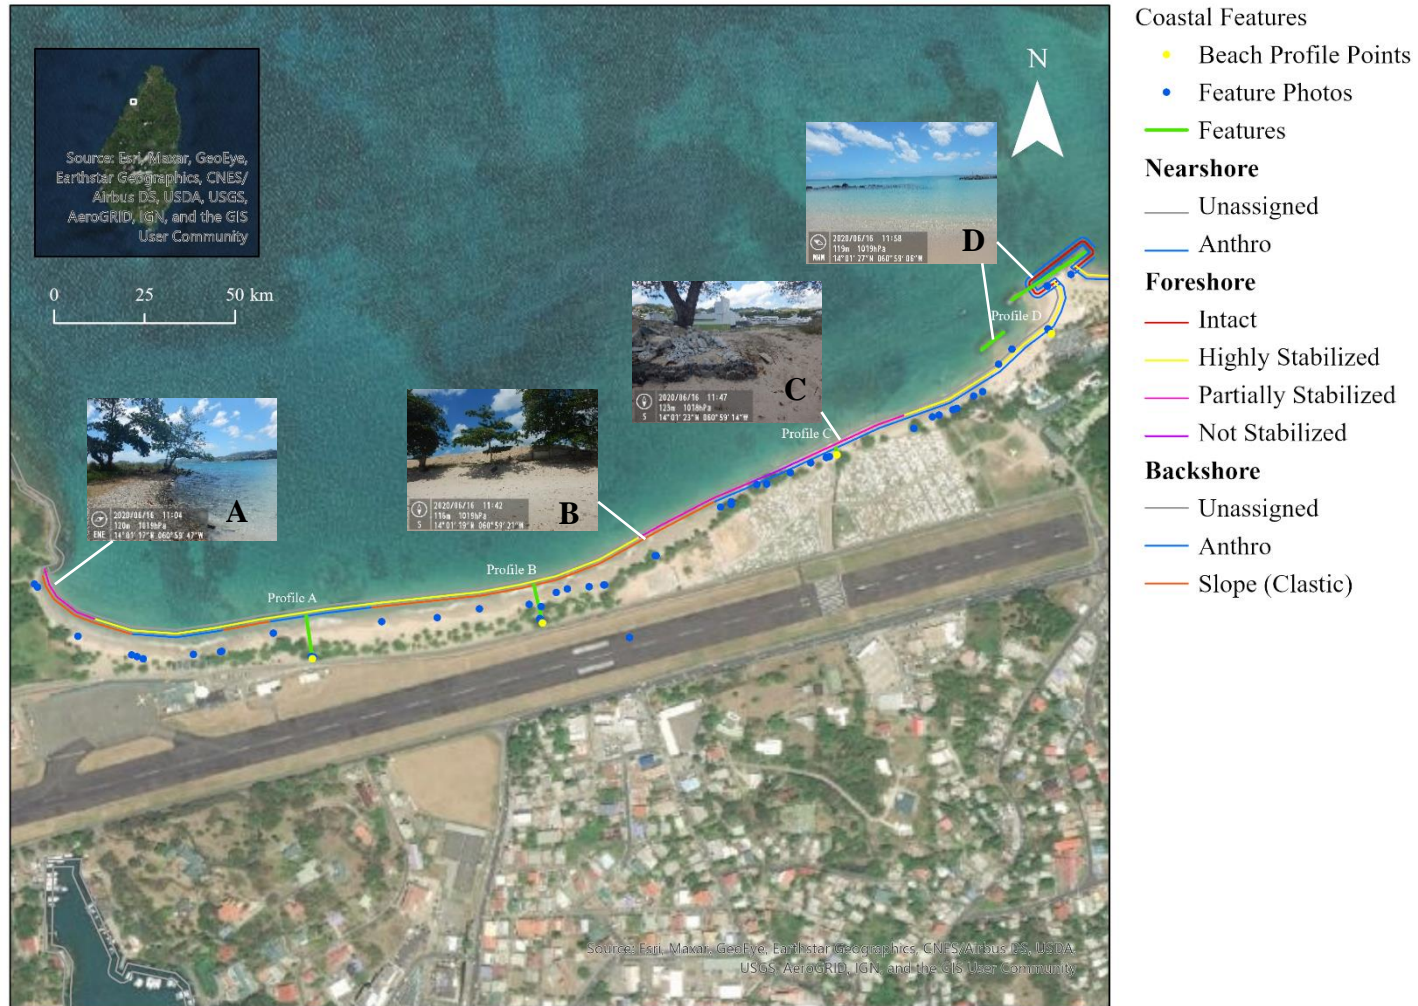
Figure 3.9 Vigie Beach- South coastal characterization map and significant profile points

The backshore composition of Vigie Beach South is the most diverse of all those assessed. Sixty five percent (65%) of Vigie South has been characterized by having an anthropogenic backshore. This comprises of a roadbed, gabion baskets, both concrete and wooden buildings, as well as remanences (masonry) of pre-existing buildings. Of these anthropogenic structures, 43% is intact, 15% of these are damaged, and 7% is failing. The remaining 45% of the beach is characterized by clastic slopes of which 12% is considered highly stabilized, 20% partially stabilized and 3% unconsolidated material- which appears to have been relocated to this portion of the beach (Figure 3.9 photo B)

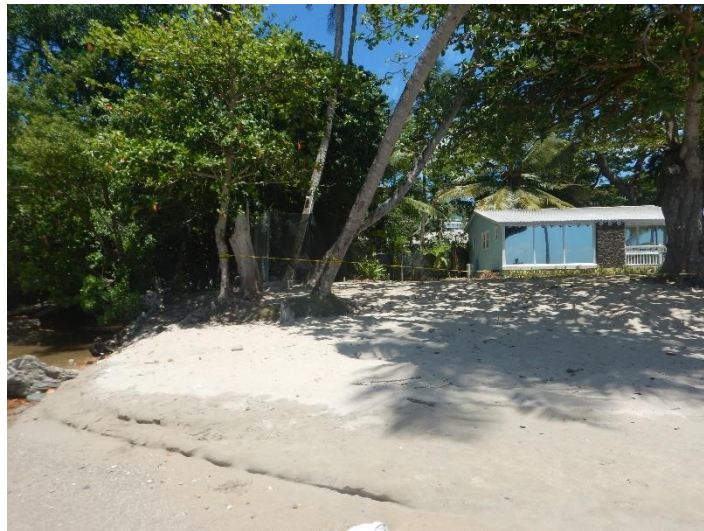
Figure 3.12 Mangrove bordering resort on Vigie
Beach- North

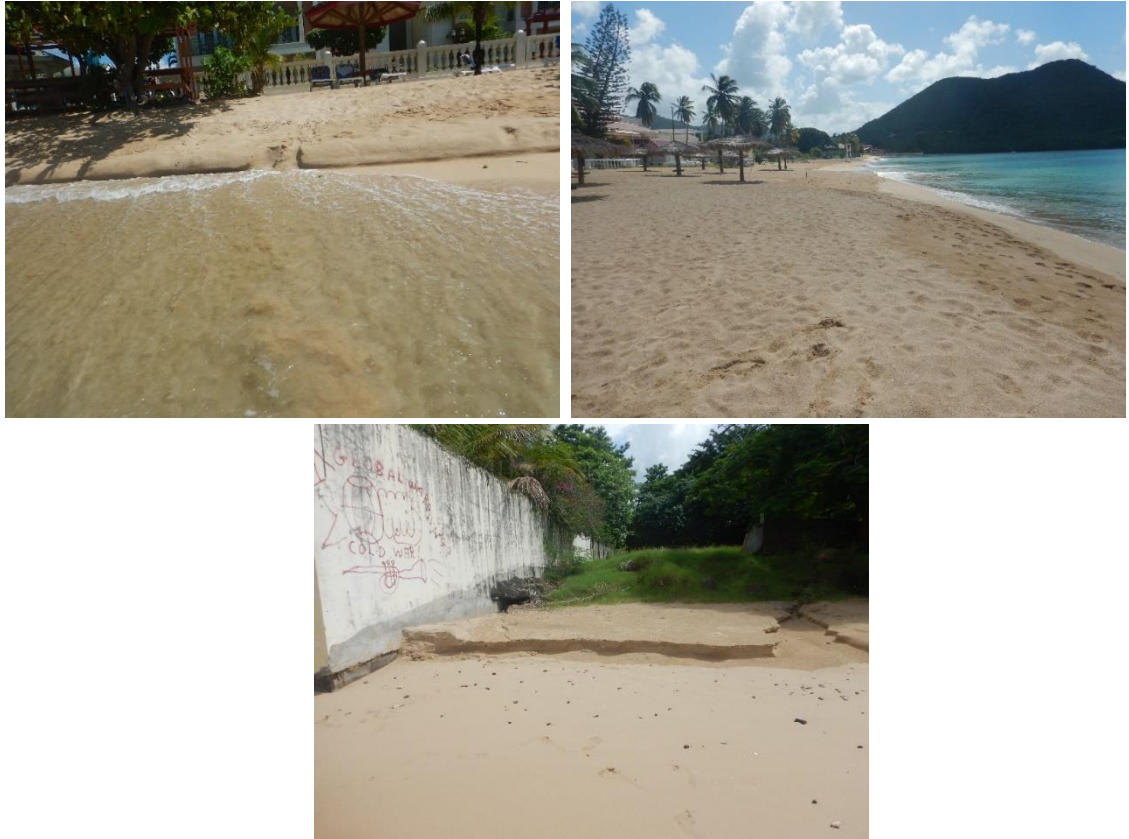
Figure 3.27 Appearance of Profile A (top left), profile B (top right) and profile C (bottom) waterline 2 weeks post disturbance

The appearance of the beach displayed a more comprehensive representation of the previous disturbance than small changes in the profiles. *Table 3.2* provides a comprehensive review of extreme changes observed on Redit Beach before the disturbance (pre-disturbance) and 2 weeks after the disturbance (post disturbance).
