**GOVERNMENT HOUSE, HALIFAX:
ARCHAEOLOGICAL RESOURCE IMPACT ASSESSMENT**

Heritage Research Permit A2006NS76, A2007NS05

March 2007

Submitted by:
Davis Archaeological Consultants Limited
6519 Oak Street
Halifax, Nova Scotia
B3L 1H6

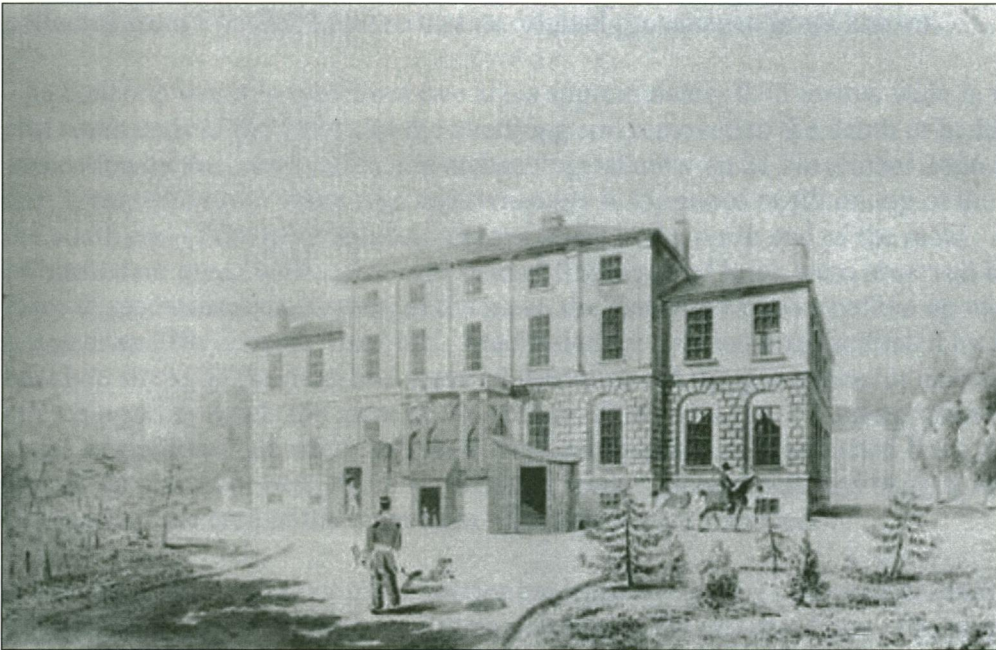
Figure 2.1-1: *Government House At Halifax Facing North-East, Hollis Street.* Guard houses can be seen in front of the entrance.⁵

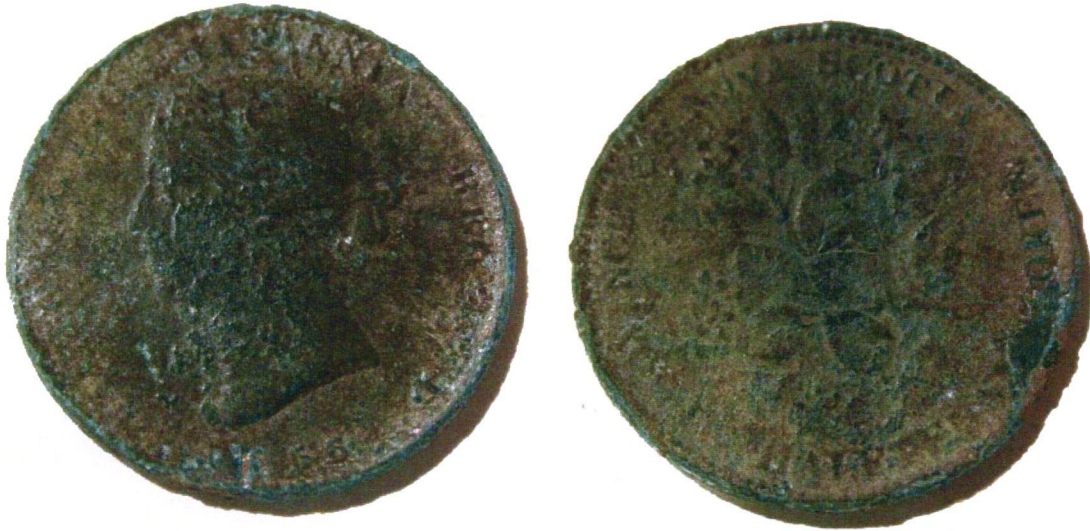
Visual inspection of the gardens on the west side of the house and landscaped areas along the Barrington Street property wall revealed fragments of black bottle glass, flat glass, and brick. An 1856 Nova Scotia Half Penny Token as well as a sherd of a grey stoneware blacking bottle were collected by Mr. Ken Jacobson, a stone mason, to whom we are grateful for turning them over to the archaeologists (Plate 1). The coin was collected from a backdirt pile so that its original provenance is not known.

Plate 1: 1856 Nova Scotia Half Penny Token before archaeological conservation (left: obverse, right: reverse).

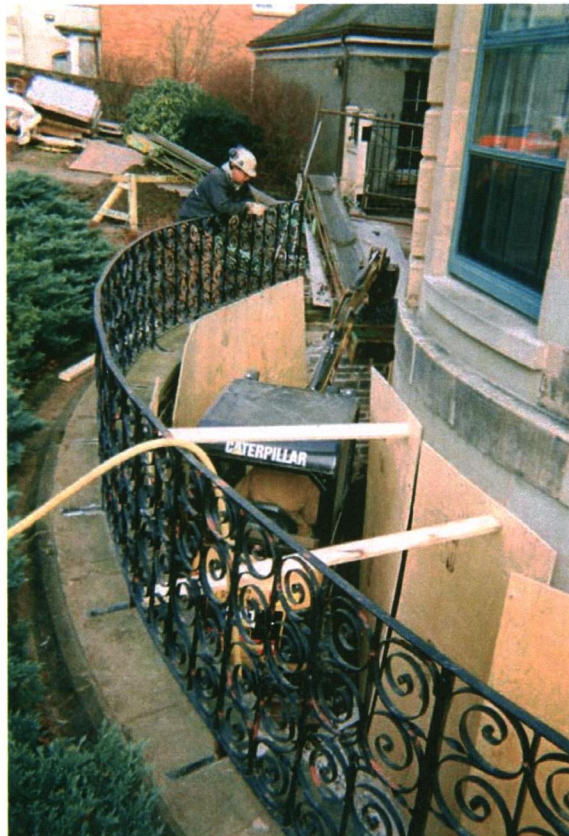
Plate 4: Mechanical excavation in the moat showing the set up of the mini-excavator (foreground) and conveyor belt (background).
